GEOTUBES ALONG THE GULF SHORELINE OF THE UPPER TEXAS COAST: OBSERVATIONS DURING 2001

**A Report of the Texas Coastal Coordination Council pursuant to National Oceanic
and Atmospheric Administration Award No. NA97OZ0179
GLO Contract Number 01-597 R**

**Bureau of Economic Geology
Scott W. Tinker, Director
The University of Texas at Austin
Austin, Texas 78713-8924**

March 2002

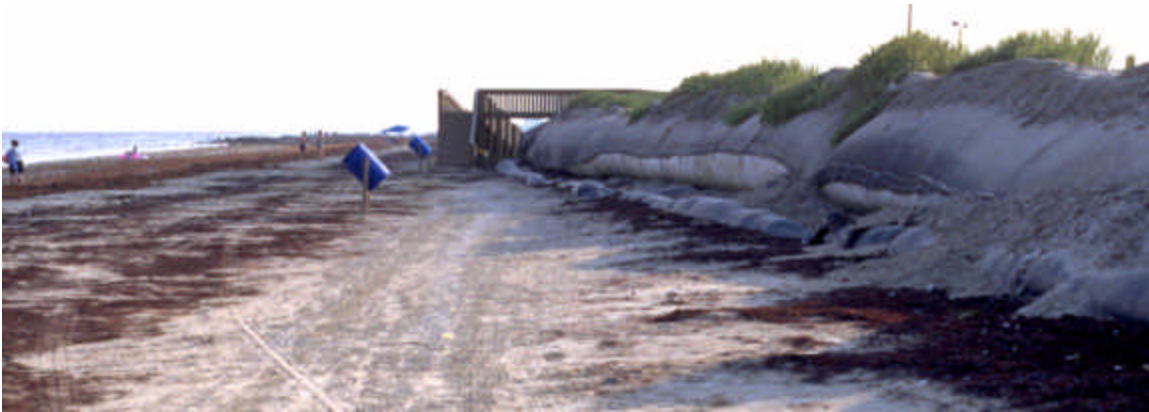
Figure 7. Example of fully exposed geotube front and scour apron at the Dellanera project on Galveston Island, July 18, 2001.

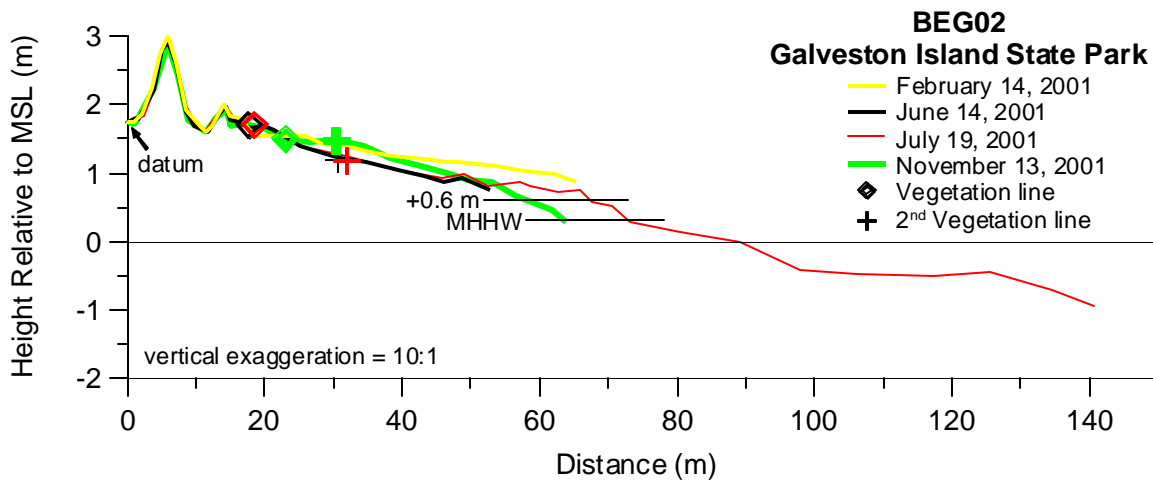
Figure 11. Beach profiles at Galveston Island State Park, location BEG02 (see Fig. 6 for location). The foredune and incipient dune seaward of the foredune survived Tropical Storm Allison in early June, 2001.

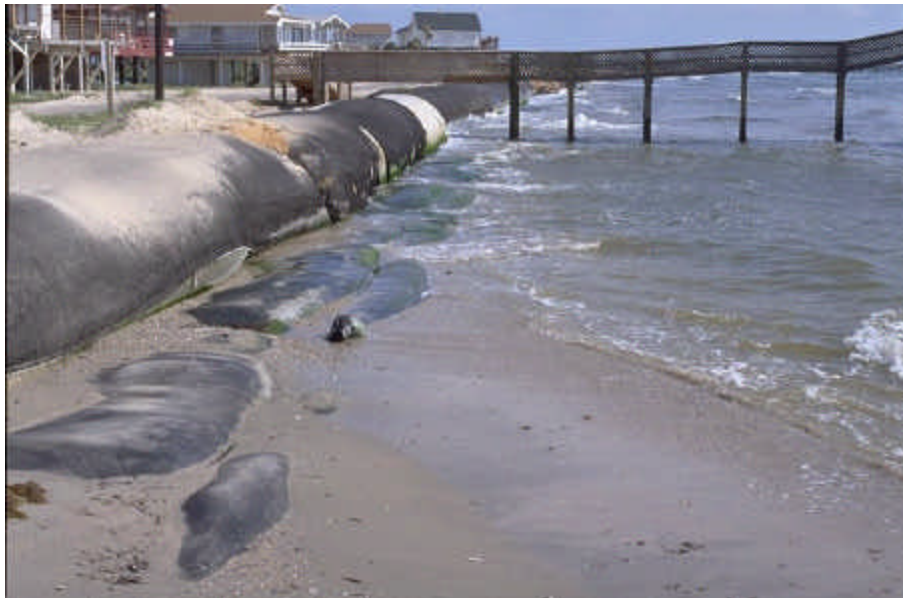
Figure 14. Treasure Island middle geotube on July 19, 2001. Except for a short piece in the foreground this section was completely destroyed in November 2001. Note exposed scour apron and damaged UV shroud.

In July there were no beaches in front of the Treasure Island middle project (Fig. 14), most of the south project, and the southern part of the north project; the bases of the geotubes were at the MHHW line (Plate 3). By November the remaining beach in front of the north geotube was eroded allowing direct wave attack on the tube. This shoreline is under the influence of San Luis Pass and has historically undergone dramatic shoreline retreat and advance in response to changes in the sand supply, tidal channels, and offshore shoals. The shoreline along the Treasure Island development is currently in a retreat phase, and the geotubes cannot prevent this natural shoreline adjustment.

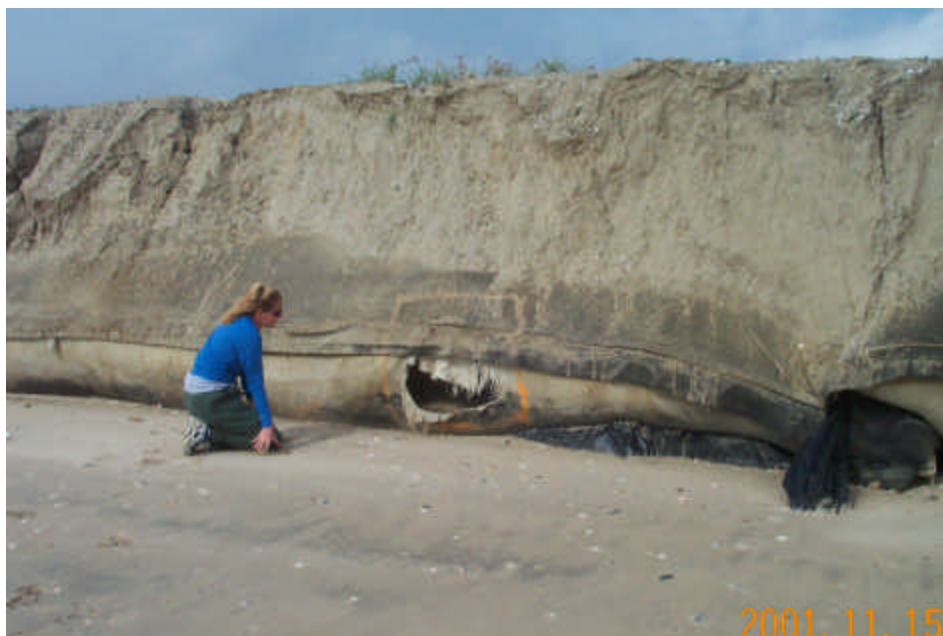
Figure 15. Puncture in Gilchrist West geotube on November 15, 2001.

1. The storm protection function of the geotubes has not been tested.
2. The geotubes will fail when exposed to direct wave attack making them useful only for short-term erosion control. This is evident in the failure of the Treasure Island middle project, and in the holes in the geotube fabric along the Gilchrist West project. To prevent failure it is critical to keep the geotubes covered with sand, to maintain a beach in front of them, and to repair holes in the fabric as soon as possible.

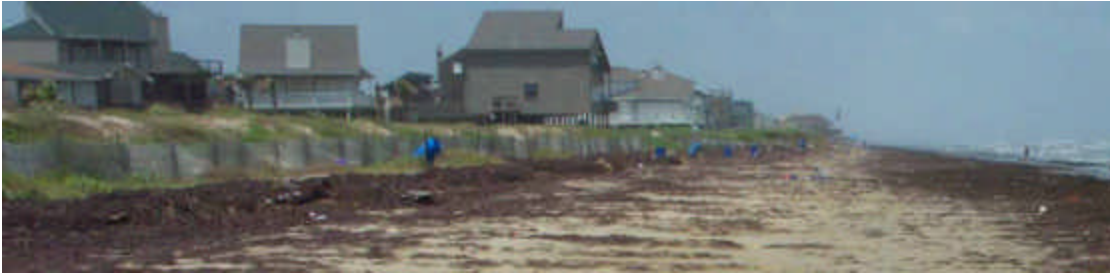
It is notable that most of the seaward faces of the Gilchrist West geotubes were exposed following Allison, but only 10% of the Pirates Beach project was exposed. This disparity occurred even though these projects had nearly the same width of beach in front of them in July (Table 3). Before Allison, however, the Pirates Beach project had sand fencing and vegetated sand in front of the geotubes unlike the Gilchrist West project (Fig. 16). This additional volume of vegetated sand and possibly the presence of nearshore

Figure 16. Pirates Beach geotube at GAL01 profile location (see figure 6 for location). This geotube remained covered and vegetated following Tropical Storm Allison. Note sand fence and lack of coppice mound subenvironment.

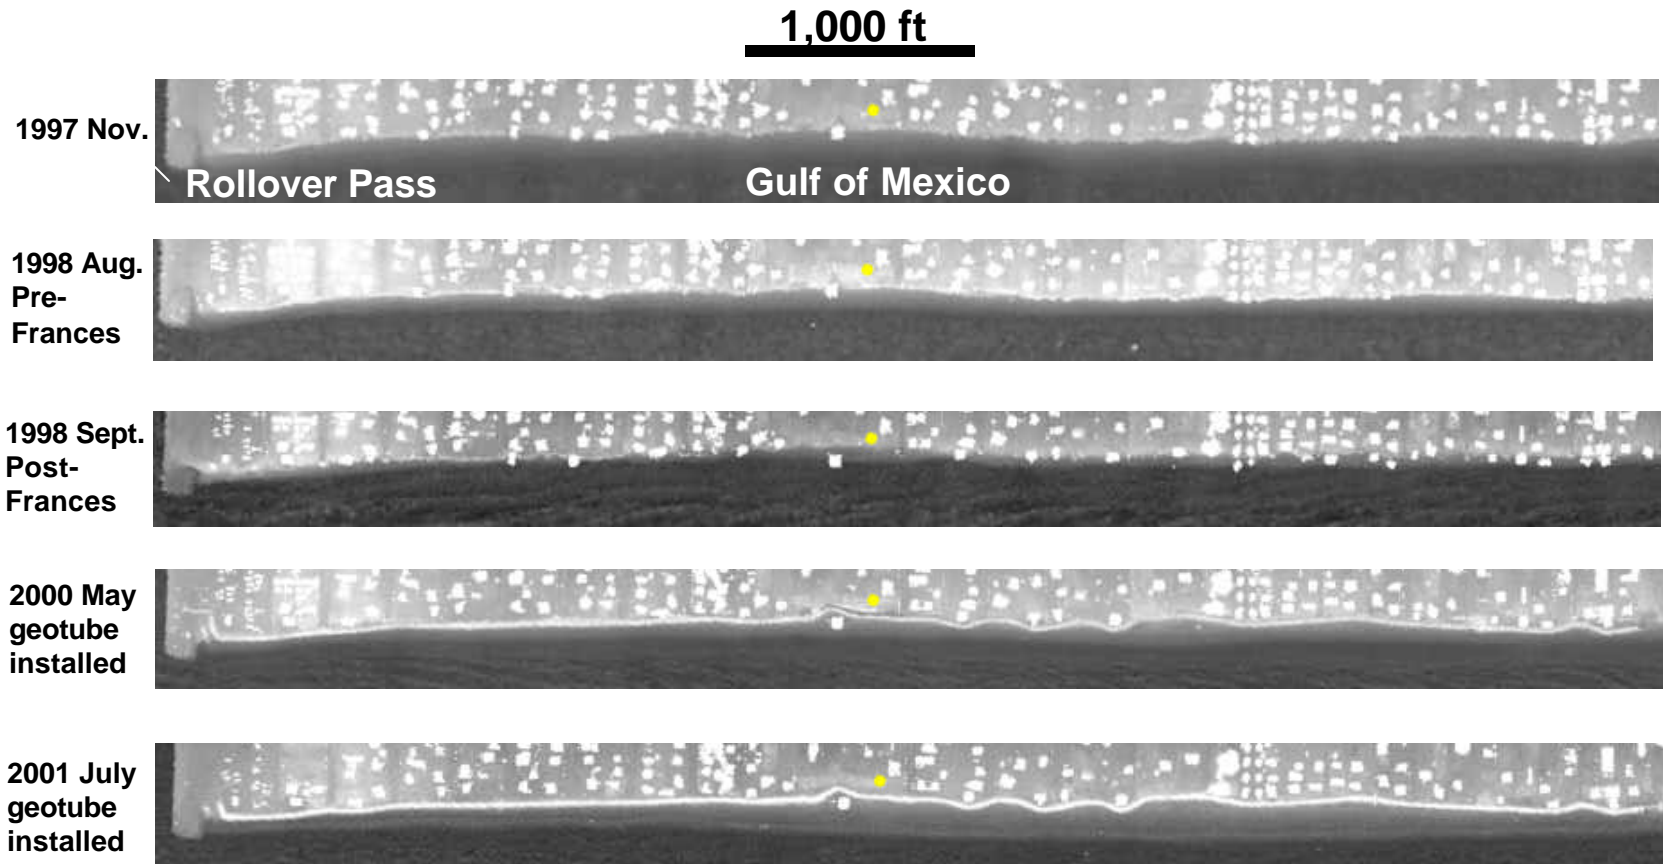
Figure 17. Lidar topographic images of Gilchrist East project. Dark areas are low elevation, lighter higher elevation. Geotube was present during the 2000 and 2001 surveys. Note how geotube was routed seaward of some houses and the overall geomorphic impact of the project.

individual houses or groups of houses (Fig. 17, Plates 1 and 2). These areas create particularly narrow beaches that are not passable during times of moderately elevated water levels (1 to 2 ft above MHHW) (Fig. 18). Furthermore, outflow from the drainage pipes along the Pirates Beach project erode channels perpendicular to the shoreline that at times hinder passage (Fig. 19). These drainage pipes, which concentrate flow through the geotubes, are required to prevent flooding from rainfall landward of the geotube.

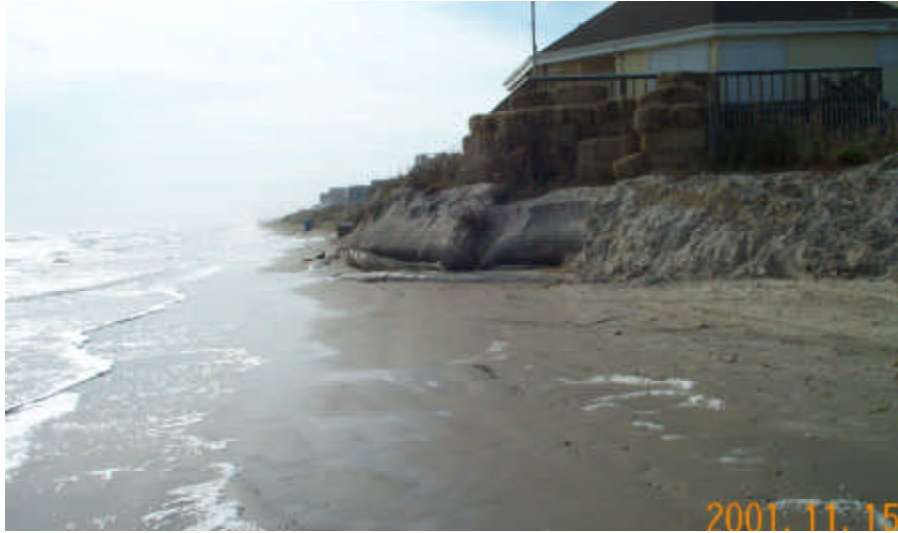
Figure 18. Pirates Beach geotube on November 15, 2001. Geotube at this location was routed seaward of the house causing a particularly narrow beach and difficulty in maintaining a sand cover on the geotube. Water level was about 2.0 ft (0.61 m) above mean sea level.

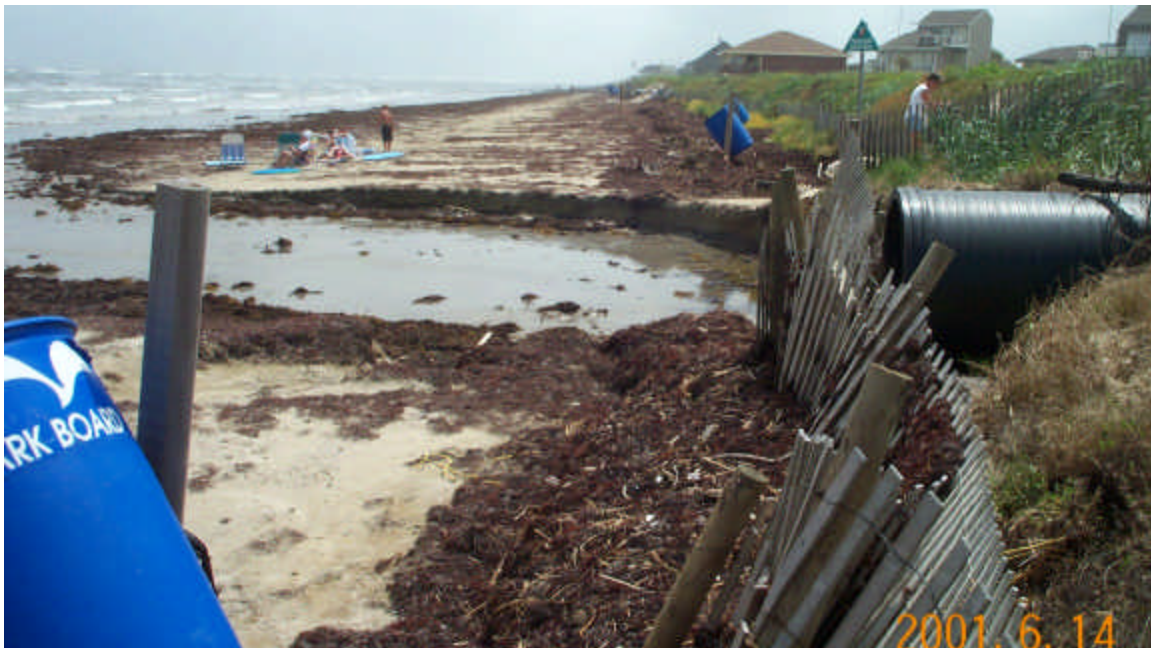
Figure 19. Pirates Beach geotube project on June 14, 2001 after Tropical Storm Allison. Rainfall runoff from Allison flowed through the black street drainage pipe beneath the geotube on the right and eroded this channel in the beach.

11. After rainfall, outflows from street drainage pipes along the Pirates Beach project erode channels perpendicular to the beach that at times hinder passage along the beach.
12. Geotubes alter the natural geomorphology of the beach/dune system and have hindered the formation of coppice mounds.
13. The geotubes have not enhanced erosion rates on adjacent beaches. If the beaches in front of the geotubes are not nourished with sand from outside the littoral system, then there may be a small enhancement of erosion of adjacent beaches until the geotubes are destroyed by wave action.

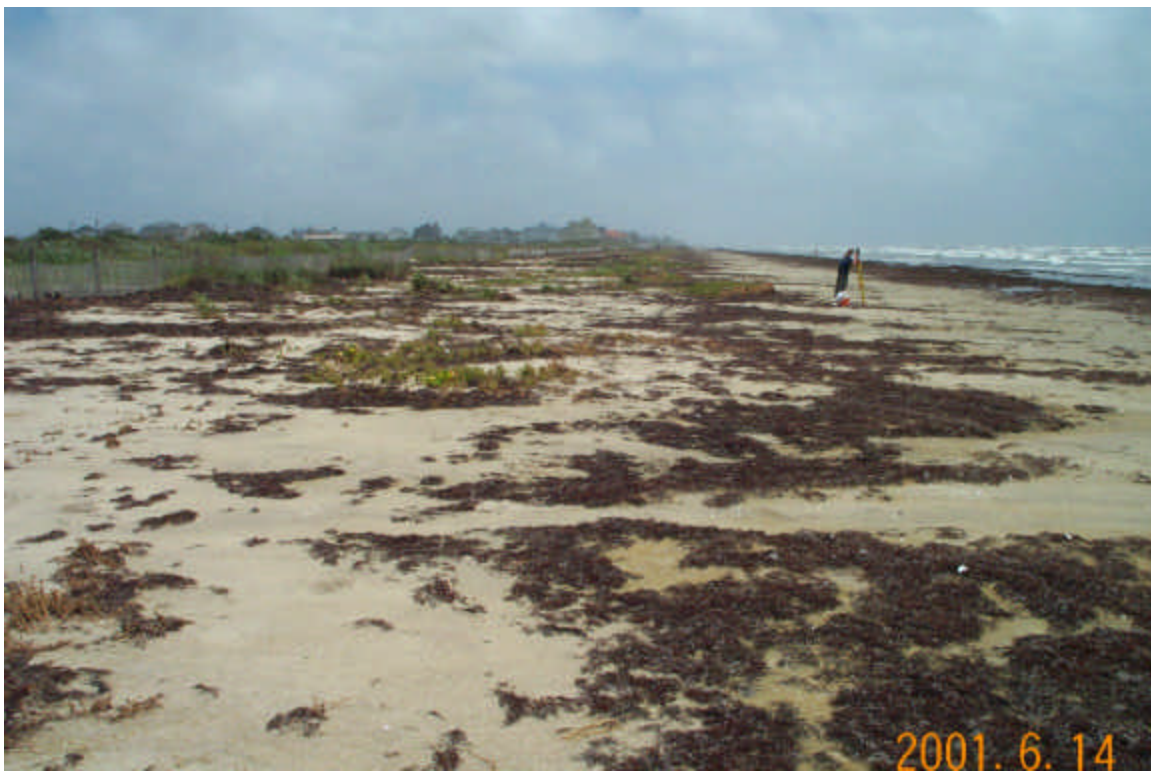
Figure 20. Coppice mounds at BEG02 profile location in Galveston Island State Park on June 14, 2001 (see figure 6 for location). This subenvironment of wind-blown sand and sparse vegetation was eroded but survived Tropical Storm Allison.
