Geotextile Tubes along the Upper Texas Gulf Coast

May 2000 to March 2003

November 2003

A Report of the
Texas Coastal
Coordination
Council pursuant
to National
Oceanic and
Atmospheric
Administration
Award No.
NA07OZ0134,
GLO Contract
No. 02-493 R

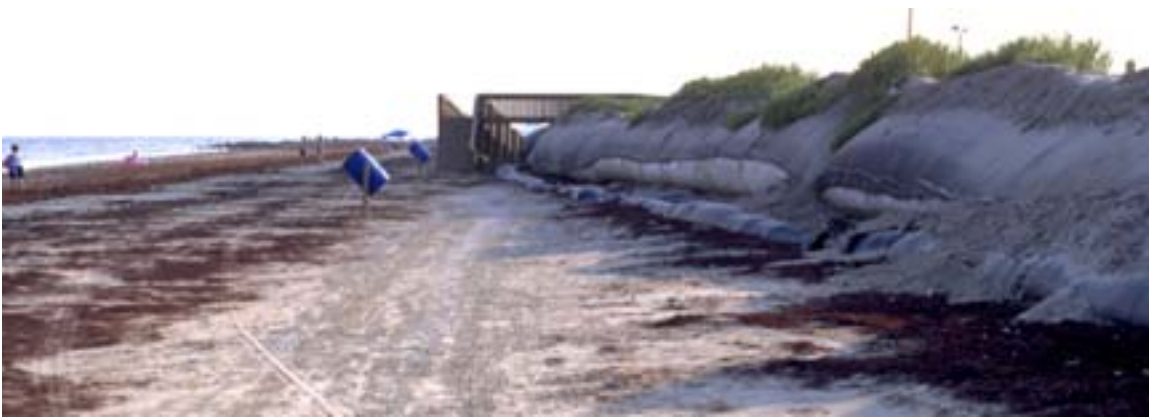
Figure 7. Example of fully exposed geotextile tube front and scour apron at the Dellanera project on Galveston Island, July 18, 2001.

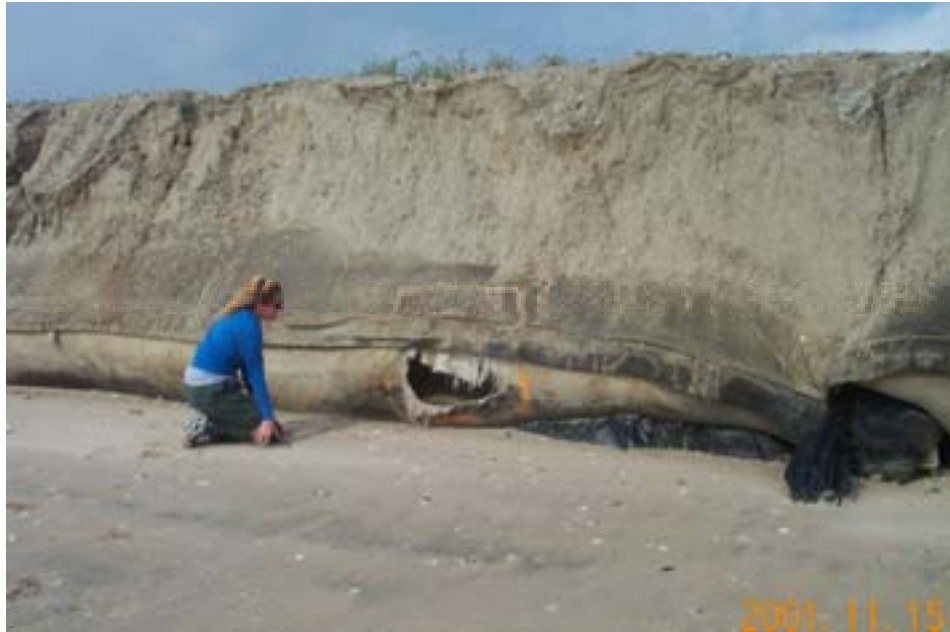
Punctures have been observed at all the projects except Pocket Park II and Pirates Beach. The Pocket Park II project retained its sand cover, and the relatively wide beach in front of the tube has protected it from damage. Much of the Pirates Beach project, however, was exposed by TS Fay in September of 2002 and remained exposed over the 2002/03 winter. If these conditions prevail, it is expected the Pirates Beach geotextile

Figure 20. Puncture in Gilchrist West (Caplen area) geotextile tube on November 15, 2001.

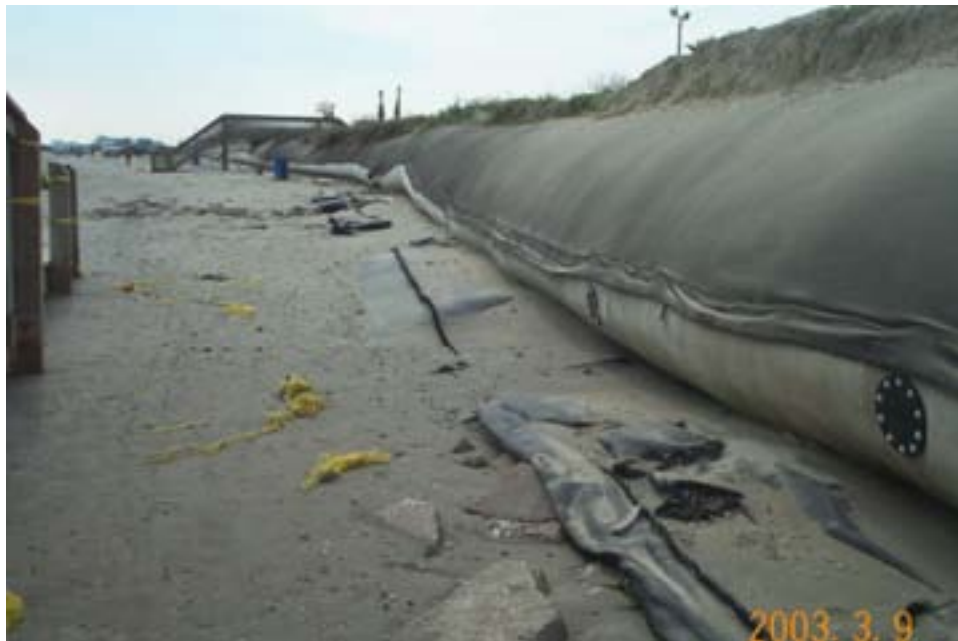
Figure 21. Seaward scour apron exposed and damaged and patched holes in Dellanera geotextile tube on March 9, 2003.

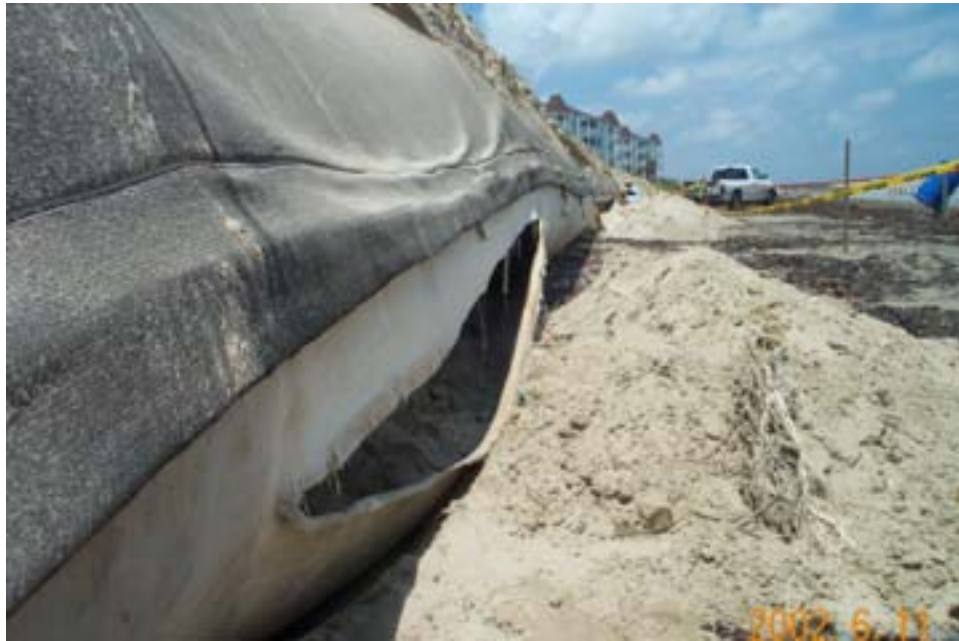
Figure 22. Tear in Dellanera geotextile tube on June 11, 2002. Some have speculated that this hole was the result of vandalism. It has since been patched

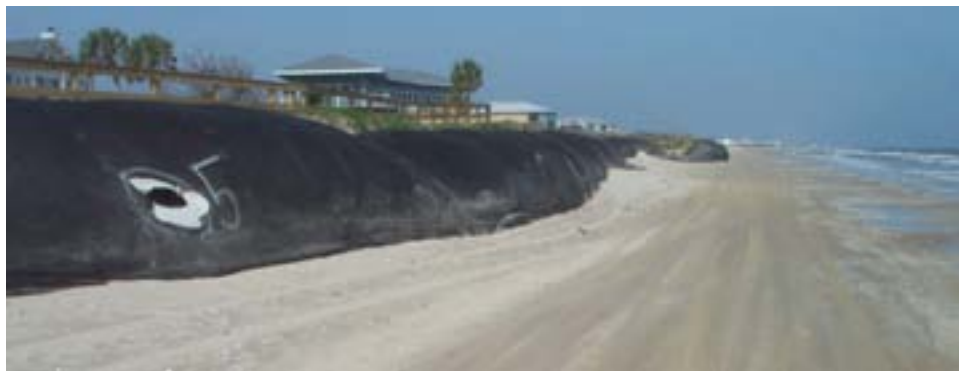
Figure 23. Slumped and collapsed geotextile tube with patched hole near east end of Gilchrist West project (in Caplen) on March 10, 2003. Note completely collapsed section in distance where tube turns seaward.

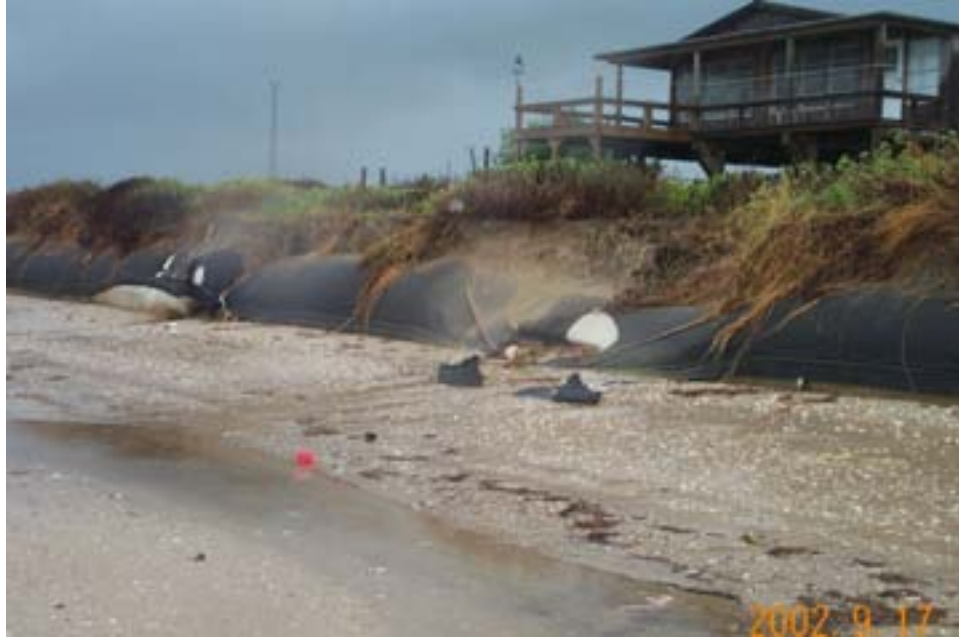
Figure 24. Collapsed geotextile tube section along west end of Gilchrist West project on September 17, 2002 after Tropical Storm Fay.

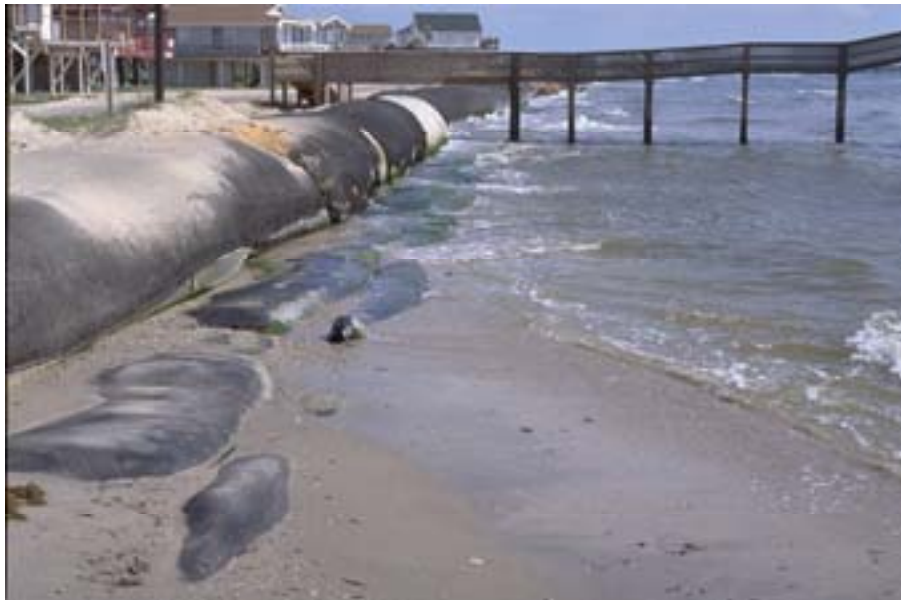
Figure 25. Treasure Island middle geotextile tube on July 19, 2001. Except for a short piece in the foreground this section was completely destroyed in November 2001. Note exposed scour apron and damaged UV shroud. Tube has begun to lose its shape and slump seaward in places.

The Treasure Island middle and south projects, which had only narrow beaches in front of the tubes at the time of installation in March 2000, had mostly been destroyed by November 2001 and June 2002, respectively (Figs. 25 and 5, Plate 3). By November 2001 the beach in front of the north tube was eroded allowing direct wave attack on the tube. In March 2003, most of the UV shroud of the north tube had been destroyed, and erosion had occurred landward of the tube (Fig. 26, Plate 3). This shoreline is under the influence of San Luis Pass and has historically undergone dramatic shoreline retreat and advance in response to changes in the sand supply, tidal channels, and offshore shoals. The shoreline along the Treasure Island development is currently in a retreat phase, and the geotextile tubes cannot prevent this natural shoreline adjustment.

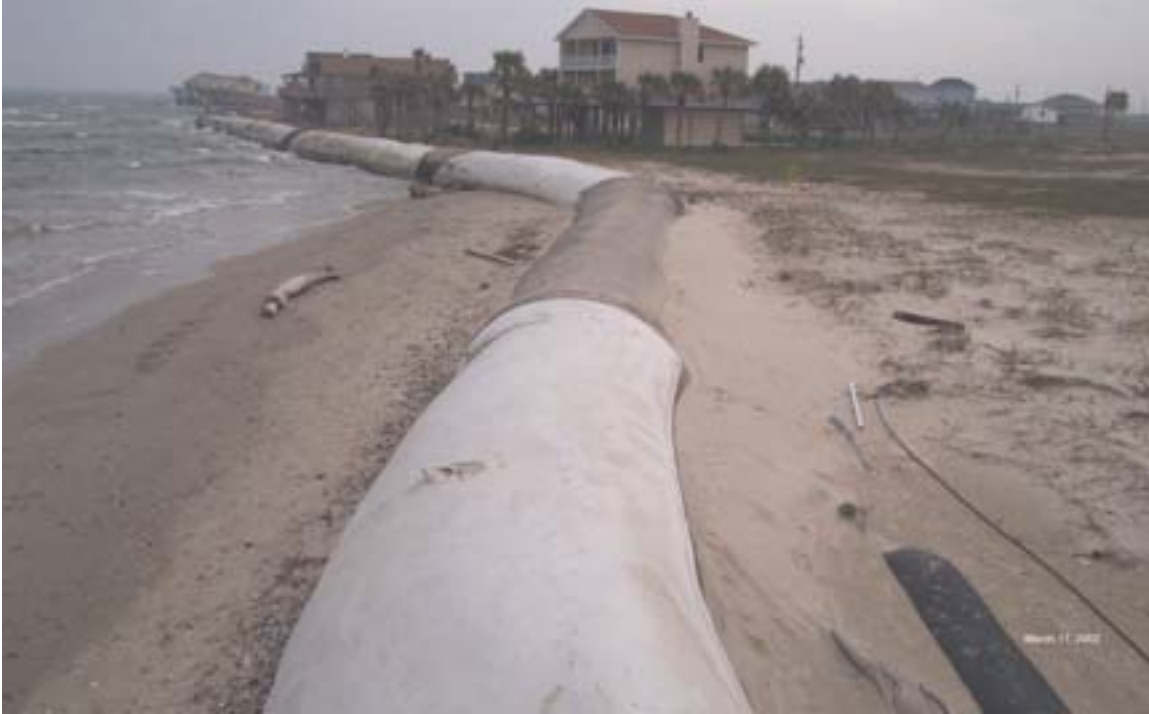
Figure 26. Treasure Island north geotextile tube on March 11, 2003. The UV shroud was almost completely destroyed and erosion had occurred behind the tube with some wind-blown sand deposited between the landward side of the tube and the erosional scarp.

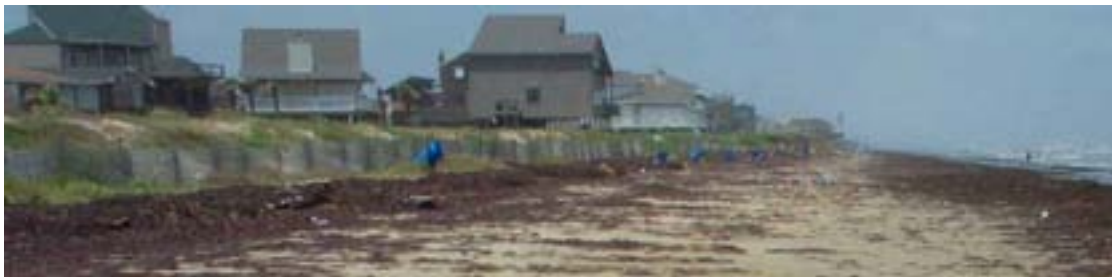
In contrast to the Gilchrist West project where most of the tube was exposed by TS Allison in June 2001, only 10% of the Pirates Beach project was exposed. Before Allison, the Pirates Beach project had sand fencing and vegetated sand in front of the tubes unlike the Gilchrist West project. This additional volume of vegetated sand and a beach wider by about 16 ft (5 m) protected the tubes (Fig. 27). Tubes exposed by TS Allison generally had beaches less than 50-ft wide (15 m). Thus this is the width beaches need to be if the tubes are to retain their sand cover during a mild storm like TS Allison. A thick and vegetated sand cover on the tubes can partly compensate for a narrower beach.

Figure 27. Pirates Beach geotextile tube at GAL01 profile location (see figure 6 for location). This project remained covered and vegetated following Tropical Storm Allison. Note sand fence and lack of coppice mound subenvironment.

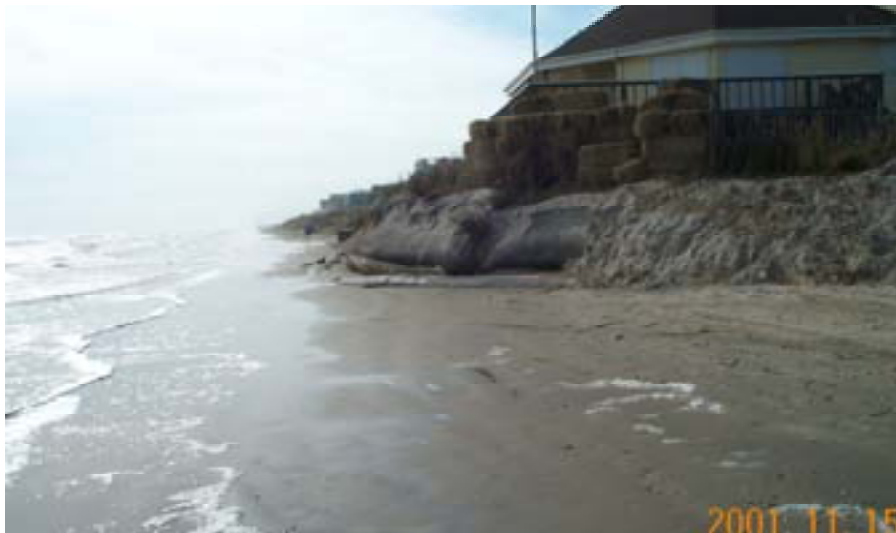
Some tube segments were routed seaward of individual houses or groups of houses (Figs. 28, 29, Plates 1 and 2). These areas create particularly narrow beaches that are not passable during times of moderately elevated water levels (1 to 2 ft above MHHW) (Fig. 28). Furthermore, outflow from the drainage pipes along the Pirates Beach project erode channels perpendicular to the shoreline that at times hinder passage (Fig. 30). These drainage pipes, which concentrate flow through the tubes, are required to prevent flooding from rainfall landward of the tubes.

Figure 28. Pirates Beach geotextile tube on November 15, 2001. The tube at this location was routed seaward of the house causing a particularly narrow beach and difficulty in maintaining a sand cover. Water level was about 1 ft (0.3 m) above mean higher high water.

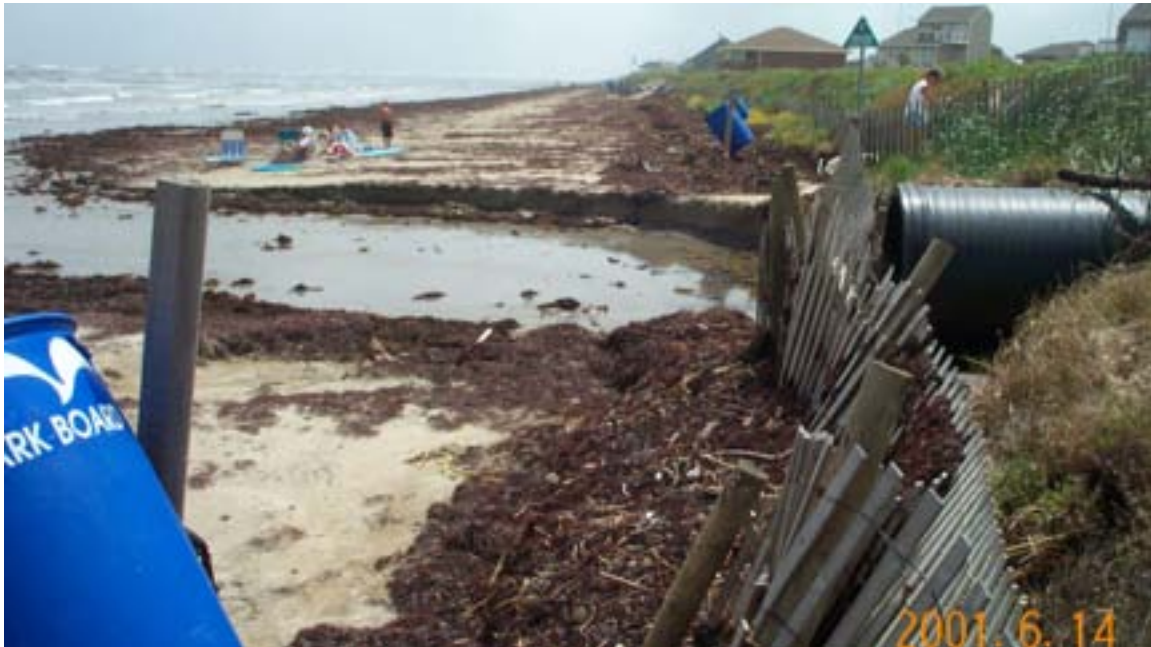
Figure 30. Pirates Beach geotextile tube project on June 14, 2001 after Tropical Storm Allison. Rainfall runoff from Allison flowed through the black street drainage pipe beneath the tube on the right and eroded this channel in the beach.

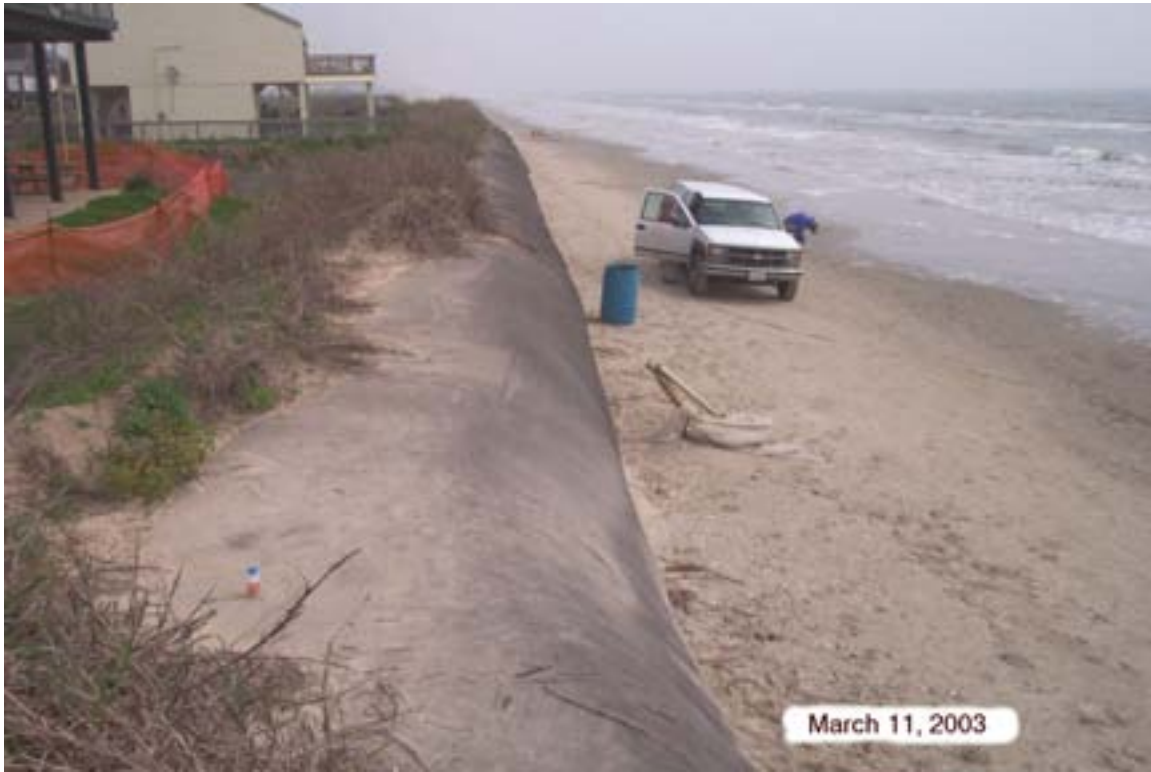
Figure 34. GAL02 beach profile location in the Pirates Beach geotextile tube project on March 11, 2003. There is no coppice mound environment seaward of the tube because the beach is too narrow and too low for vegetation and wind-blown sand to accumulate (see Fig. 6 for location and Fig. 32 for beach profile).
