# Geotextile Tubes along the Upper Texas Gulf Coast

May 2000 to March 2003

## Bureau of Economic Geology

A Report of the  
Texas Coastal  
Coordination  
Council pursuant  
to National  
Oceanic and  
Atmospheric  
Administration  
Award No.  
NA07OZ0134,  
GLO Contract  
No. 02-493 R

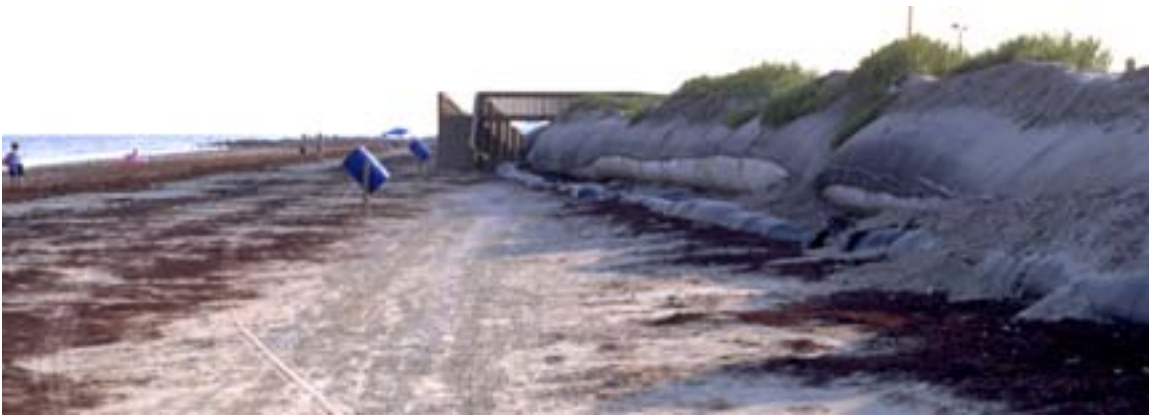
**Figure 7. Example of fully exposed geotextile tube front and scour apron at the Dellanera project on Galveston Island, July 18, 2001.**

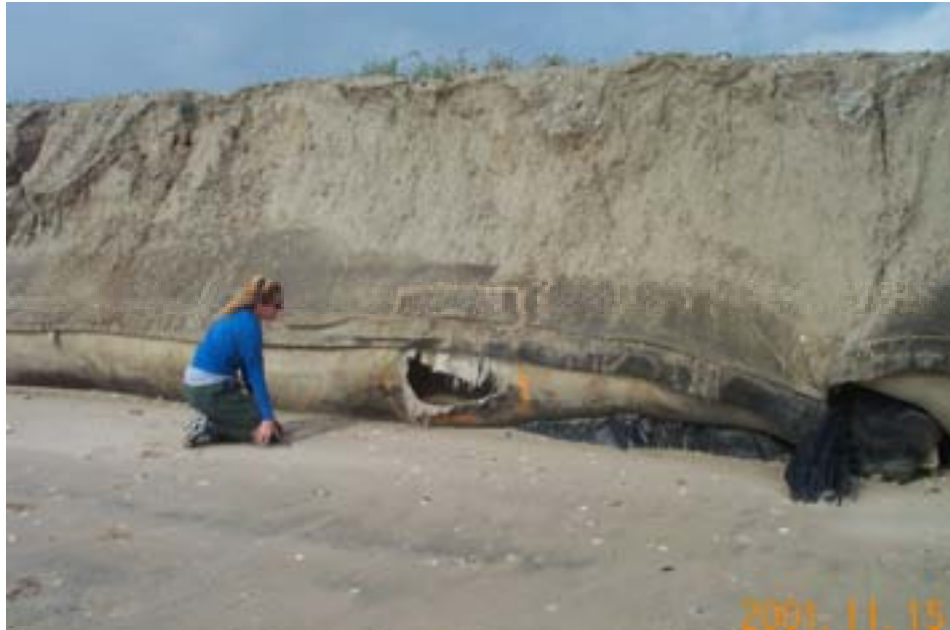
Punctures have been observed at all the projects except Pocket Park II and Pirates Beach. The Pocket Park II project retained its sand cover, and the relatively wide beach in front of the tube has protected it from damage. Much of the Pirates Beach project, however, was exposed by TS Fay in September of 2002 and remained exposed over the 2002/03 winter. If these conditions prevail, it is expected the Pirates Beach geotextile

**Figure 20. Puncture in Gilchrist West (Caplen area) geotextile tube on November 15, 2001.**

tubes will also suffer damage. If beach nourishment does not maintain a beach wide enough to keep the tubes landward of the swash zone, it is expected they will be destroyed by conditions not necessarily reaching the level of tropical storms. This is particularly true in settings with hard debris in the surf zone that can puncture the fabric such as the small riprap at Treasure Island.

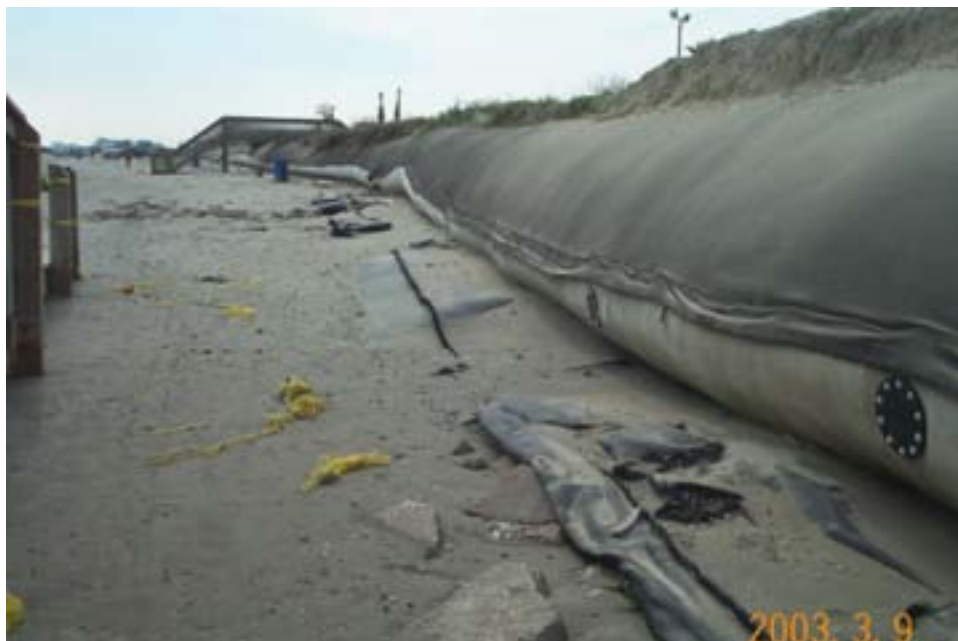
**Figure 21. Seaward scour apron exposed and damaged and patched holes in Dellanera geotextile tube on March 9, 2003.**

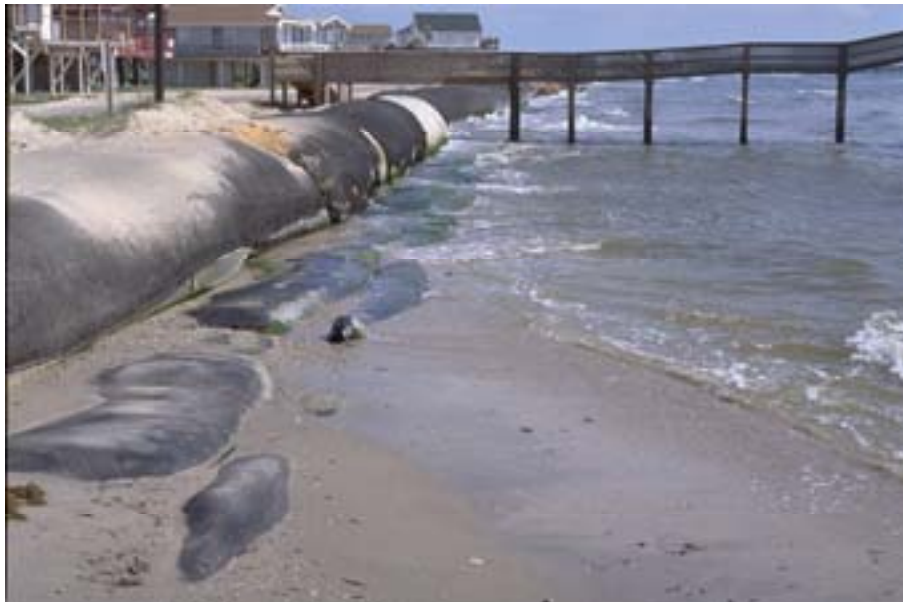
**Figure 25. Treasure Island middle geotextile tube on July 19, 2001. Except for a short piece in the foreground this section was completely destroyed in November 2001. Note exposed scour apron and damaged UV shroud. Tube has begun to lose its shape and slump seaward in places.**

The Treasure Island middle and south projects, which had only narrow beaches in front of the tubes at the time of installation in March 2000, had mostly been destroyed by November 2001 and June 2002, respectively (Figs. 25 and 5, Plate 3). By November 2001 the beach in front of the north tube was eroded allowing direct wave attack on the tube. In March 2003, most of the UV shroud of the north tube had been destroyed, and erosion had occurred landward of the tube (Fig. 26, Plate 3). This shoreline is under the influence of San Luis Pass and has historically undergone dramatic shoreline retreat and advance in response to changes in the sand supply, tidal channels, and offshore shoals. The shoreline along the Treasure Island development is currently in a retreat phase, and the geotextile tubes cannot prevent this natural shoreline adjustment.

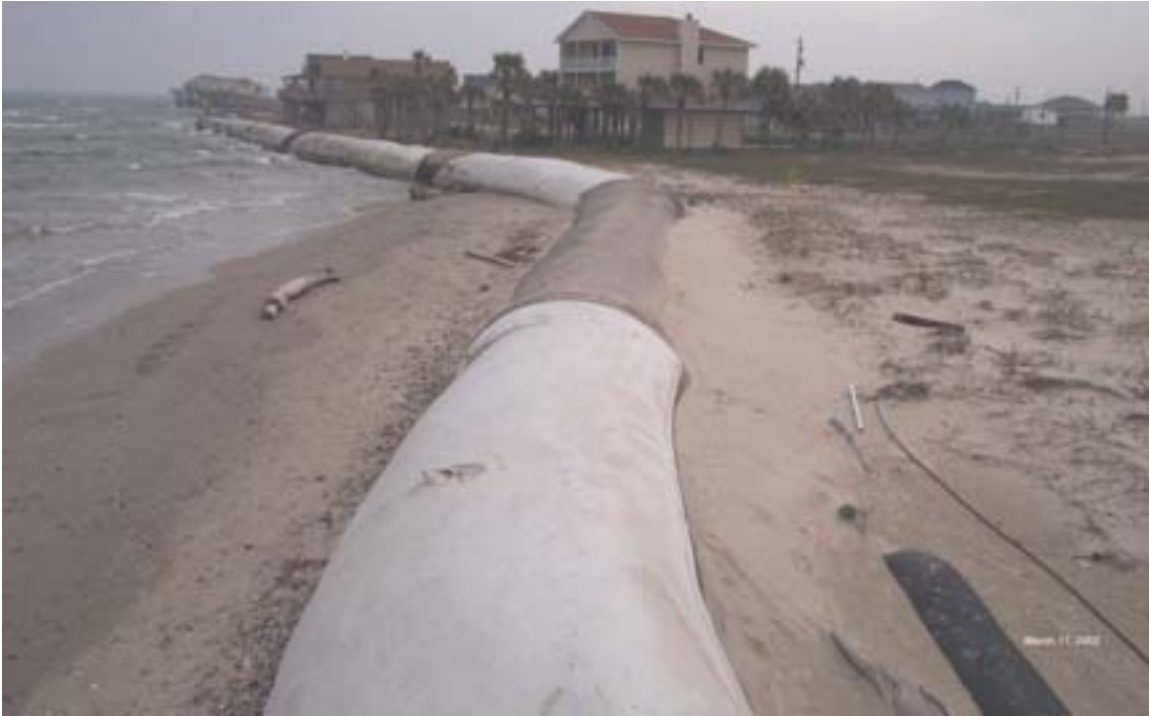
**Figure 26. Treasure Island north geotextile tube on March 11, 2003. The UV shroud was almost completely destroyed and erosion had occurred behind the tube with some wind-blown sand deposited between the landward side of the tube and the erosional scarp.**

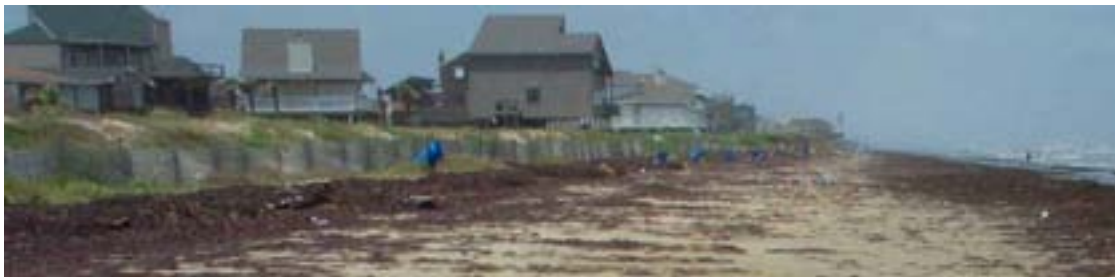
In contrast to the Gilchrist West project where most of the tube was exposed by TS Allison in June 2001, only 10% of the Pirates Beach project was exposed. Before Allison, the Pirates Beach project had sand fencing and vegetated sand in front of the tubes unlike the Gilchrist West project. This additional volume of vegetated sand and a beach wider by about 16 ft (5 m) protected the tubes (Fig. 27). Tubes exposed by TS Allison generally had beaches less than 50-ft wide (15 m). Thus this is the width beaches need to be if the tubes are to retain their sand cover during a mild storm like TS Allison. A thick and vegetated sand cover on the tubes can partly compensate for a narrower beach.

**Figure 27. Pirates Beach geotextile tube at GAL01 profile location (see figure 6 for location). This project remained covered and vegetated following Tropical Storm Allison. Note sand fence and lack of coppice mound subenvironment.**

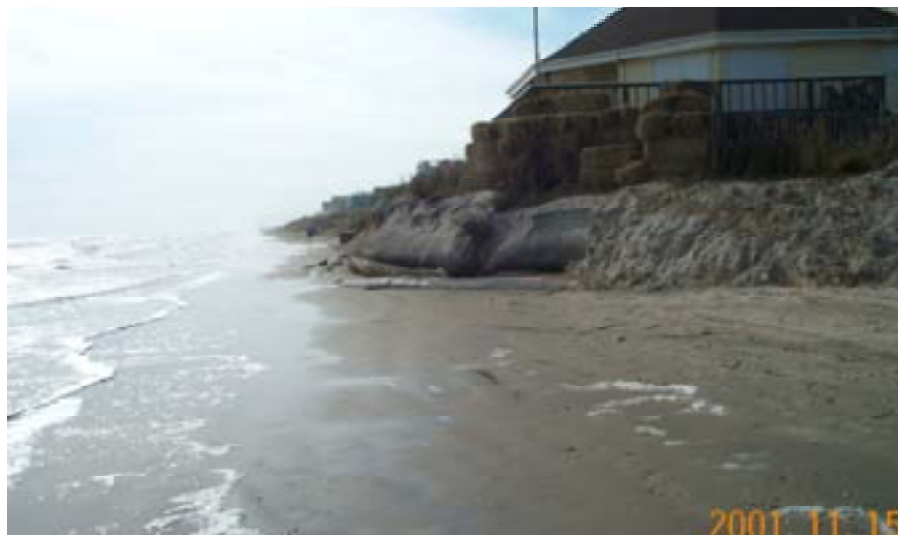
Some tube segments were routed seaward of individual houses or groups of houses (Figs. 28, 29, Plates 1 and 2). These areas create particularly narrow beaches that are not passable during times of moderately elevated water levels (1 to 2 ft above MHHW) (Fig. 28). Furthermore, outflow from the drainage pipes along the Pirates Beach project erode channels perpendicular to the shoreline that at times hinder passage (Fig. 30). These drainage pipes, which concentrate flow through the tubes, are required to prevent flooding from rainfall landward of the tubes.

**Figure 28. Pirates Beach geotextile tube on November 15, 2001. The tube at this location was routed seaward of the house causing a particularly narrow beach and difficulty in maintaining a sand cover. Water level was about 1 ft (0.3 m) above mean higher high water.**

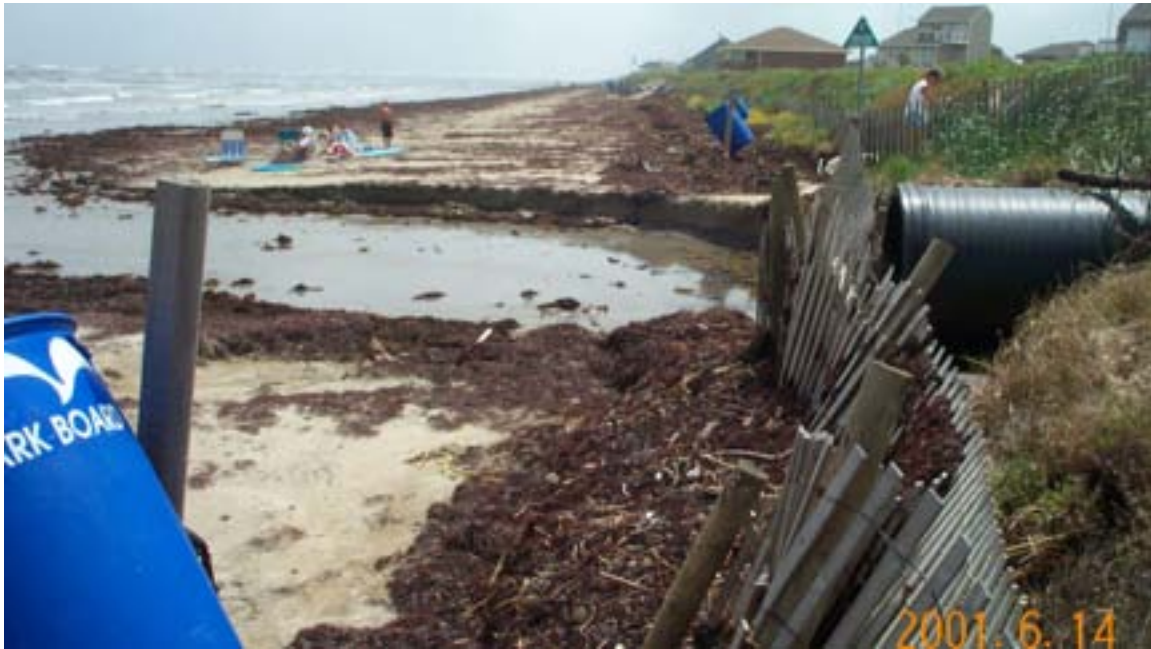
**Figure 30. Pirates Beach geotextile tube project on June 14, 2001 after Tropical Storm Allison. Rainfall runoff from Allison flowed through the black street drainage pipe beneath the tube on the right and eroded this channel in the beach.**

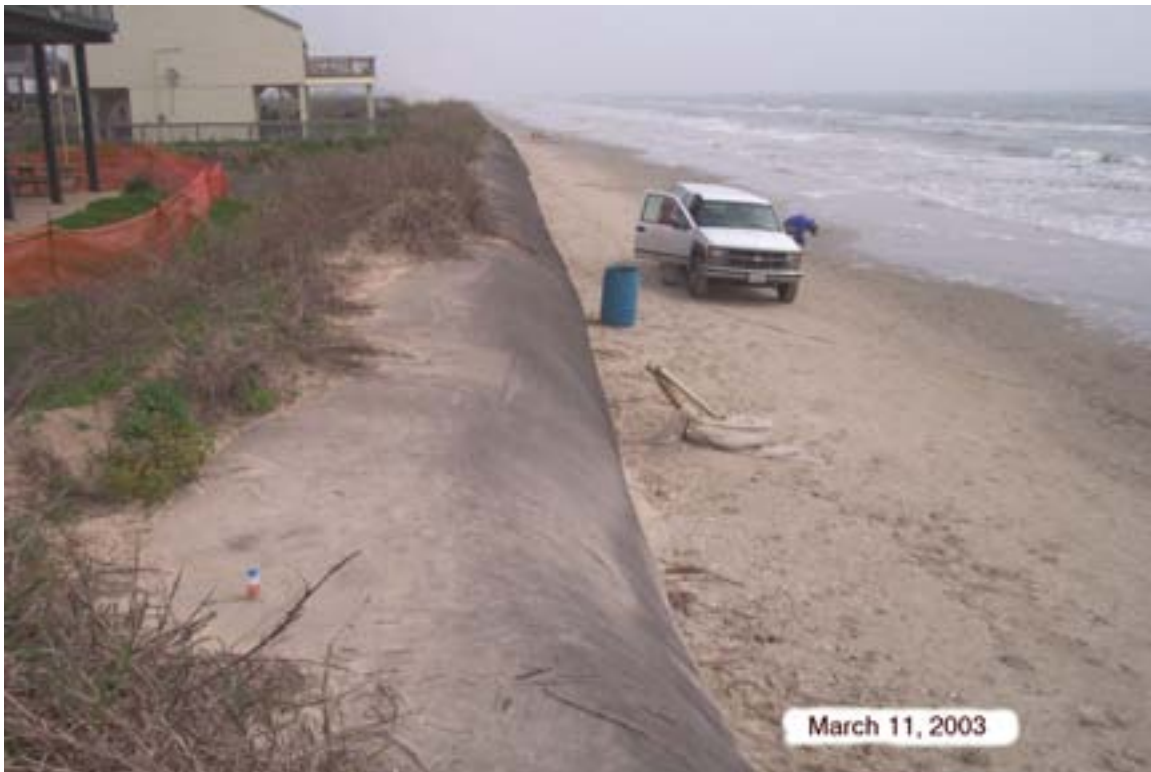
**Figure 34. GAL02 beach profile location in the Pirates Beach geotextile tube project on March 11, 2003. There is no coppice mound environment seaward of the tube because the beach is too narrow and too low for vegetation and wind-blown sand to accumulate (see Fig. 6 for location and Fig. 32 for beach profile).**
