# GEOTUBES ALONG THE GULF SHORELINE OF THE UPPER TEXAS COAST: OBSERVATIONS DURING 2001

James C. Gibeaut, Tiffany L. Hepner, Rachel Waldinger, John R. Andrews,  
Rebecca C. Smyth, Roberto Gutierrez

A Report of the Texas Coastal Coordination Council pursuant to National Oceanic  
and Atmospheric Administration Award No. NA97OZ0179  
GLO Contract Number 01-597 R

March 2002

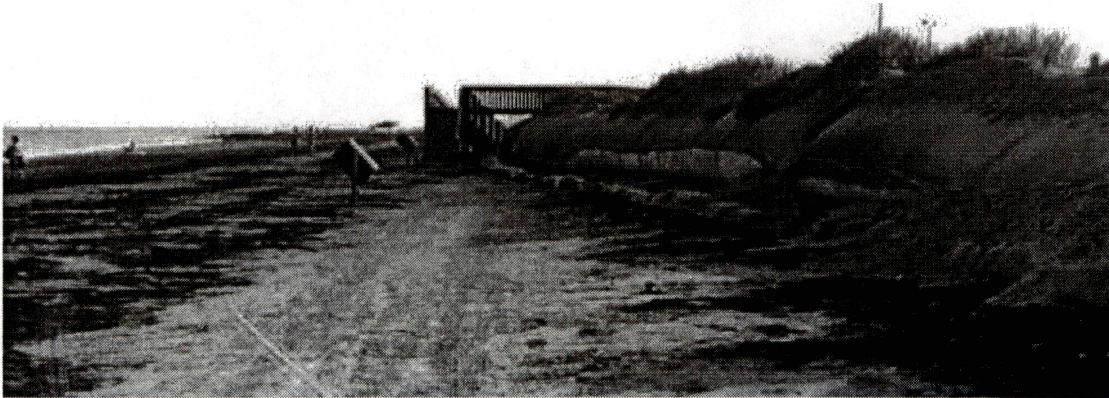
**Figure 7. Example of fully exposed geotube front and scour apron at the Dellanera project on Galveston Island, July 18, 2001.**

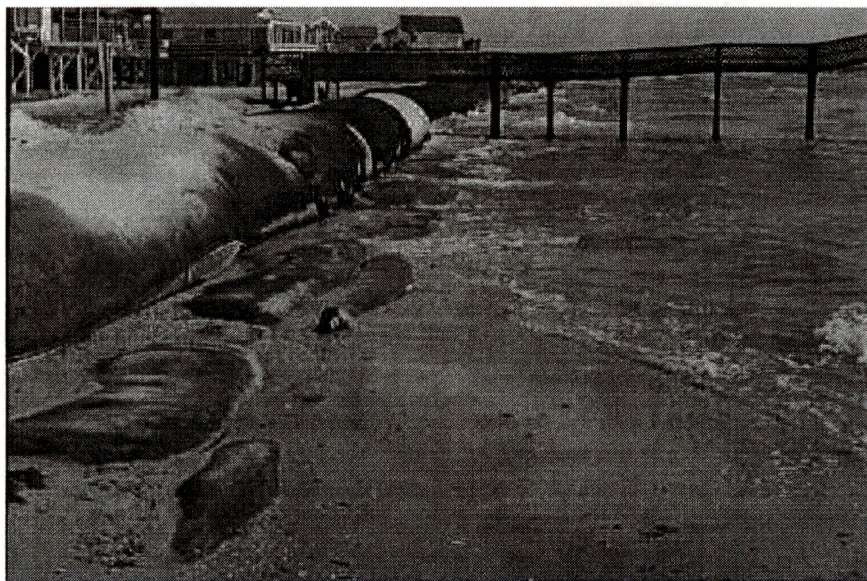
**Figure 14. Treasure Island middle geotube on July 19, 2001. Except for a short piece in the foreground this section was completely destroyed in November 2001. Note exposed scour apron and damaged UV shroud.**

In July there were no beaches in front of the Treasure Island middle project (Fig. 14), most of the south project, and the southern part of the north project; the bases of the geotubes were at the MHHW line (Plate 3). By November the remaining beach in front of the north geotube was eroded allowing direct wave attack on the tube. This shoreline is under the influence of San Luis Pass and has historically undergone dramatic shoreline retreat and advance in response to changes in the sand supply, tidal channels, and offshore shoals. The shoreline along the Treasure Island development is currently in a retreat phase, and the geotubes cannot prevent this natural shoreline adjustment.

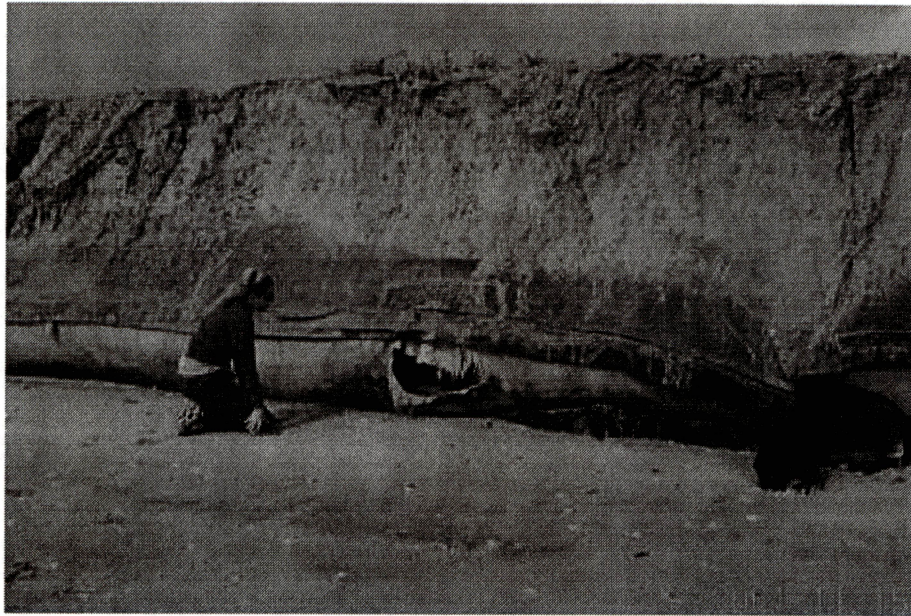
**Figure 15. Puncture in Gilchrist West geotube on November 15, 2001.**

1. The storm protection function of the geotubes has not been tested.
2. The geotubes will fail when exposed to direct wave attack making them useful only for short-term erosion control. This is evident in the failure of the Treasure Island middle project, and in the holes in the geotube fabric along the Gilchrist West project. To prevent failure it is critical to keep the geotubes covered with sand, to maintain a beach in front of them, and to repair holes in the fabric as soon as possible.

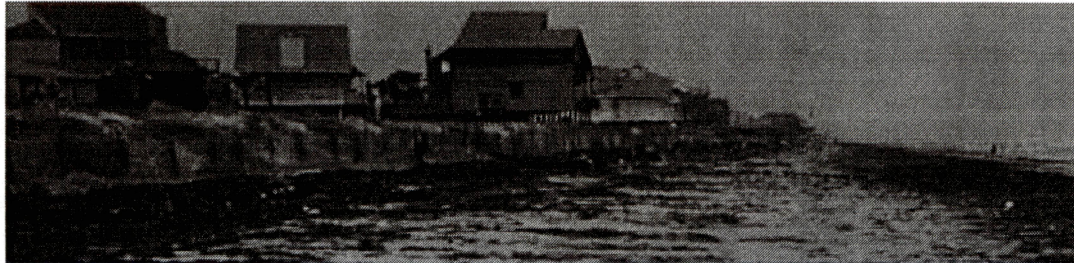
It is notable that most of the seaward faces of the Gilchrist West geotubes were exposed following Allison, but only 10% of the Pirates Beach project was exposed. This disparity occurred even though these projects had nearly the same width of beach in front of them in July (Table 3). Before Allison, however, the Pirates Beach project had sand fencing and vegetated sand in front of the geotubes unlike the Gilchrist West project (Fig. 16). This additional volume of vegetated sand and possibly the presence of nearshore

bars, which attenuate wave energy arriving at the beach, offshore of the Pirates Beach project protected the geotubes. It is also possible that the pre-Allison beach in front of the Pirates Beach project was wider than in front of the Gilchrist West project. We do not have the data to determine which factors are the most important in the uncovering of the Gilchrist West geotubes. Continued monitoring is needed to answer this important question.

**Figure 16. Pirates Beach geotube at GAL01 profile location (see figure 6 for location). This geotube remained covered and vegetated following Tropical Storm Allison. Note sand fence and lack of coppice mound subenvironment.**

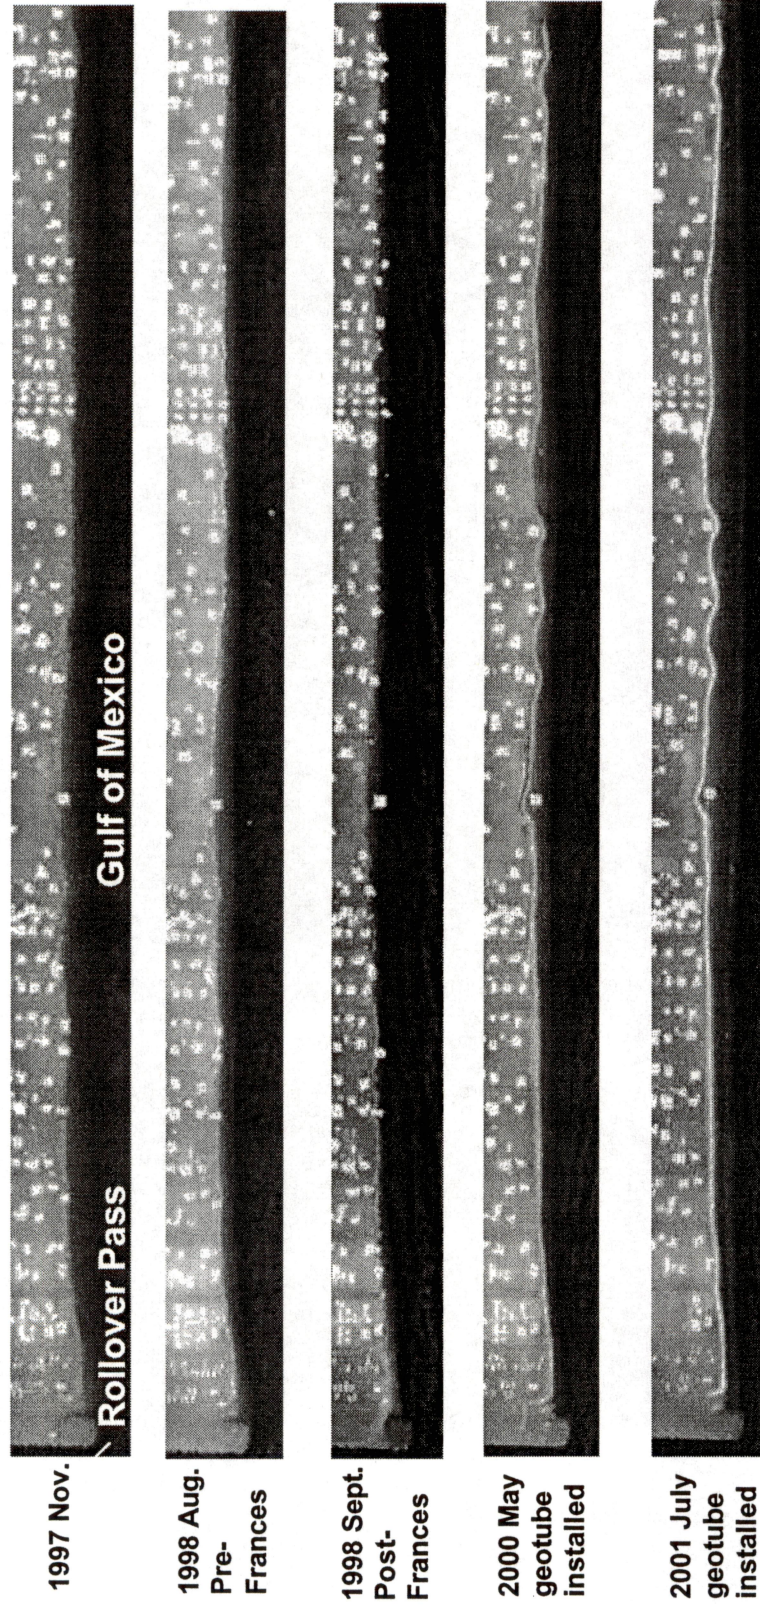
Figure 17. Lidar topographic images of Gilchrist East project. Dark areas are low elevation, lighter higher elevation. Geotube was present during the 2000 and 2001 surveys. Note how geotube was routed seaward of some houses and the overall geomorphic impact of the project.

individual houses or groups of houses (Fig. 17, Plates 1 and 2). These areas create particularly narrow beaches that are not passable during times of moderately elevated water levels (1 to 2 ft above MHHW) (Fig. 18). Furthermore, outflow from the drainage pipes along the Pirates Beach project erode channels perpendicular to the shoreline that at times hinder passage (Fig. 19). These drainage pipes, which concentrate flow through the geotubes, are required to prevent flooding from rainfall landward of the geotube.

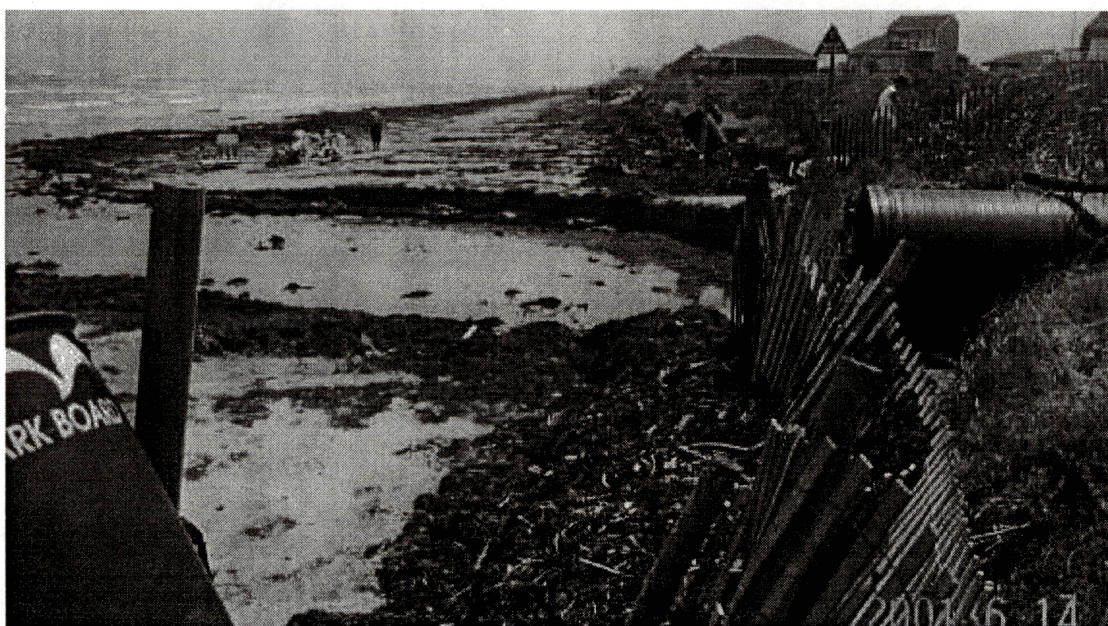
**Figure 19. Pirates Beach geotube project on June 14, 2001 after Tropical Storm Allison. Rainfall runoff from Allison flowed through the black street drainage pipe beneath the geotube on the right and eroded this channel in the beach.**

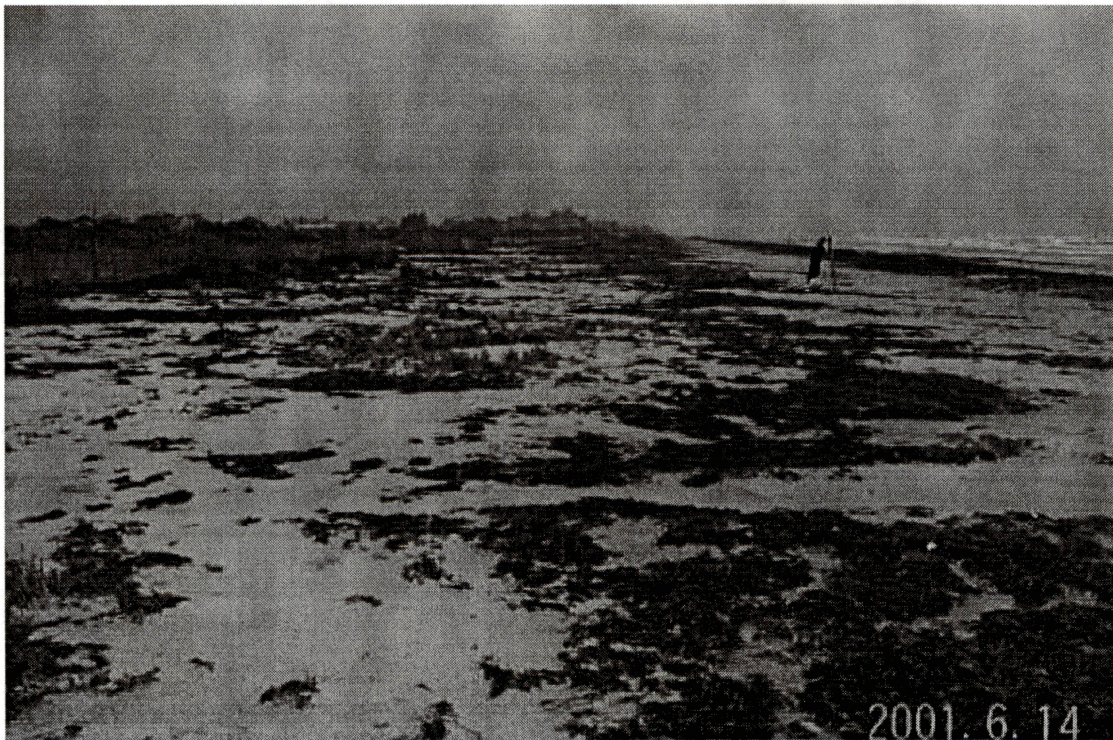
**Figure 20. Coppice mounds at BEG02 profile location in Galveston Island State Park on June 14, 2001 (see figure 6 for location). This subenvironment of wind-blown sand and sparse vegetation was eroded but survived Tropical Storm Allison.**
