FINAL REPORT

Geotextile Tubes along the Upper Texas Gulf Coast

May 2000 to March 2003

Bureau of Economic Geology

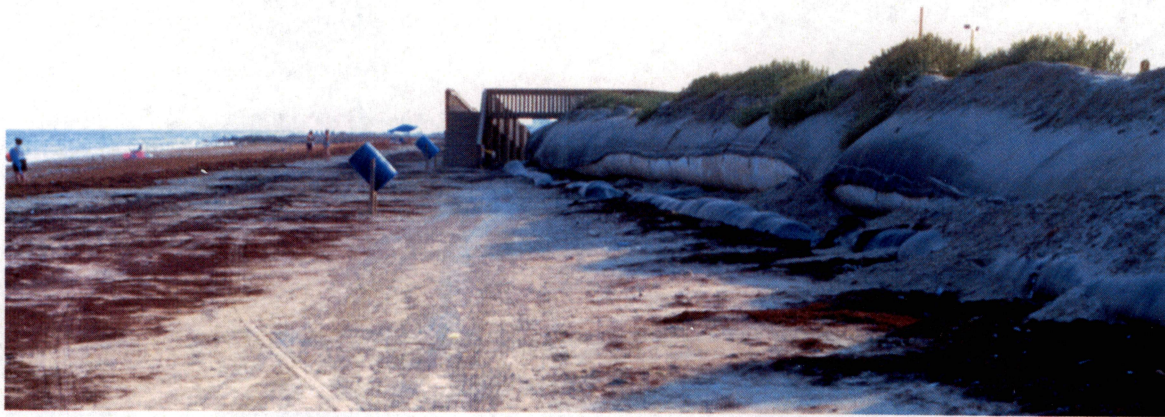
Figure 7. Example of fully exposed geotextile tube front and scour apron at the Dellanera project on Galveston Island, July 18, 2001.

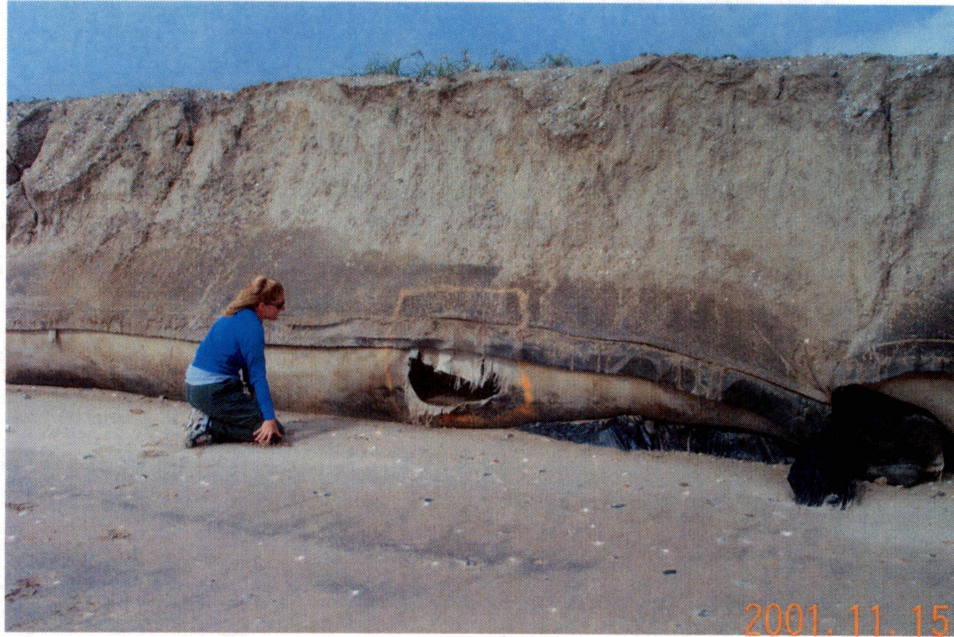
Figure 20. Puncture in Gilchrist West (Caplen area) geotextile tube on November 15, 2001.

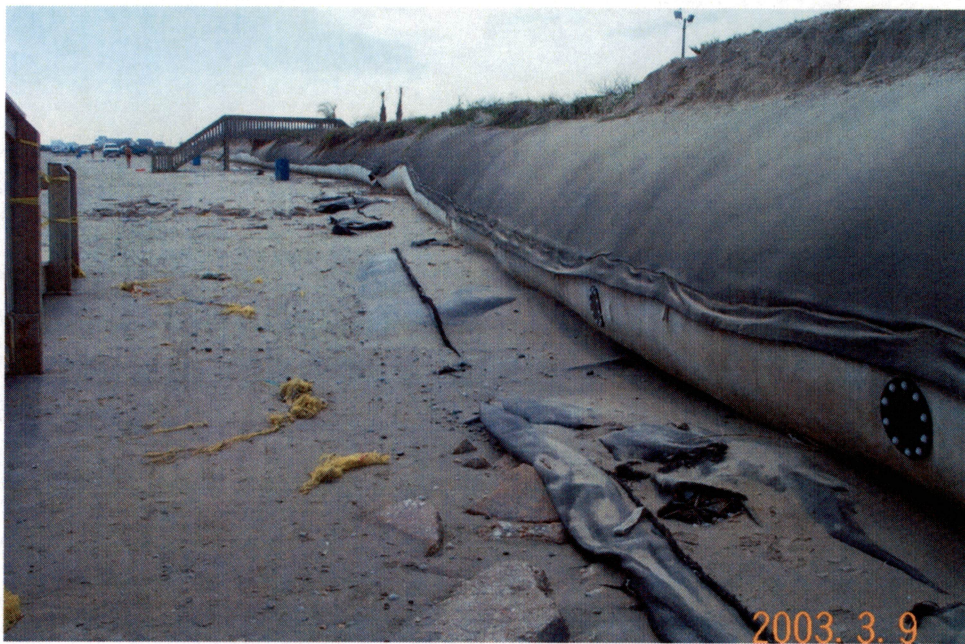
Figure 21. Seaward scour apron exposed and damaged and patched holes in Dellanera geotextile tube on March 9, 2003.

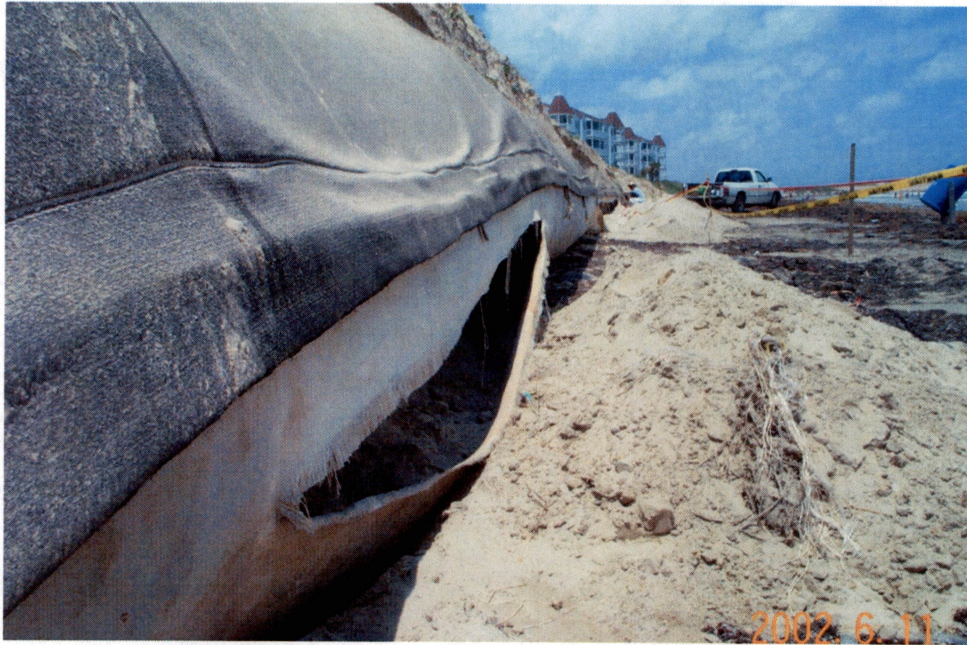
Figure 22. Tear in Dellanera geotextile tube on June 11, 2002. Some have speculated that this hole was the result of vandalism. It has since been patched

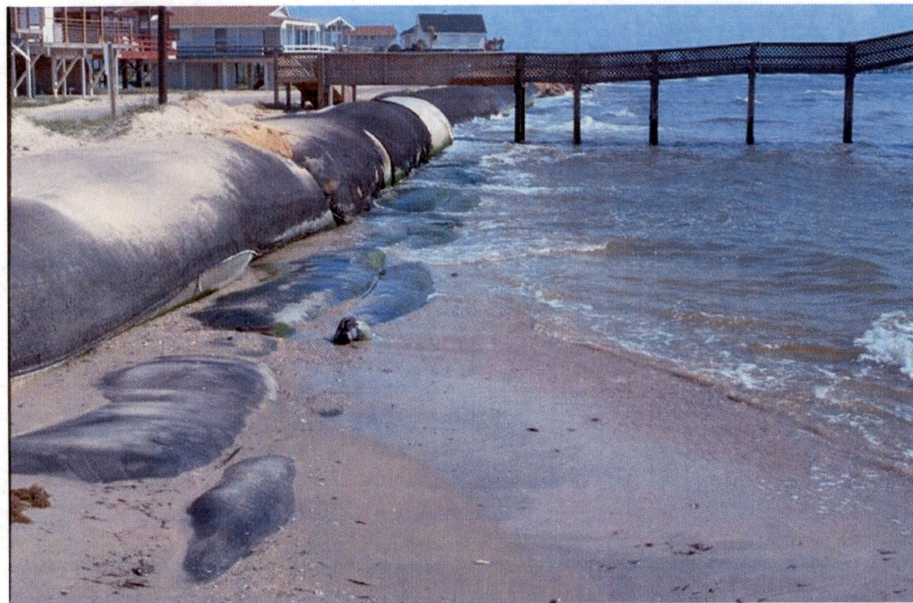
Figure 25. Treasure Island middle geotextile tube on July 19, 2001. Except for a short piece in the foreground this section was completely destroyed in November 2001. Note exposed scour apron and damaged UV shroud. Tube has begun to loose its shape and slump seaward in places.

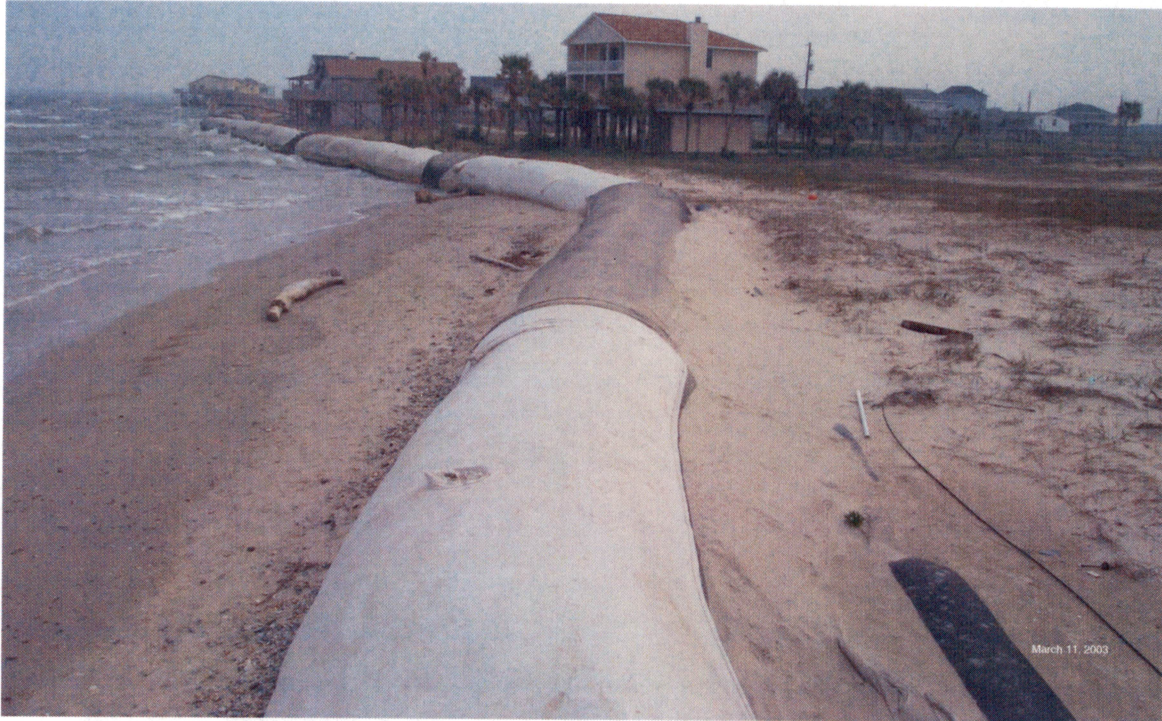
Figure 26. Treasure Island north geotextile tube on March 11, 2003. The UV shroud was almost completely destroyed and erosion had occurred behind the tube with some wind-blown sand deposited between the landward side of the tube and the erosional scarp.

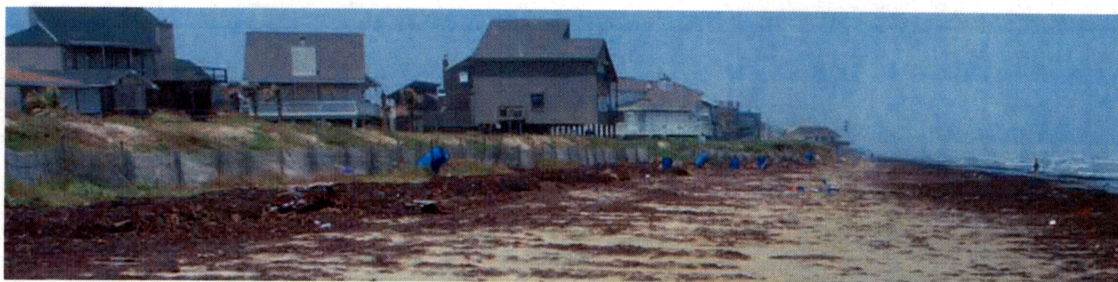
Figure 27. Pirates Beach geotextile tube at GAL01 profile location (see figure 6 for location). This project remained covered and vegetated following Tropical Storm Allison. Note sand fence and lack of coppice mound subenvironment.

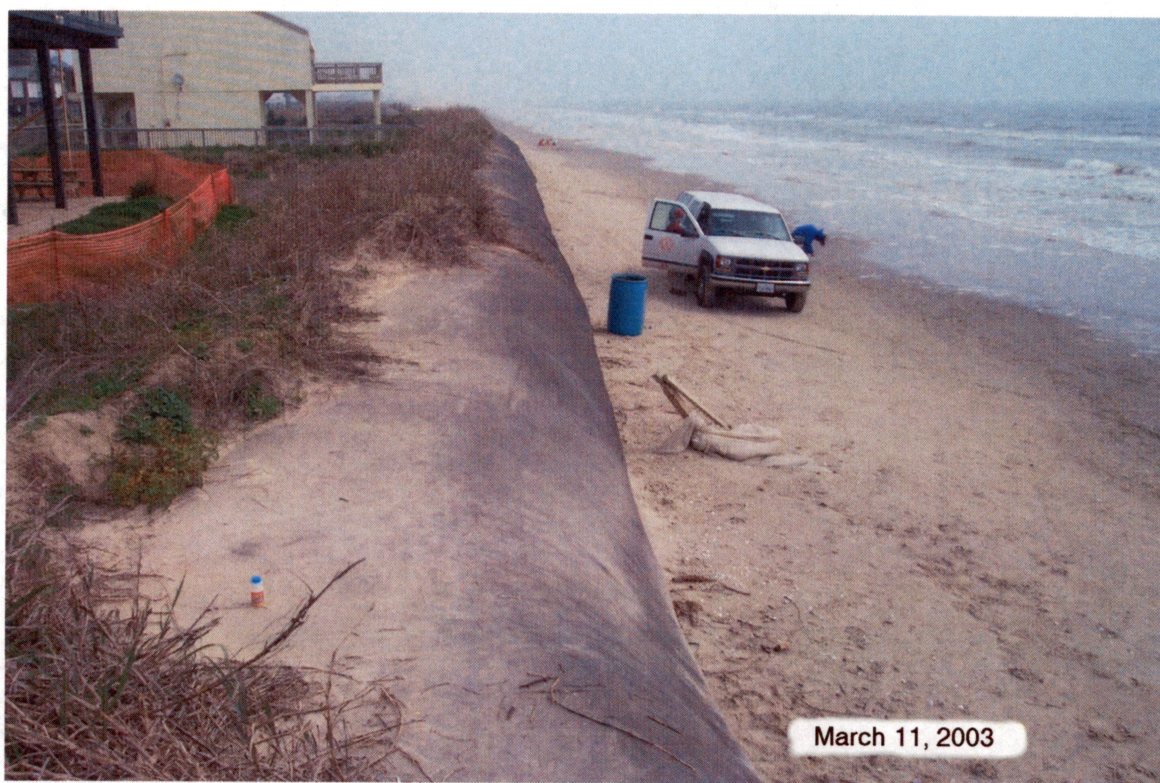
Figure 34. GAL02 beach profile location in the Pirates Beach geotextile tube project on March 11, 2003. There is no coppice mound environment seaward of the tube because the beach is too narrow and too low for vegetation and wind-blown sand to accumulate (see Fig. 6 for location and Fig. 32 for beach profile).
