Hurricane Rita Impacts on the Texas Shoreline A Summary Report

Prepared for the Texas General Land Office under GLO Interagency Contract Number 02-267C

Bureau of Economic Geology
Scott W. Tinker, Director
The University of Texas at Austin
Austin, Texas 78713-8924

March 2008

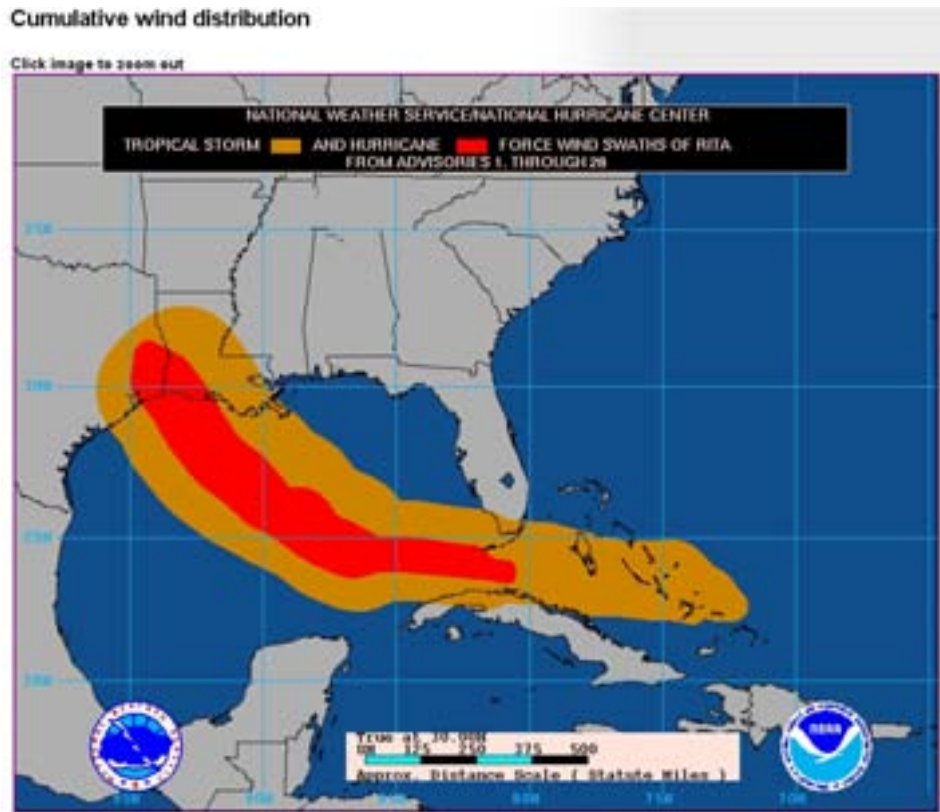
Figure 1. Cumulative wind distribution taken from NOAA Website.

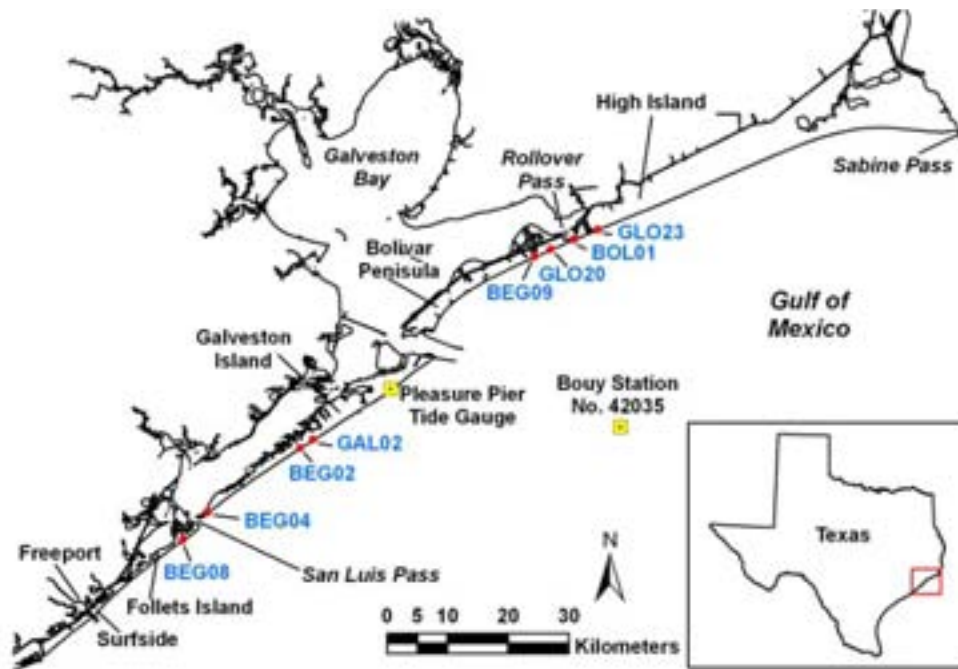
Figure 2. Location map showing beach profile network, offshore buoy, and Pleasure Pier tide gauge. Profiles surveyed following Hurricane Rita were BEG08, GLO23, BOL01, BEG09, GLO20, GAL02, BEG02, and BEG04.

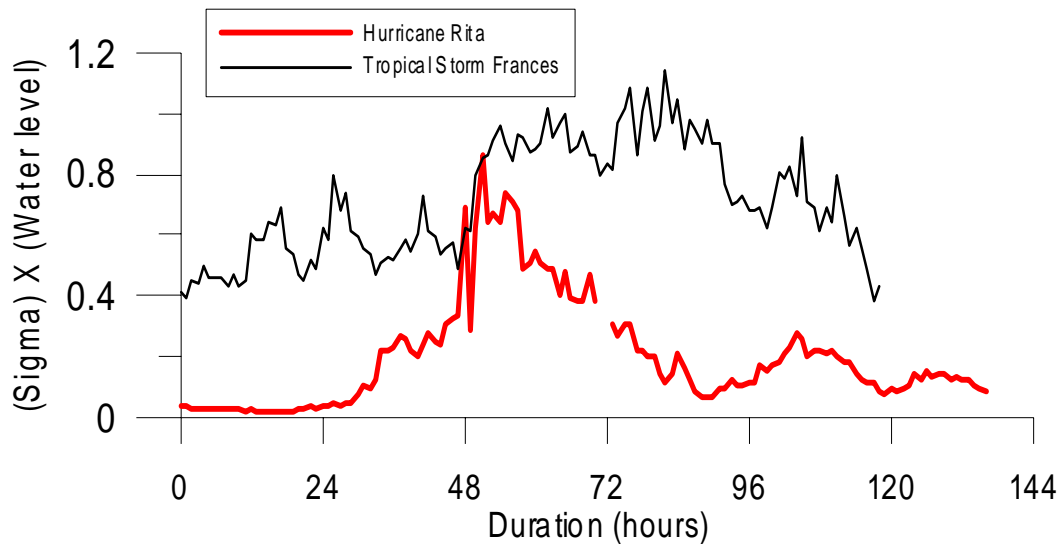
Figure 4 compares the sigma X water level curves for Hurricane Rita and Tropical Storm Frances in 1998. Using data from the Pleasure Pier tide gauge, the mean and standard deviation of the sigma X water level hourly time series from June 1992 to October 2002 were computed, and values greater than 3 times the standard deviation above the mean are considered extreme conditions. The Frances curve in Figure 4 shows extreme values (>0.409) lasted for 119 hours and peaked at 1.138. In contrast, during Rita sigma X water level peaked at 0.86 and extreme

values lasted for only 17 hours. Integrating these curves above the extreme value of 0.409 yields a value called the extreme area (EA). The EA parameter is a measure of surge, wave energy, and duration of extreme conditions. The EA was calculated for several storms since 1995 and a value of 12 or greater is thought to cause episodic beach erosion and vegetation line retreat great enough to create significant coastal management issues along the upper Texas coast (Tropical Storm Josephine in 1996 is considered to be a “threshold” storm for creating significant problems) (Gibeaut et al. 2002). The EA for Frances is 36, and for Rita it is only 3.3. Table 1 list the EA computed for recent storms.

Figure 4. Sigma X water level curves computed from the Pleasure Pier tide gauge for Hurricane Rita in 2005 and Tropical Storm Frances in 1998.

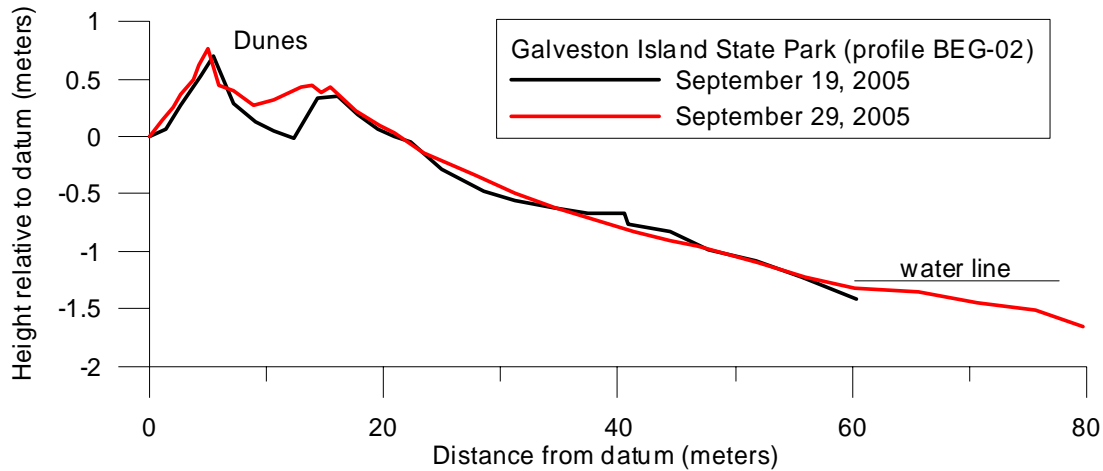
1998, respectively. This is consistent with an EA of only 3.3 for Rita. Figure 5 is a plot of pre- and post-storm beach profiles measured at the Galveston Island State Park. Ball High School science students measured the pre-storm profile as part of the Texas High School Coastal Monitoring Program (Hepner and Gibeaut 2004). Rita flattened the profile and caused a small amount of overwash deposition, but the position of the vegetation line and shoreline was not greatly affected (Fig. 6). The state park is a relatively naturally managed beach/dune system and the wide beach, foredune, and structures setback from the shoreline served to limit problems at this location due to beach erosion and washover. However, Rita worsened conditions at locations where structures encroached on the beach before Rita.

Figure 5. Beach profile comparison at profile BEG-02. See Figure 2 for location.

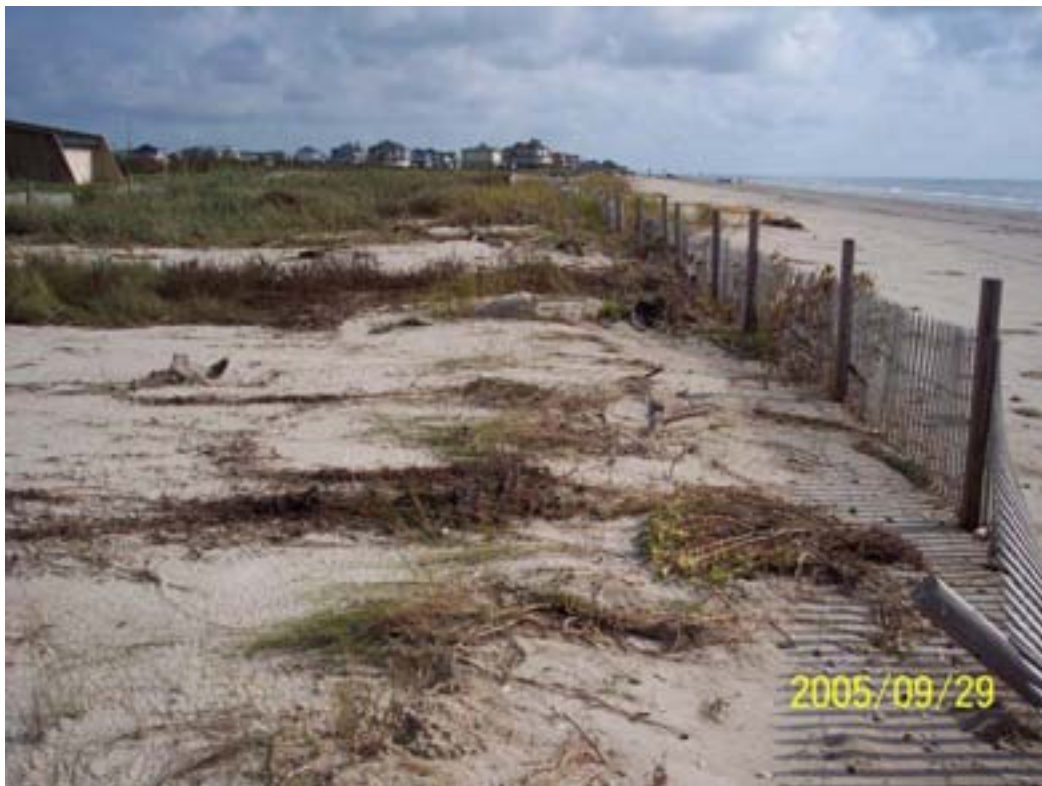
Figure 6. Washover deposition at the Galveston Island State Park, BEG-02 profile location.

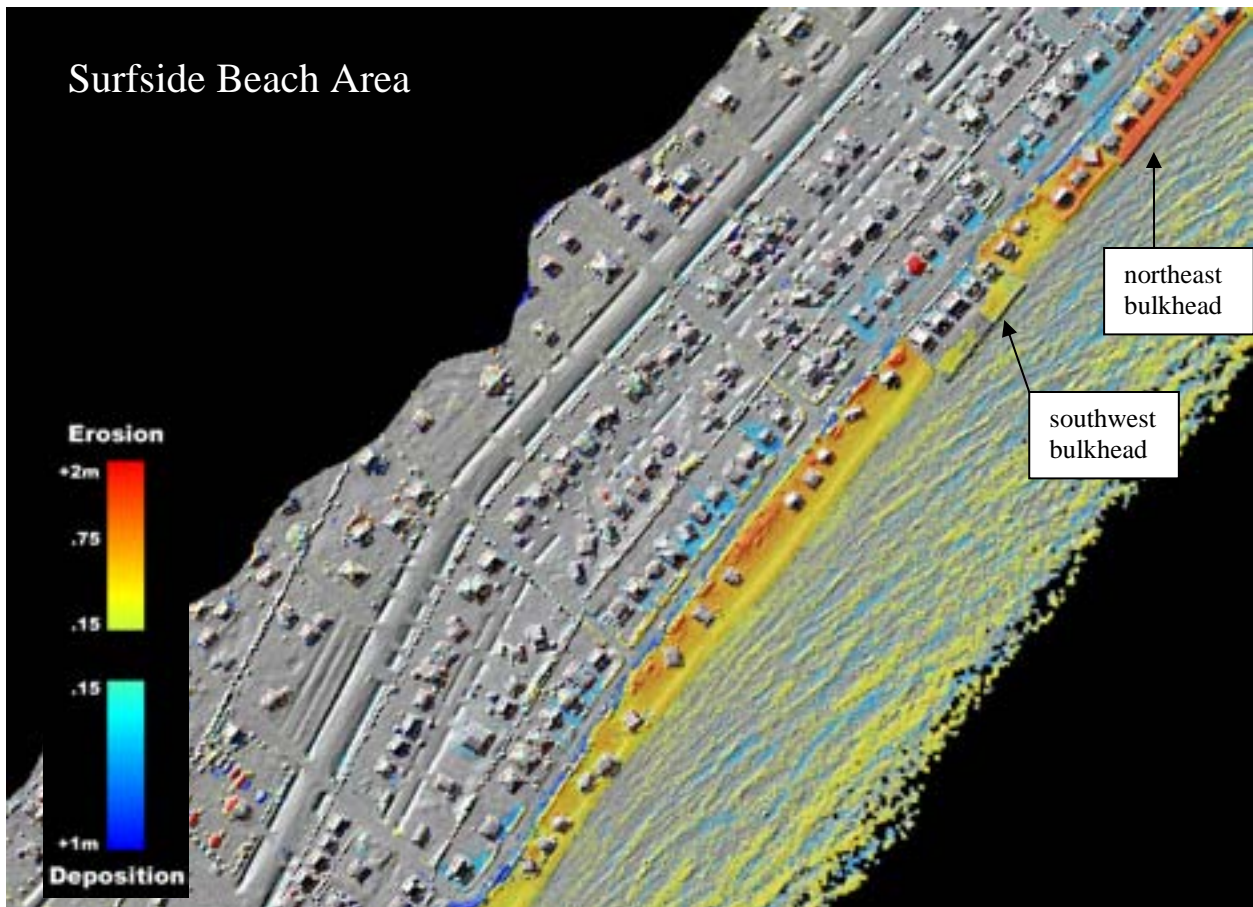
The Surfside area within 1.5 km north of the Freeport jetties was washed over and the beach surface seaward of the shore-parallel beach road was lowered 0.5 to 1.0 m (Figs. 7 and 8). Two old metal and piling bulkheads had been protecting houses since at least the 1990's and the beach in front of them was very narrow or nonexistent before Hurricane Rita. Rita severely damaged the southwestern bulkhead, and destroyed the northeastern bulkhead (Figs. 7, 9, and 10). In an area within about 450 m of the jetty, concrete rip rap appeared to have remained in place, but erosion and washover deposition occurred behind it (Fig. 11). First-row houses to the northeast, which were on the public beach before the storm, were further undermined. Power, water, and sewage connections to these houses were damaged (Figs. 12 and 13). Washover deposition covered the shore-parallel beach road (Beach Drive) and extended to behind the second row of houses, a distance from the shoreline of about 60 m. This washover deposition is evident in the lidar comparison (Fig. 7). On September 29, there was much activity scraping washover sand from the roads and putting it on the beach (Figs. 14 and 15).

Figure 7. Comparison of pre- and post-storm lidar digital elevation models showing erosion and deposition of 0.15 m or more caused by Hurricane Rita.

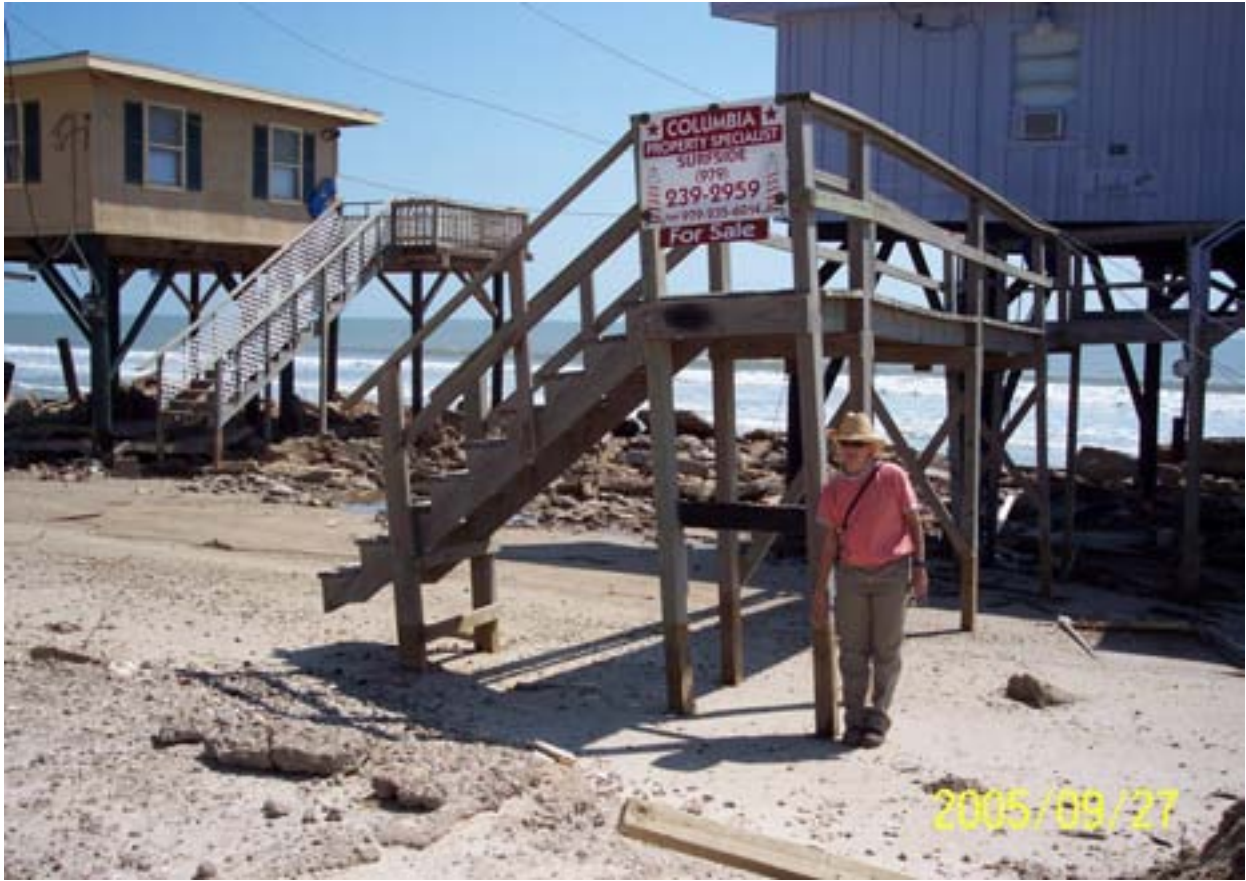
Figure 8. Erosion exposing stair supports indicating a lowering of the beach in Surfside Beach.

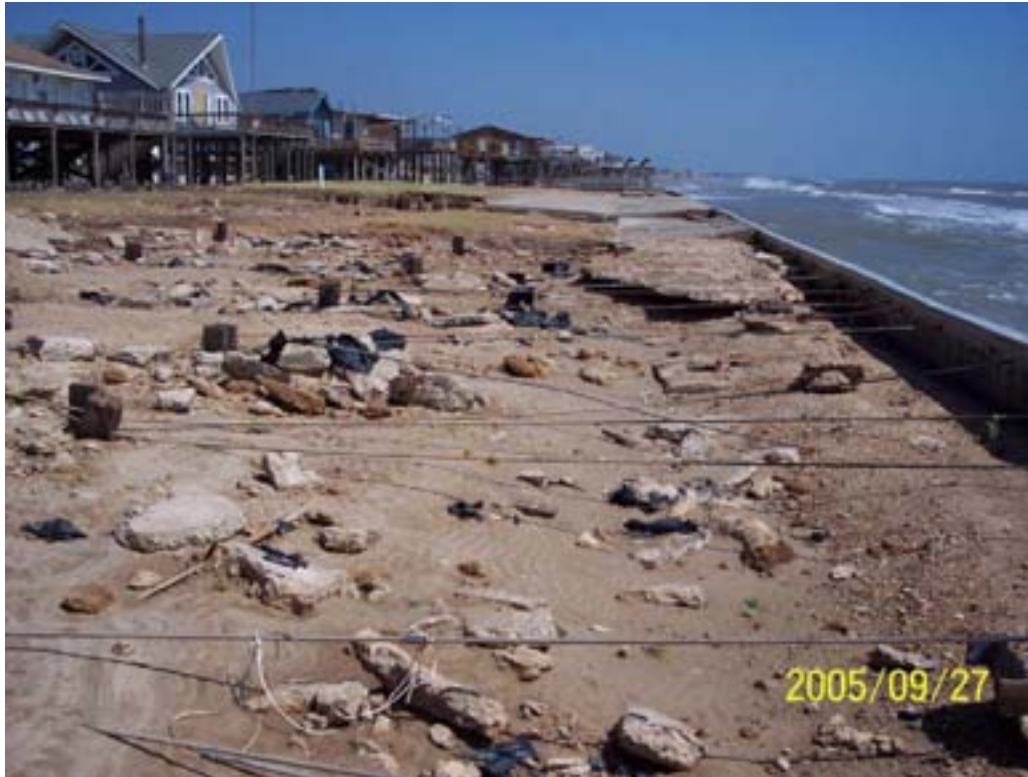
Figure 9. Damaged southwest bulkhead in Surfside Beach.

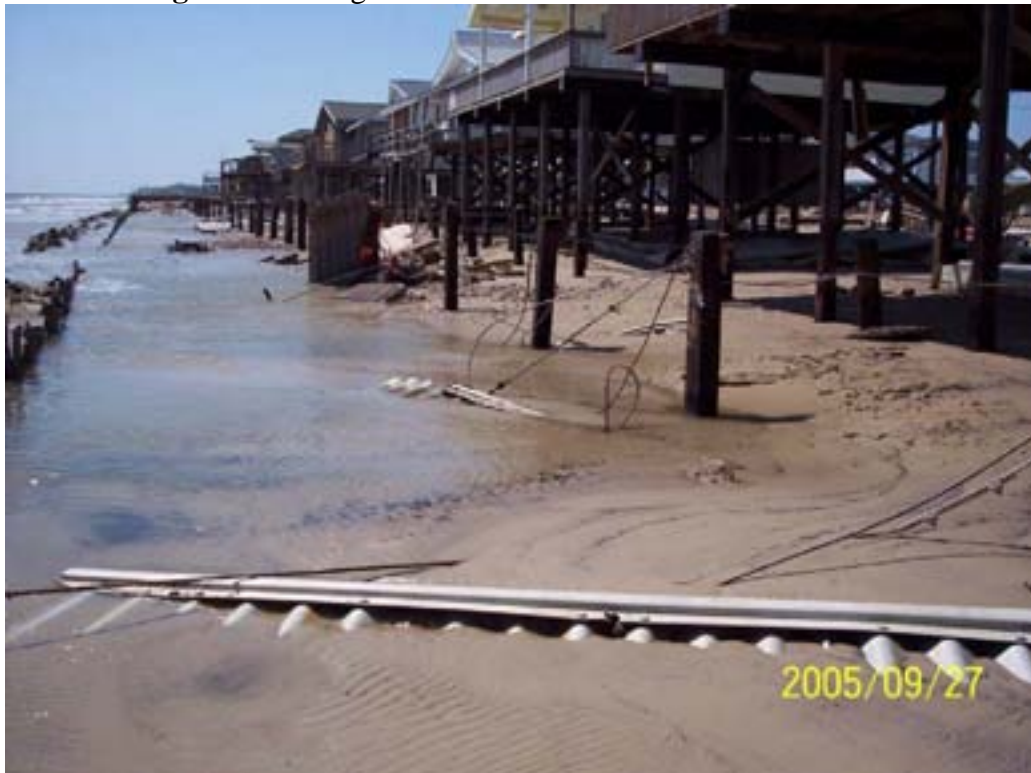
Figure 10. Destroyed northeast bulkhead in Surfside Beach.

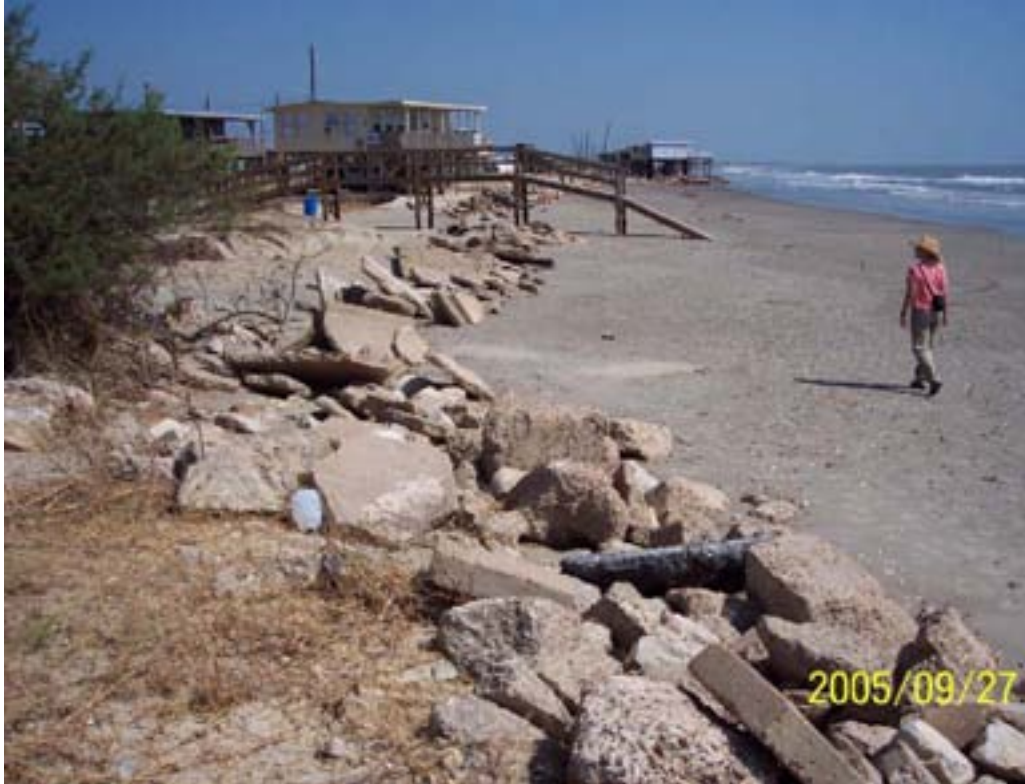
Figure 11. Surfside Beach. Beach eroded and washed over landward of concrete rip rap.

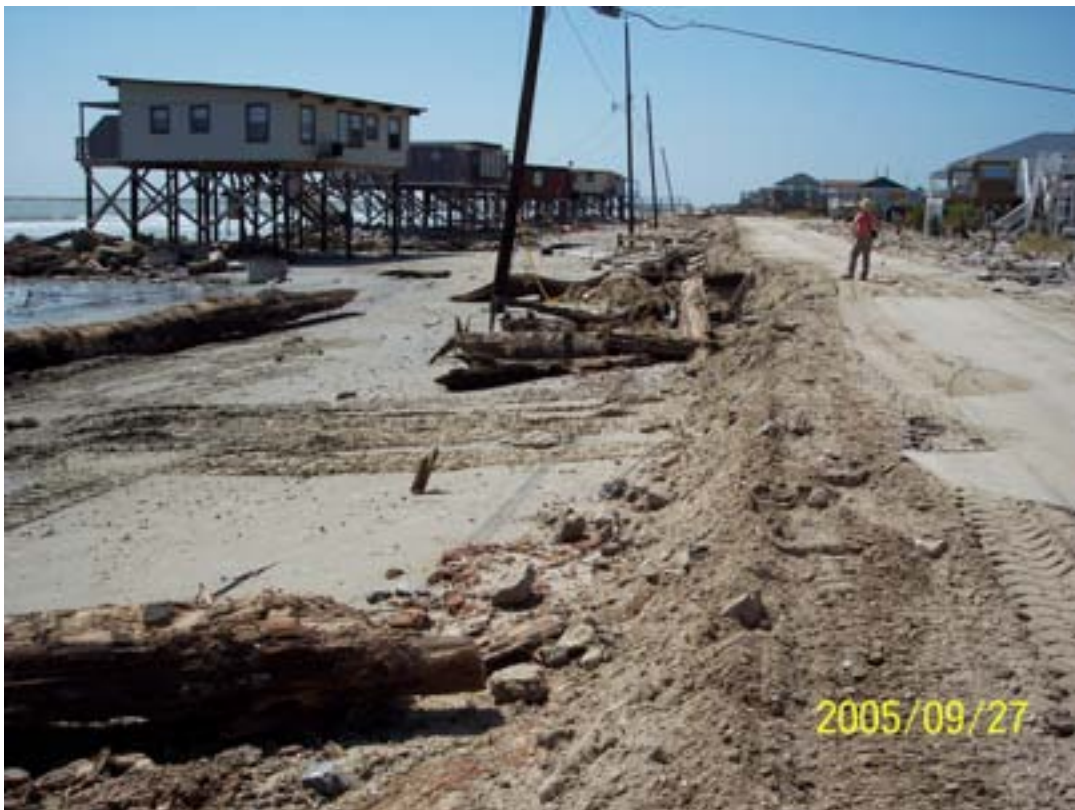
Figure 12. Looking southwest along Beach Drive in Surfside Beach.

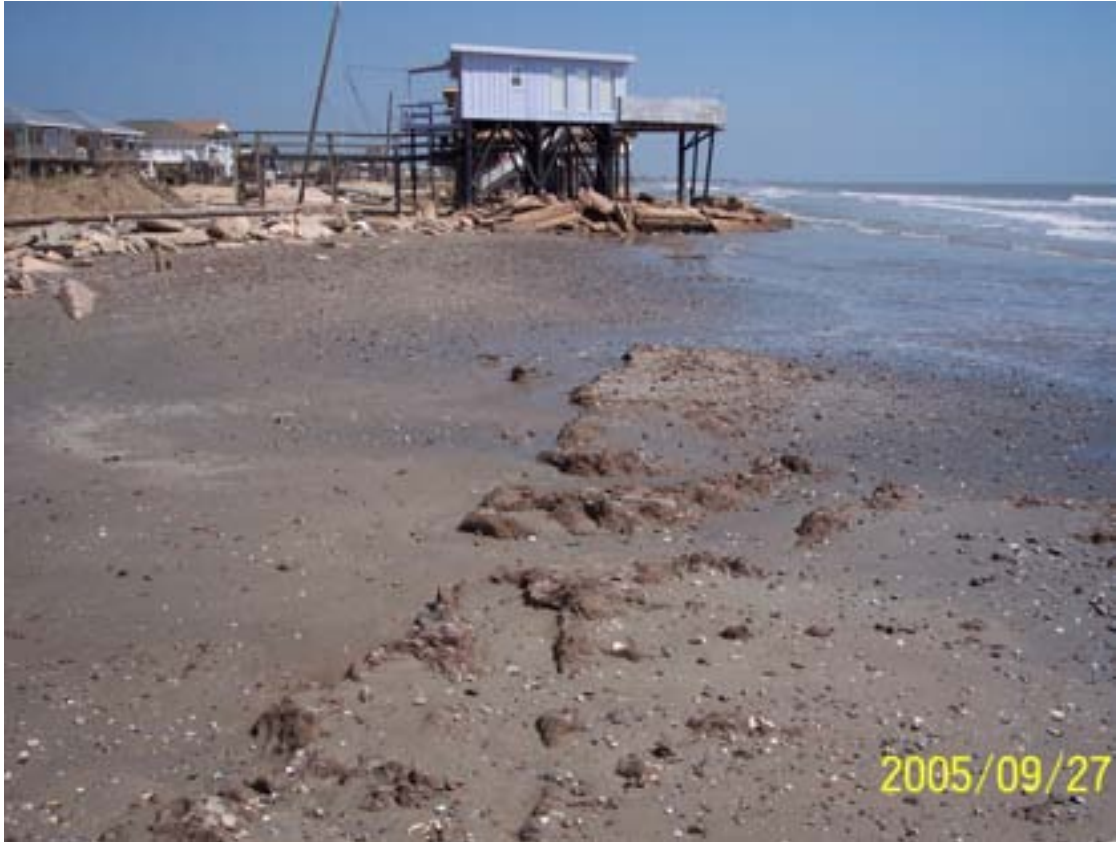
Figure 13. Surfside Beach houses in the surf zone. Layer of Holocene sandy mud exposed in foreground which attests to the erosional state of the beach.

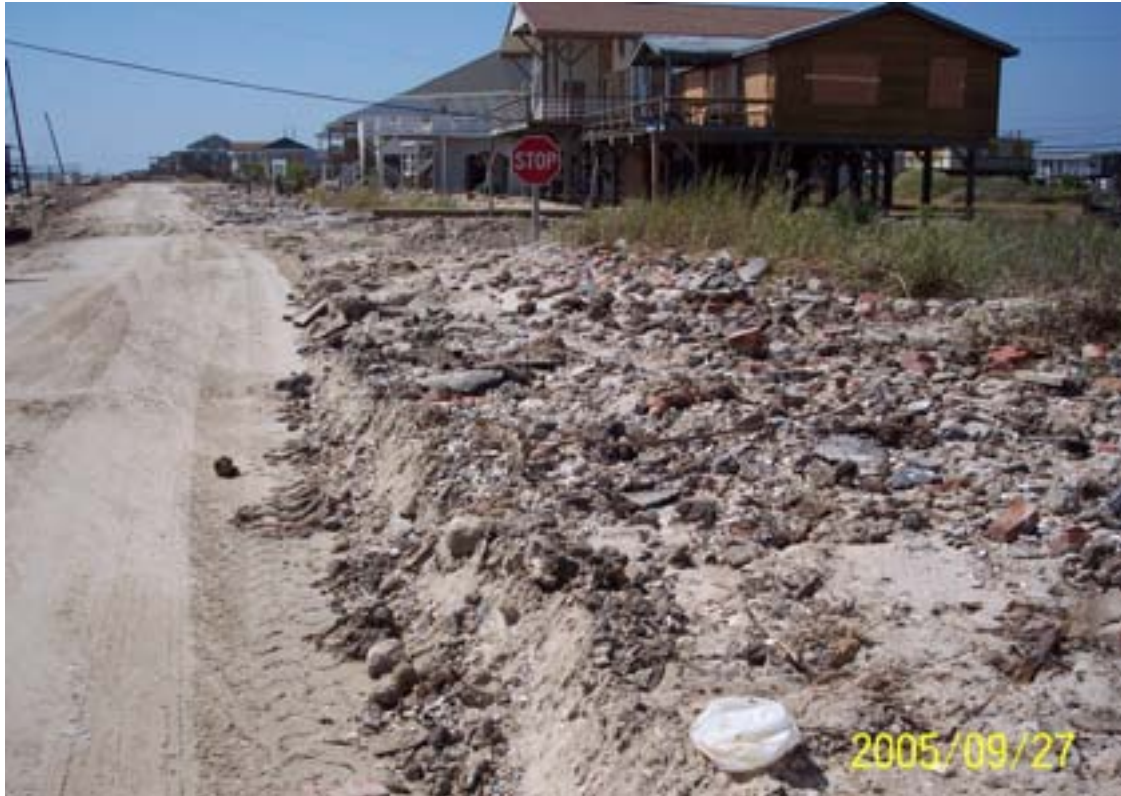
Figure 14. Washover deposition including debris and asphalt pieces transported landward of Beach Drive. Beach Drive has been plowed.

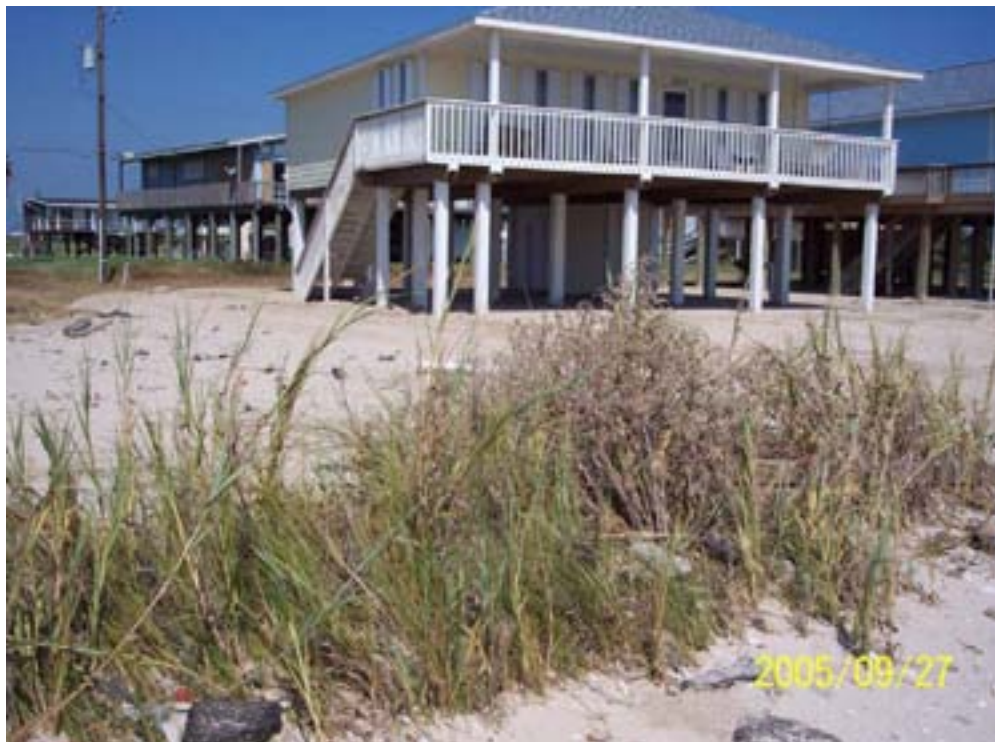
Figure 15. Washover sand deposited beyond row of houses landward of Beach Drive in Surfside Beach.

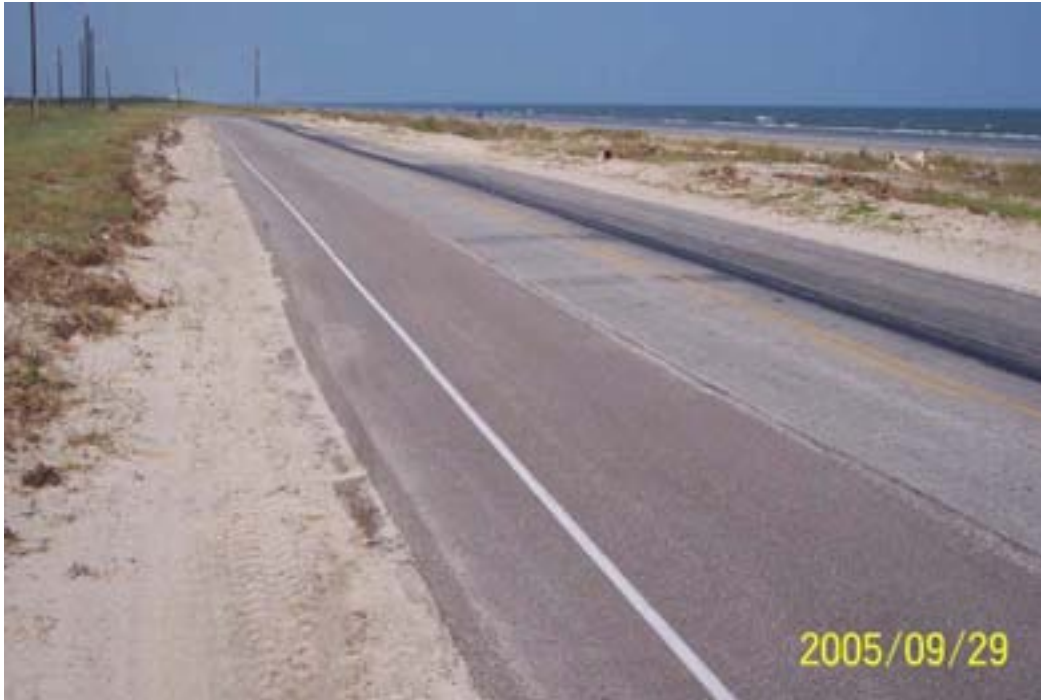
Lidar data show that beaches along Follets Island northeast of Surfside Beach (Fig. 2) suffered little. However, there was washover through the beach access roads, and sand was deposited on the main road where the road is close to the beach (Fig. 16). A Pre- and post-storm beach profile comparison at the BEG-08 location (Fig. 2) showed only moderate change similar to that discussed for the Galveston Island State Park profile (BEG-02).

Figure 16. Follets Island. The road is only about 50 m from the shoreline here and had no pre-storm foredune. Sand was transported onto the road by Rita's waves and surge and then bulldozed.

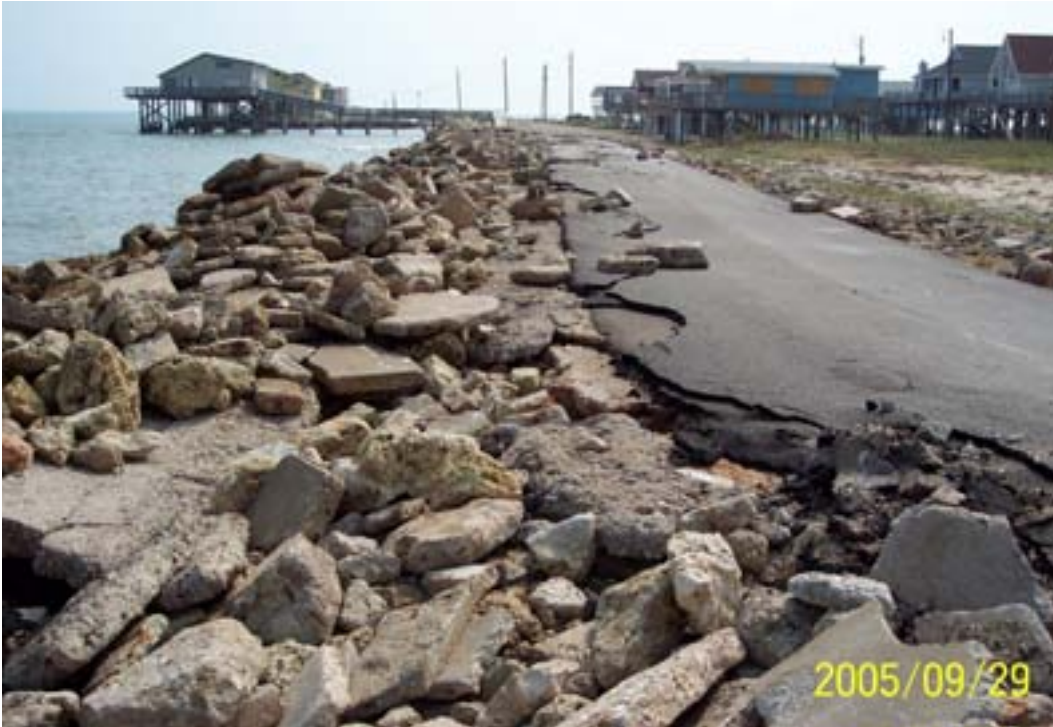
Figure 18. Treasure Island subdivision. Asphalt road is damaged and rip rap dislodged.

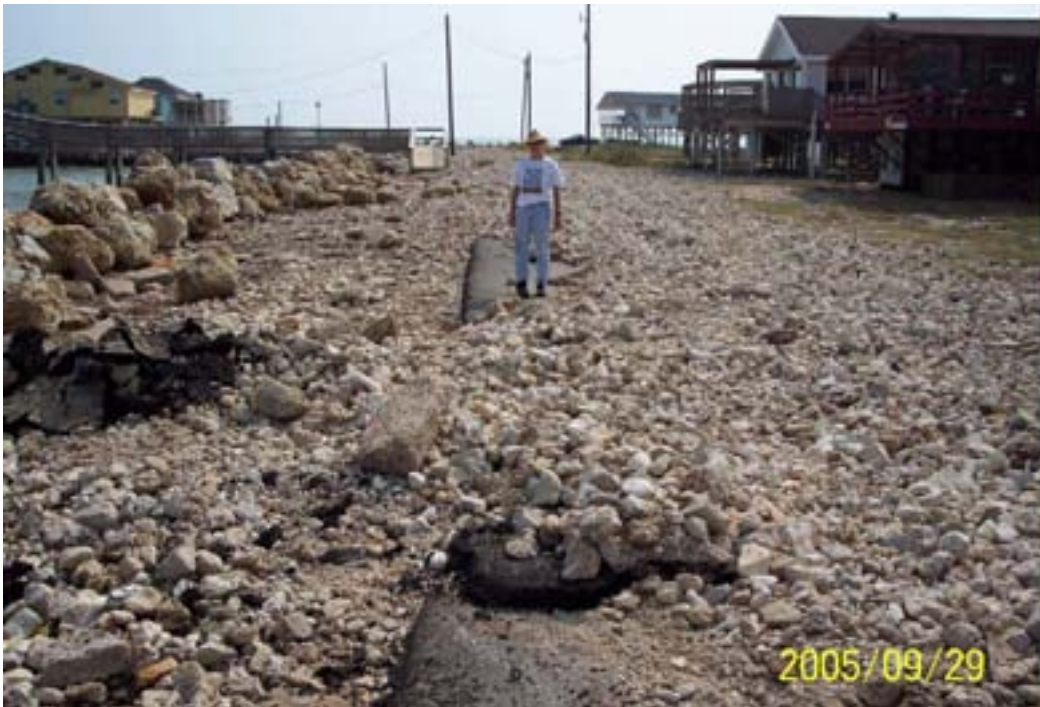
Figure 19. Treasure Island subdivision. Cobbles from shore-protection efforts deposited by Rita's waves on the road.

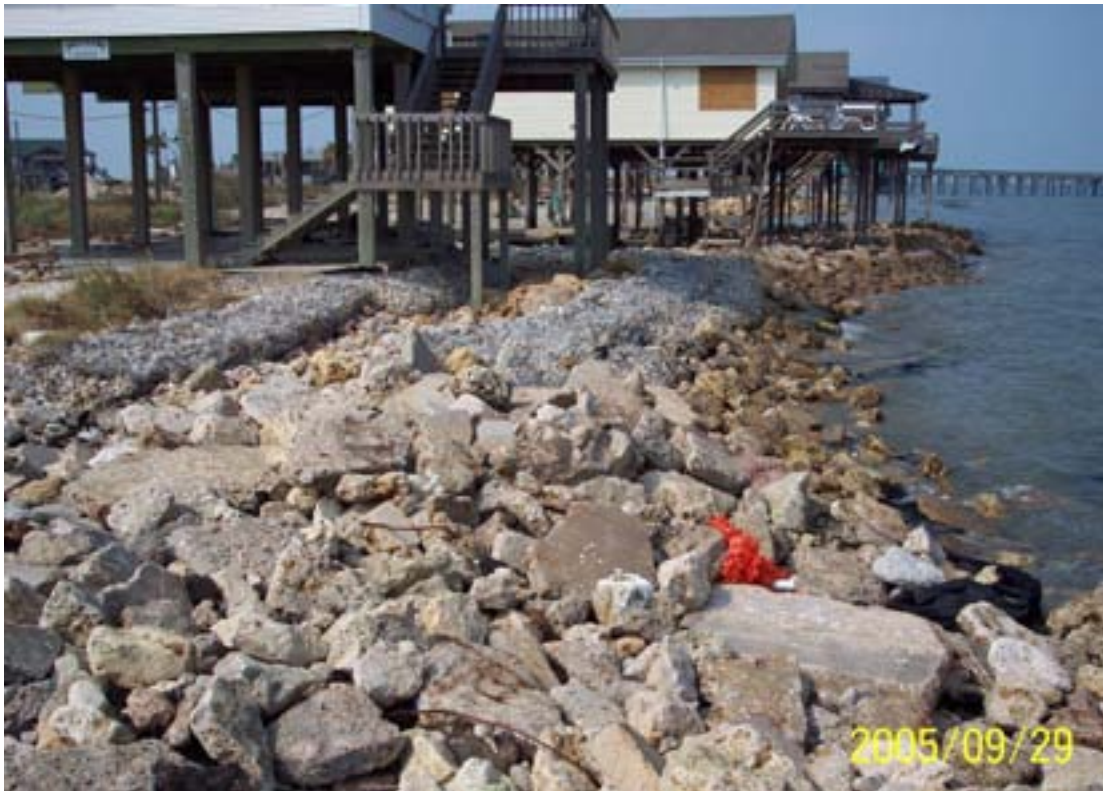
Figure 20. Looking toward the fishing pier in the Treasure Island subdivision.

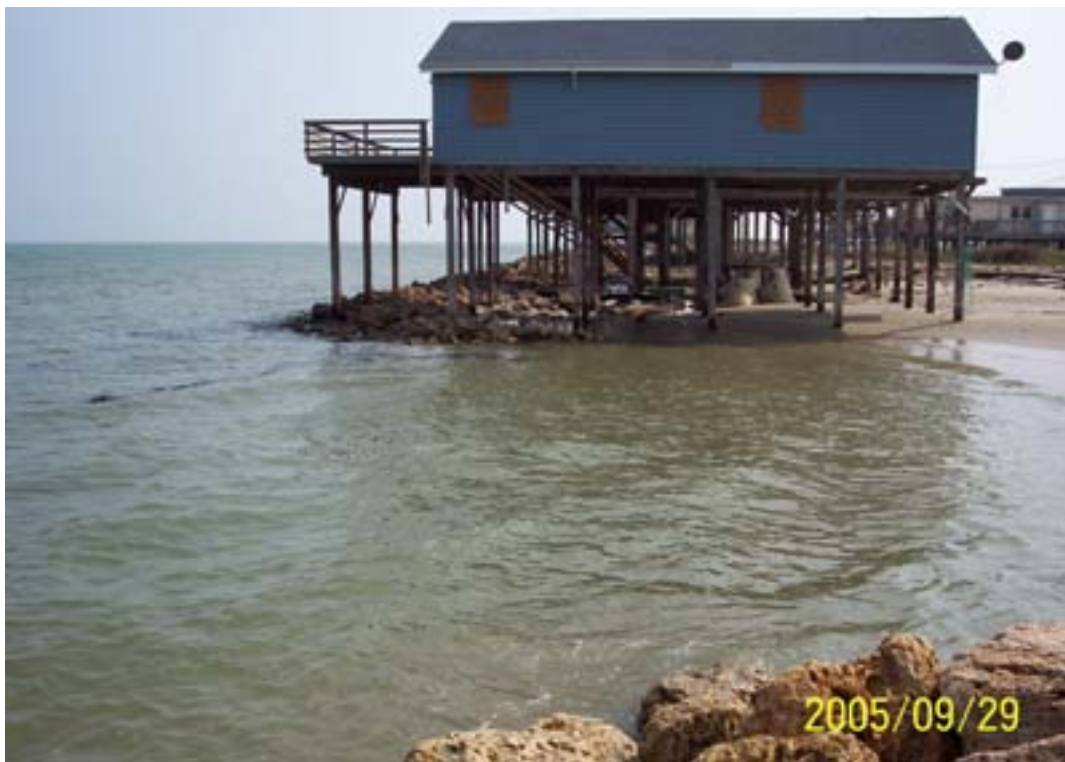
Figure 21. Houses in surf zone in Treasure Island subdivision. Remnants of geotextile tube in water on left. Tube was largely destroyed before Rita.

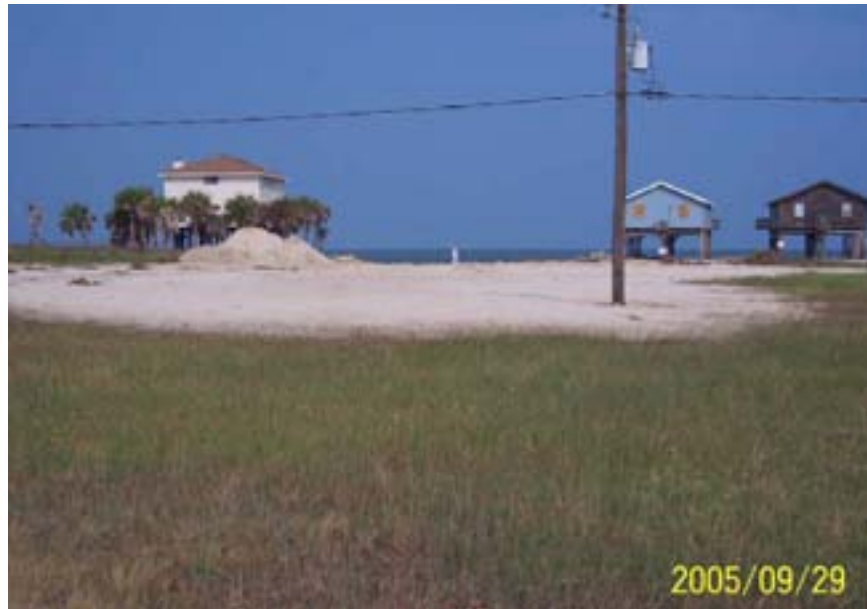
Figure 22. Sandy washover fan deposit in the Treasure Island subdivision. Also note stock piles of sand on left of fan. Piles like these were being placed around Treasure Island.

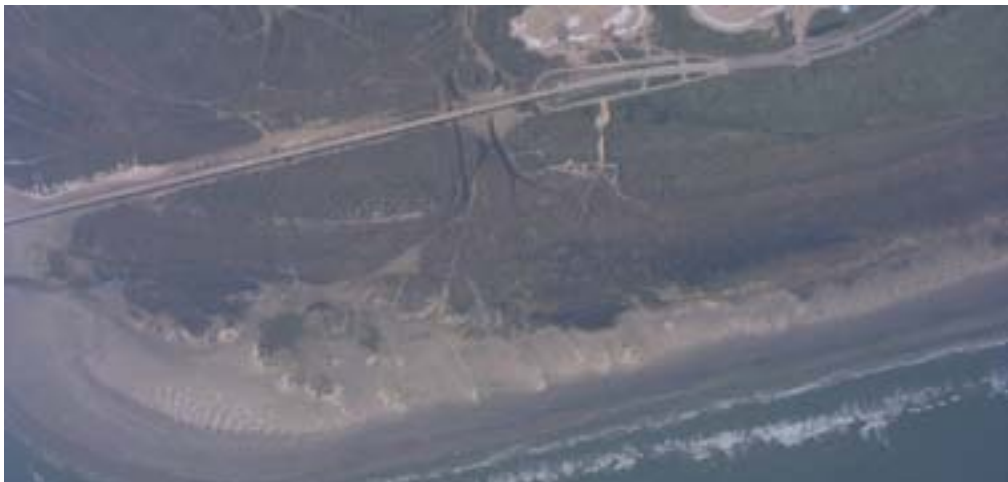
The beach on the southwest end of Galveston Island adjacent to San Luis Pass showed evidence of strong alongshore currents directed to the southwest. Figure 23 is an aerial photo taken two days after Hurricane Rita. It shows sand waves oriented to the southwest (toward the pass). Figure 24 is a ground photograph of these features. Given the large waves out of the east, we expect that littoral currents and sand transport were strongly directed toward the southwest during the storm and that sand was transported into San Luis Pass from Galveston beaches. This sand transport into San Luis Pass and the strong ebb flow out of the pass discussed earlier will potentially affect shoreline change on each side of the pass.

Figure 23. Vertical aerial photograph of Galveston Island at San Luis Pass taken 2 days after Hurricane Rita landfall. Note the train of sand waves on the left and other asymmetrical features on the upper beach to the right indicating littoral drift toward the southwest (right to left). Photo acquired from NOAA website.

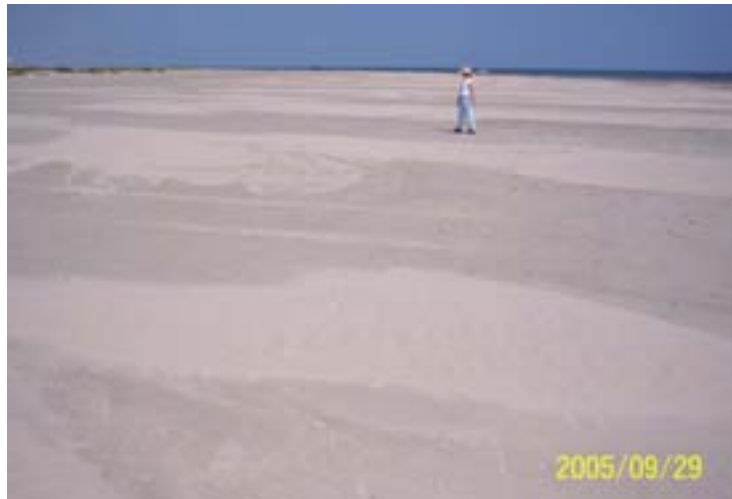
Figure 24. Galveston Island near San Luis Pass. Looking updrift at sand waves formed by alongshore currents caused by oblique wave approach and flood tidal currents during Rita. Sand waves have been modified by wind.

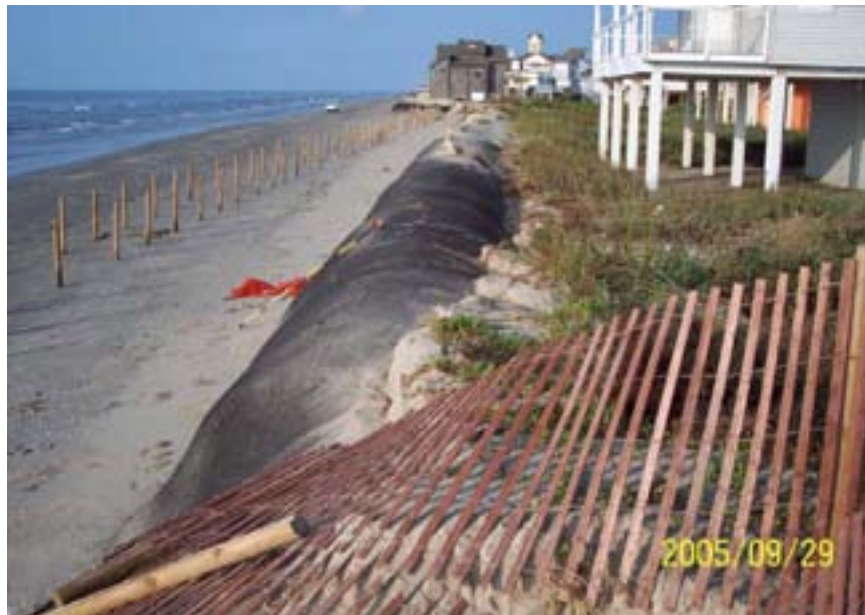
Geotextile tubes along Galveston Island and Bolivar Peninsula were installed beginning in 1999 as a stop-gap measure to stem beach retreat and for protection from storm surge (Gibeaut et al. 2002). These tubes were largely exposed by Rita. The southwest end of the Pirates Beach project on Galveston Island northeast of the BEG-02 beach profile site (Fig. 2), and a portion of a project adjacent to the southwest side of Rollover Pass (Fig. 2), however, were not exposed. Sand fencing in front of the Pirates beach project was damaged (Fig. 25), but large-scale damage to the geotextile tubes was not observed. Overall, the beach was narrower at the geotextile tube projects. Erosion and damage at Bermuda Beach and Spanish Grant on Galveston Island was similar to that observed at Surfside Beach and Treasure Island. These are also areas with pre-Rita erosion problems.

Figure 25. Exposed geotextile tube, eroded beach, and damaged sand fencing (only posts remaining) along Pirates Beach at the GAL-01 location (see Fig. 2 for location).

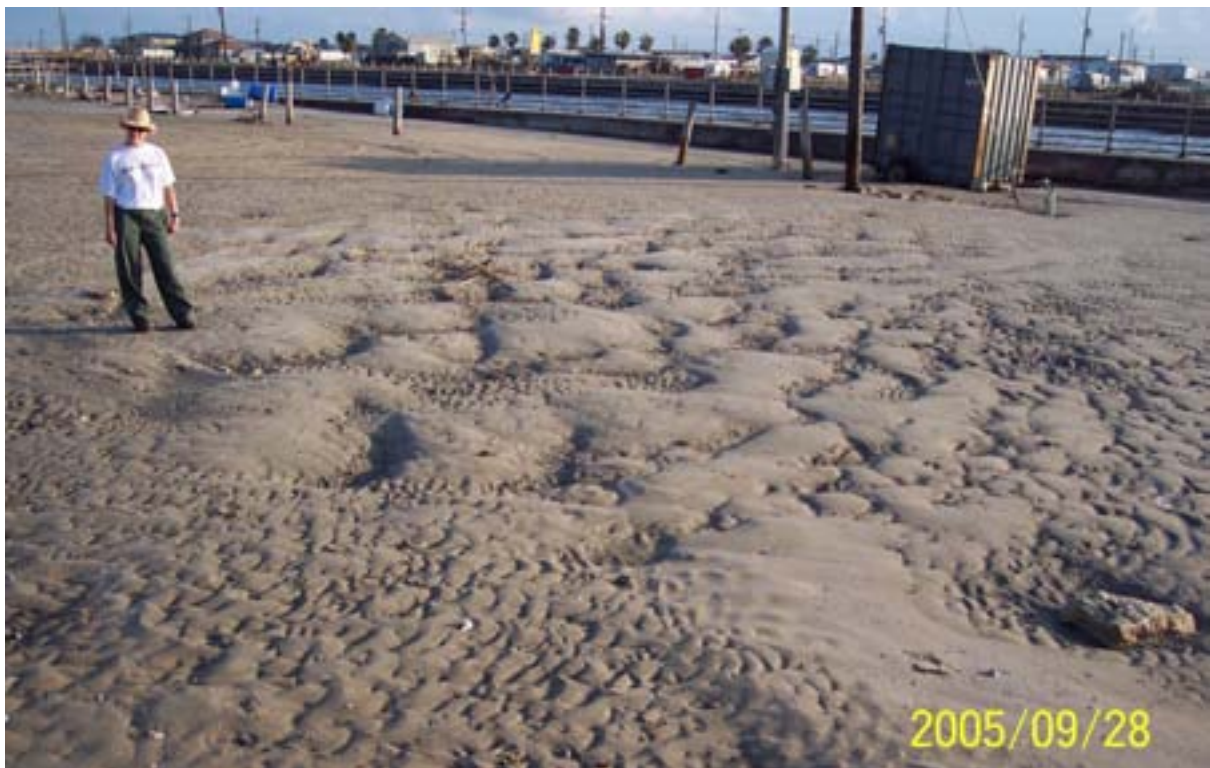
Beach erosion was moderate and did not cause significant damage to structures along Bolivar Peninsula, including the geotextile tube projects. The area of Rollover Pass is particularly low and prone to washover (Fig. 2). Sand deposits including landward oriented sand waves indicate that Rollover Pass was washed over and that unidirectional flow of about 0.5- to 1-m depth occurred in the sand parking lot next to the channel (Fig. 26, 27). Other than at Rollover, there was a lack of sand washover deposition along Bolivar Peninsula. There were, however, grassy debris lines on the back barrier indicating levels reached by the surge and waves from the bay side (Fig. 28). Wind damage to structures and power lines was consistent with offshore directed (northerly winds). Broken power poles were leaning or lying toward the south (Fig. 29).

Figure 26. Rollover Pass. Landward oriented sand waves indicating washover flow during Rita.

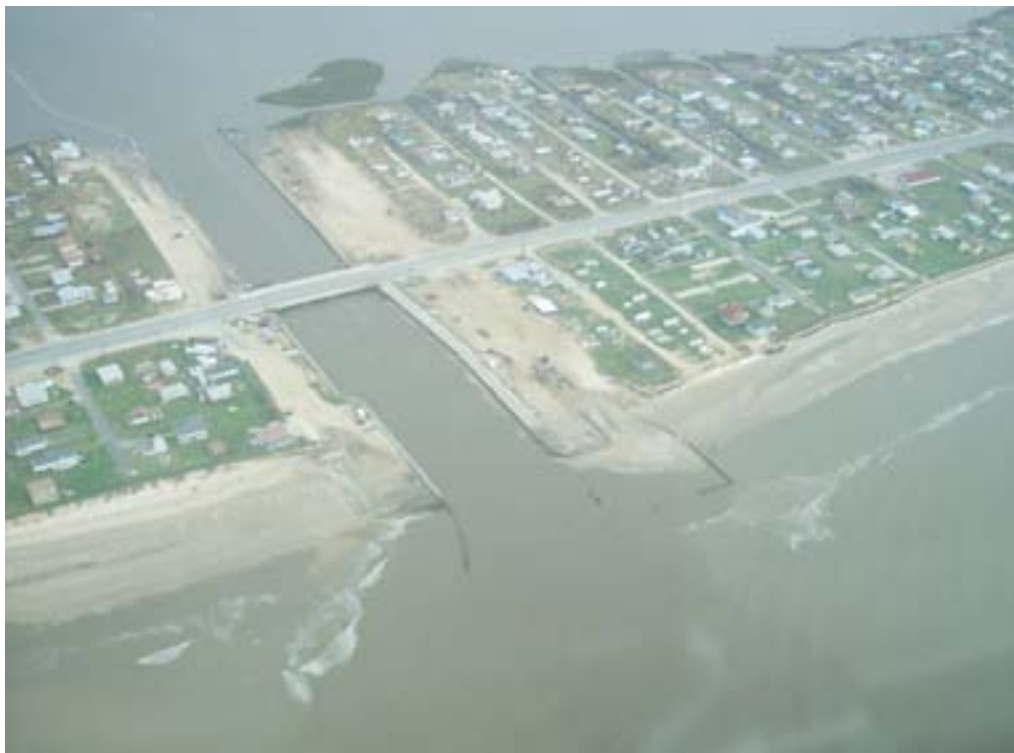
Figure 27. Rollover Pass. Rita caused washover and sand transport through the unpaved parking lots and across highway 87. Geotextile tubes are exposed to the northeast (right) of the pass but not on the southwest side.

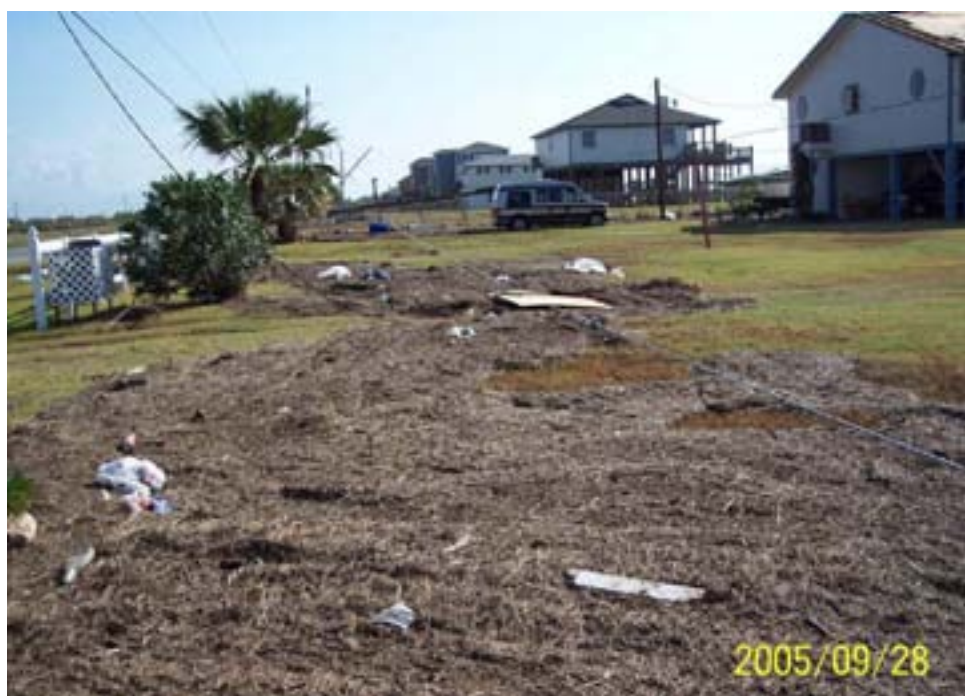
Figure 28. Bolivar Peninsula grassy debris line landward of first row of houses. Main highway and bay is on the left, Gulf of Mexico on the right.

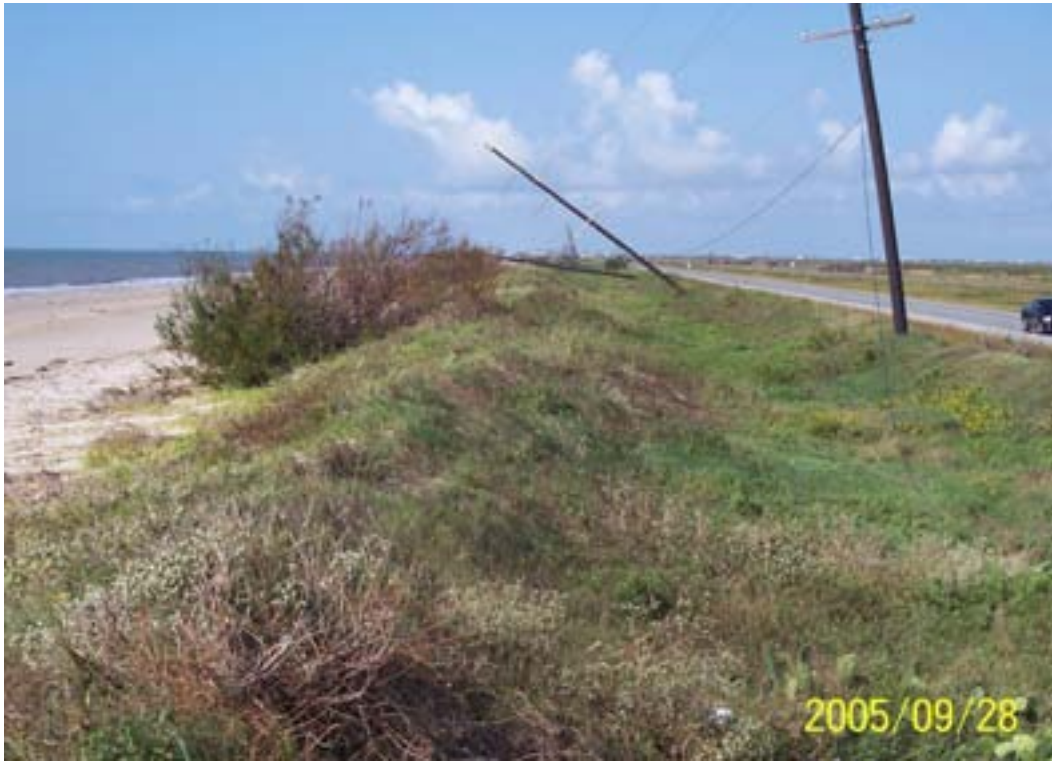
Figure 29. Power poles lying in the offshore direction along Bolivar Peninsula.
