Hurricane Rita Impacts on the Texas Shoreline A Summary Report

Prepared for the Texas General Land Office under GLO Interagency Contract Number 02-267C

Bureau of Economic Geology
Scott W. Tinker, Director
The University of Texas at Austin
Austin, Texas 78713-8924

March 2008

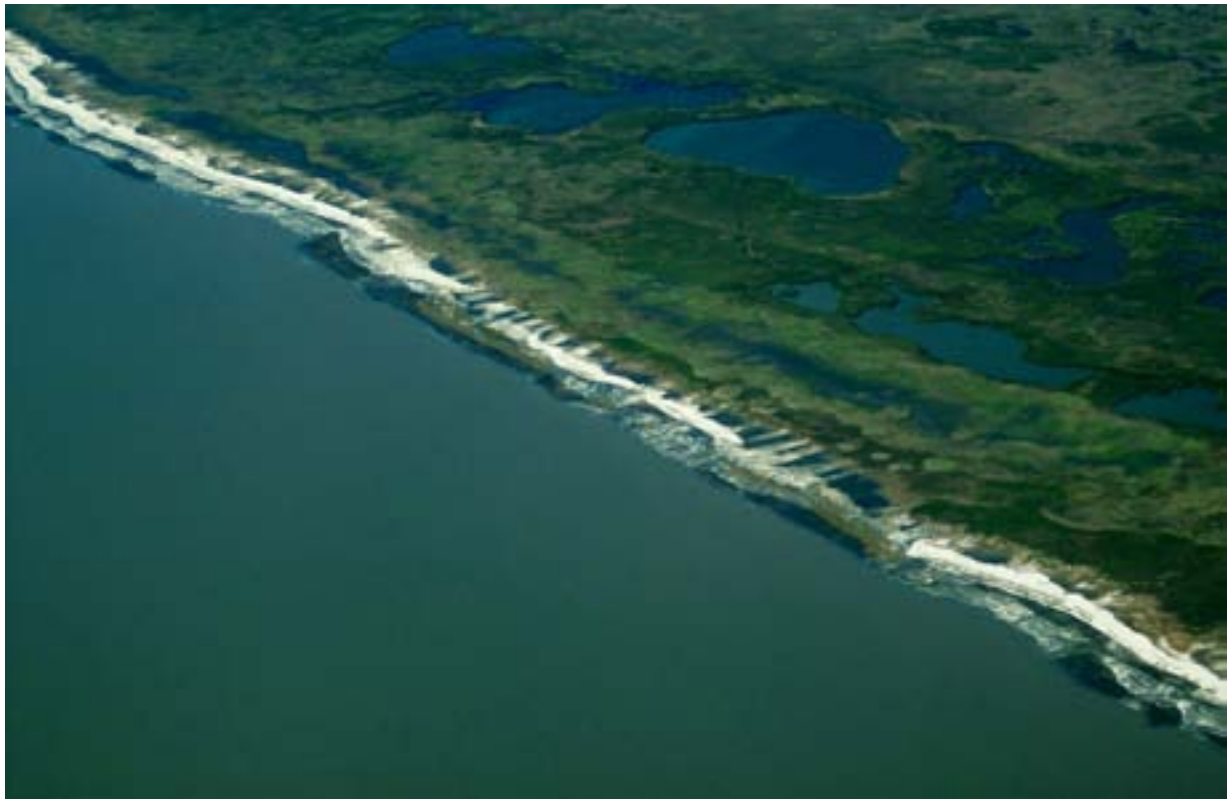
Closer to landfall the uninhabited shoreline from High Island to Sabine Pass (Fig. 2) experience episodic retreat and washover deposition as shown by unvegetated sand creating a new storm platform (Fig. 30). This stretch of shoreline consists of cohesive muddy sediments and fringing, narrow sandy beaches backed by brackish wetland environments. In places, the sand is more plentiful and may form foredunes. Washover deposition by large storms resulting in the vertical accretion of a storm platform and subsequent dune development on that platform is an important process along this shoreline. The storm platform protects landward wetland habitats during more common events that raise water level moderate amounts and helps maintain the shoreline during long-term relative sea level rise. Figure 31 is a lidar change comparison map and profile for a portion of this shoreline. It shows well the landward translation of the profile and the alongshore variation of this shift. Figure 32 shows the difference in Rita's impact on shoreline retreat between the right (east) and left (west) sides of the landfall. On the right, shoreline retreat reached up to 80 m with some of the variation caused by shoreline structures, such as breakwaters, and varying shoreline types. On the left side (Texas), retreat rates were less than 15 m and generally less than 10 m.

Figure 30. Rita erosion and washover deposition building up the storm platform along the Texas chenier plain between High Island and Sabine Pass.

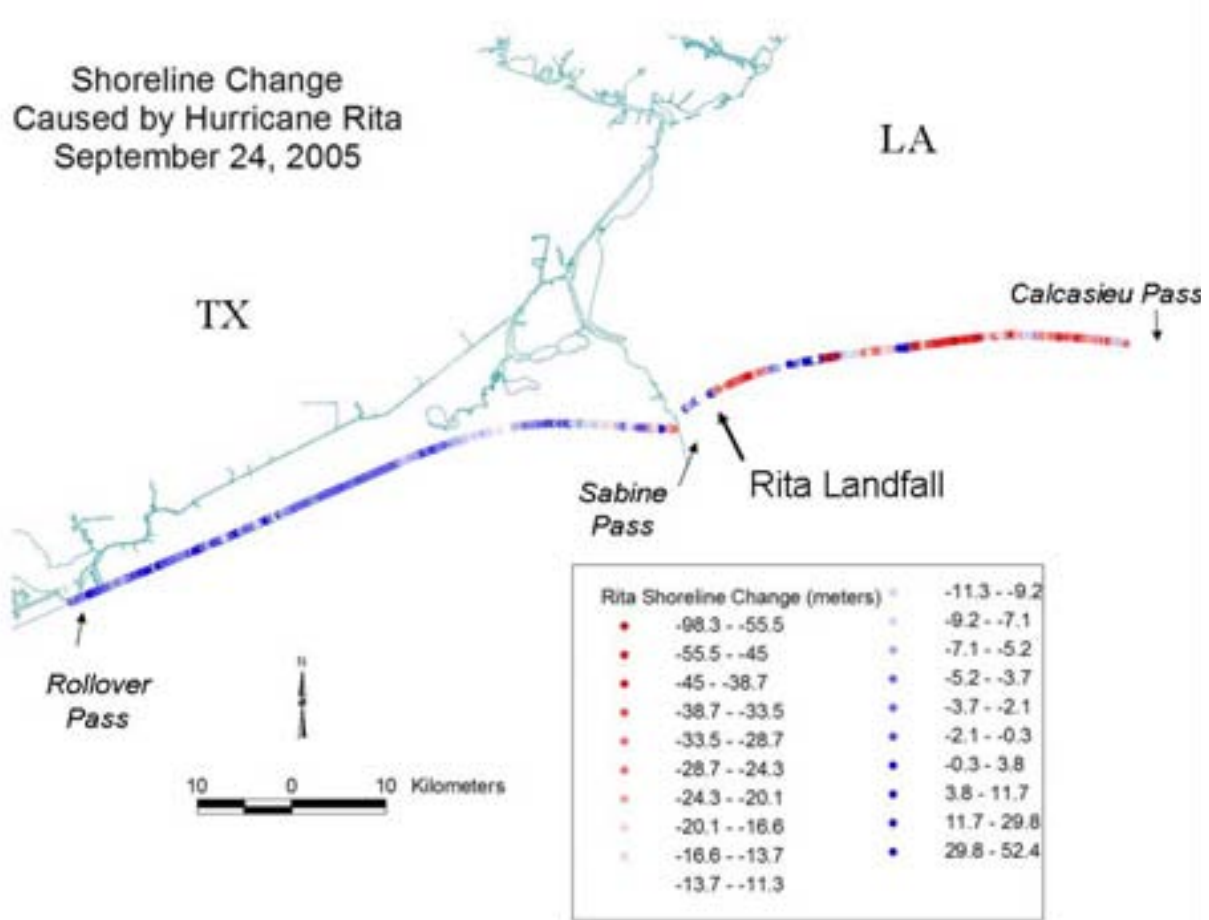
Figure 32. Shoreline change caused by Hurricane Rita.

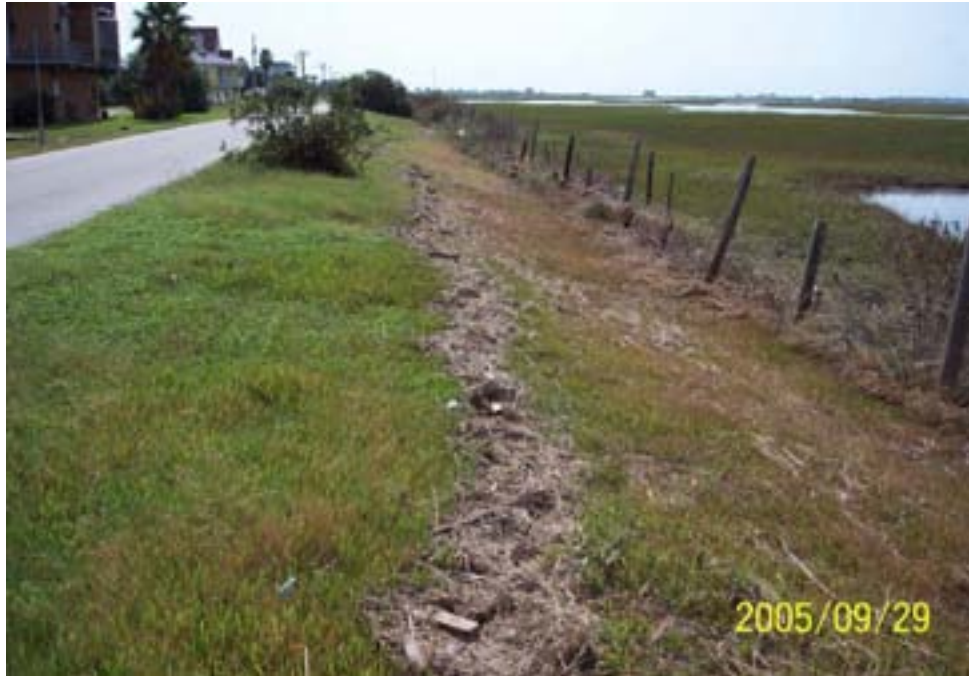
Strong northerly winds (Fig. 3b) created a setup and relatively high waves on the bayside of the barrier islands. In the town of Jamaica Beach on Galveston Island, debris lines of mostly vegetation revealed that a storm tide about 0.6 to 1 m above mean sea level occurred here (Fig. 33). Geotextile tubes also appeared damaged in that the ultraviolet shrouds were not completely covering the tubes and that they appeared to have slumped and lost the usual rounded shape (Figs. 34 and 35). It is not clear how much of this damage Rita caused, if any.

Figure 33. Grass debris line left by Hurricane Rita at 0.6 to 1-m above mean sea level. Jamaica Beach on West Bay side of Galveston Island.

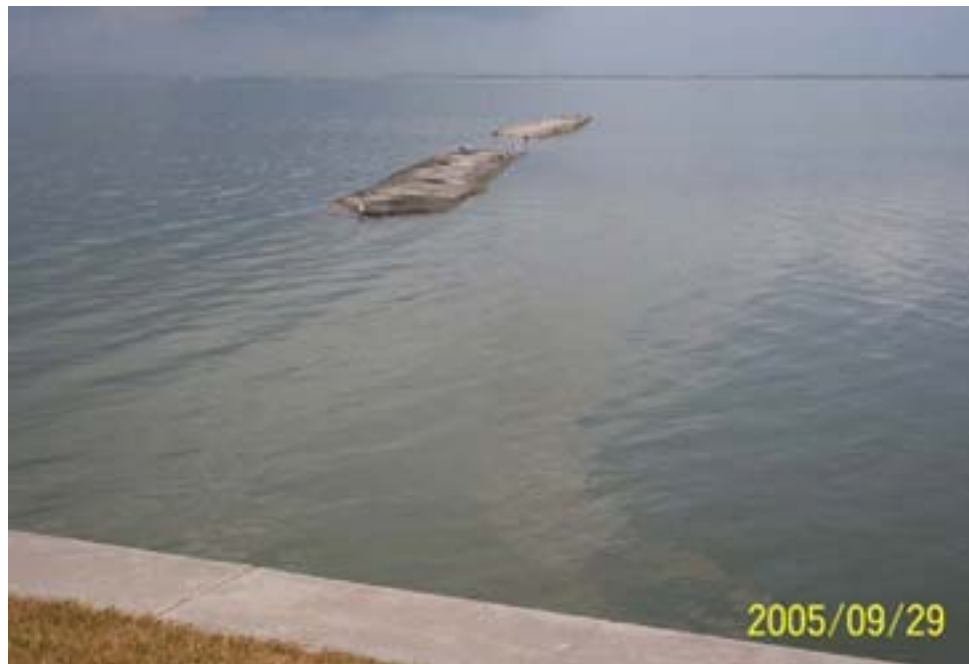
Figure 34. Damaged geotextile tube protecting marsh restoration project adjacent to Jamaica Beach (Galveston Island State Park project). The UV shroud is not present, the tube appears slumped and flattened. It is possible that the tube was damaged further during Hurricane Rita.

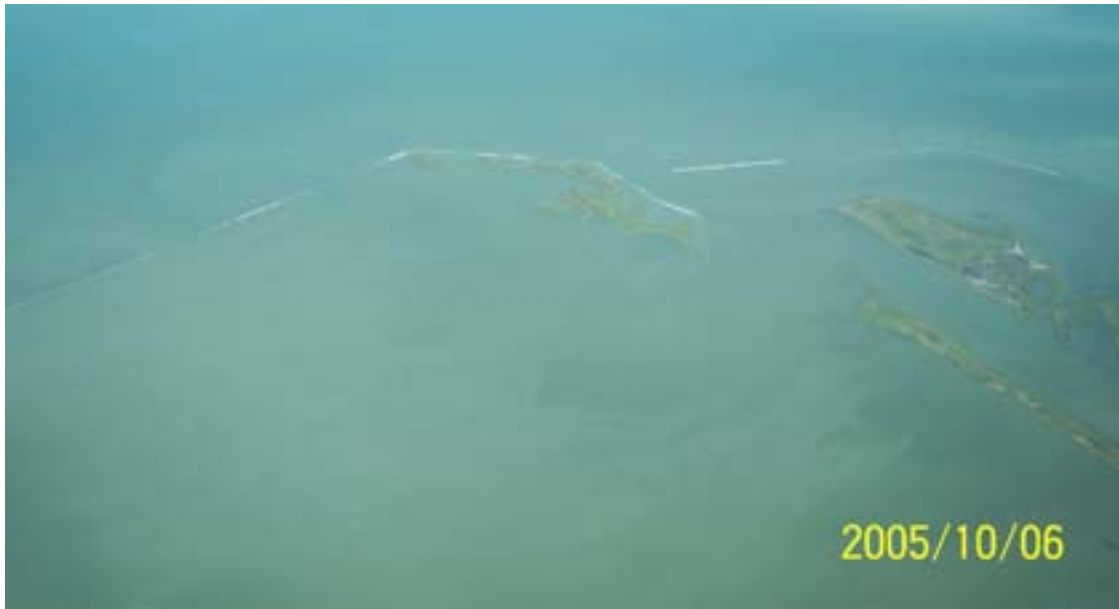
Figure 35. Aerial view of geotextile tubes protecting marsh restoration project in Galveston Island State Park.
