IDENTIFICATION OF SHORELINE EROSION FEATURES AND  
60 YEAR PROJECTION OF THE GULF SHORELINE POSITION,  
GALVESTON AND BRAZORIA COUNTIES, TEXAS

Prepared for the Texas General Land Office

GLO Contract 96-204 R

Bureau of Economic Geology  
The University of Texas at Austin  
Noel Tyler, Director

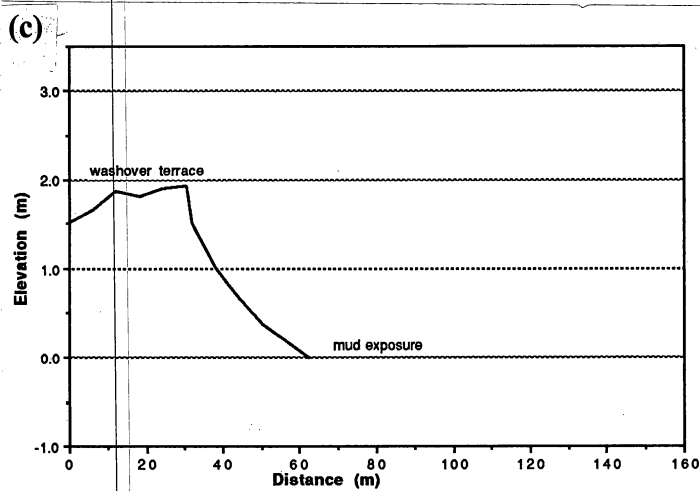
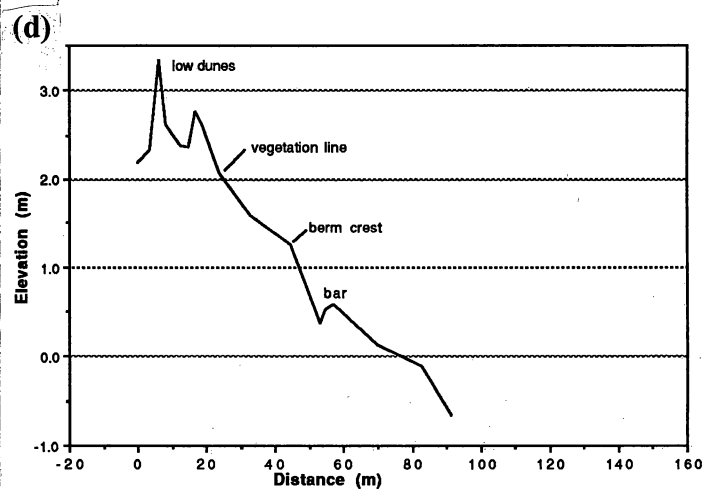
Figure 3. Surveyed profiles selected from the four morpho-compositional beach sections representing (a) washover terrace and marsh (mud) substrate west of Sabine Pass, (b) sand beach with low dunes near Sea Rim State Park, (c) washover terrace with mud substrate along Highway 87 east of High Island, (d) narrow sand beach with artificial dunes west of High Island, (e) steep sand beach and erosional scarp west of Rollover Pass, and (f) wide sand beach with low dunes on the southwestern end of Bolivar Peninsula.

Proper selection of a shoreline monitoring feature that tracks long-term shoreline movement partly depends on understanding the factors that control beach morphology at different time scales. Shoreline stability is ultimately controlled by the regional geologic framework, which includes the bedrock or late Quaternary deposits and coastal processes. Where tidal range and wave climate are essentially constant, such as along the southeastern Texas coast, alongshore variations in beach morphology (fig. 3) are related

The western morpho-compositional section is the broad, sand-rich barriers (Bolivar Peninsula, Galveston Island, Follets Island) that extend from Caplen to Freeport (fig. 1). Within this section, Gulf beaches are sandy and moderately wide, and the undeveloped backbeaches grade into low, densely vegetated dunes (fig. 3f) or an erosional scarp

(fig. 3e). Beach morphologies from Freeport to the Brazos River (new Brazos delta) are similar in that Gulf beaches are sandy, and the undeveloped backbeaches grade into low, densely vegetated dunes (fig. 3f) or an erosional scarp (fig. 3e). However beaches tend to be relatively narrow southwest of Freeport.
