HISTORICAL SHORELINE
CHANGES IN THE GALVESTON BAY
AND SAN ANTONIO BAY SYSTEMS,
TEXAS GULF COAST

R. A. Morton, J. G. Paine, and W. A. White

Bureau of Economic Geology
The University of Texas at Austin
Austin, Texas 78712

August 1983

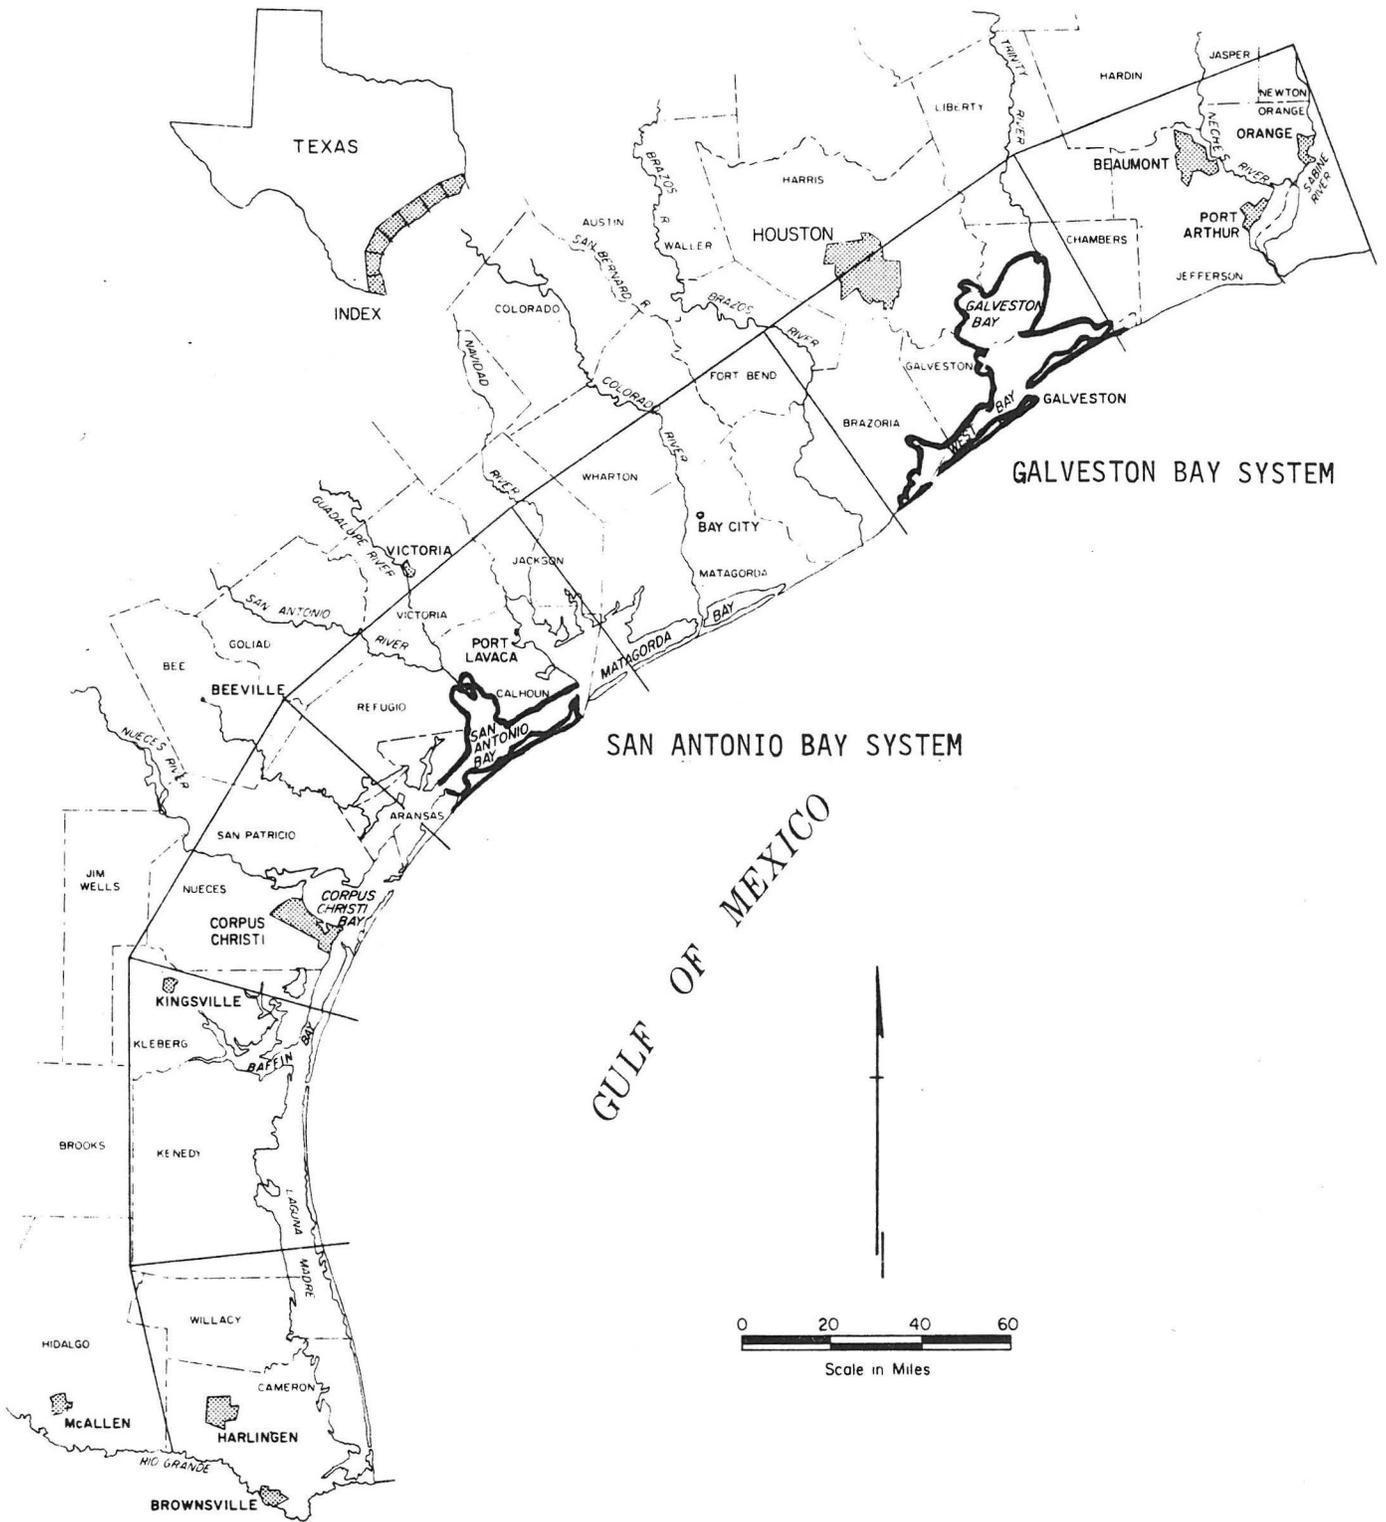
Figure 1-1. The Galveston and San Antonio Bay systems, Texas Gulf Coast.

Shoreline changes in Galveston and San Antonio Bays (fig. 1-1) are attributable to both natural causes and human activities. Regardless of the cause, vast areas of land are being lost in some places and gained in others; accurate estimates of land losses and gains or their equivalent economic value are unavailable because bay shoreline changes have not been systematically investigated. The purpose of this study is (1) to quantify the significant shoreline changes that occurred within the Galveston and San Antonio Bay systems during the past century, (2) to describe the physical processes that cause shoreline movement, and (3) to discuss the anticipated future changes on the basis of long-term historical records and present-day coastal conditions.

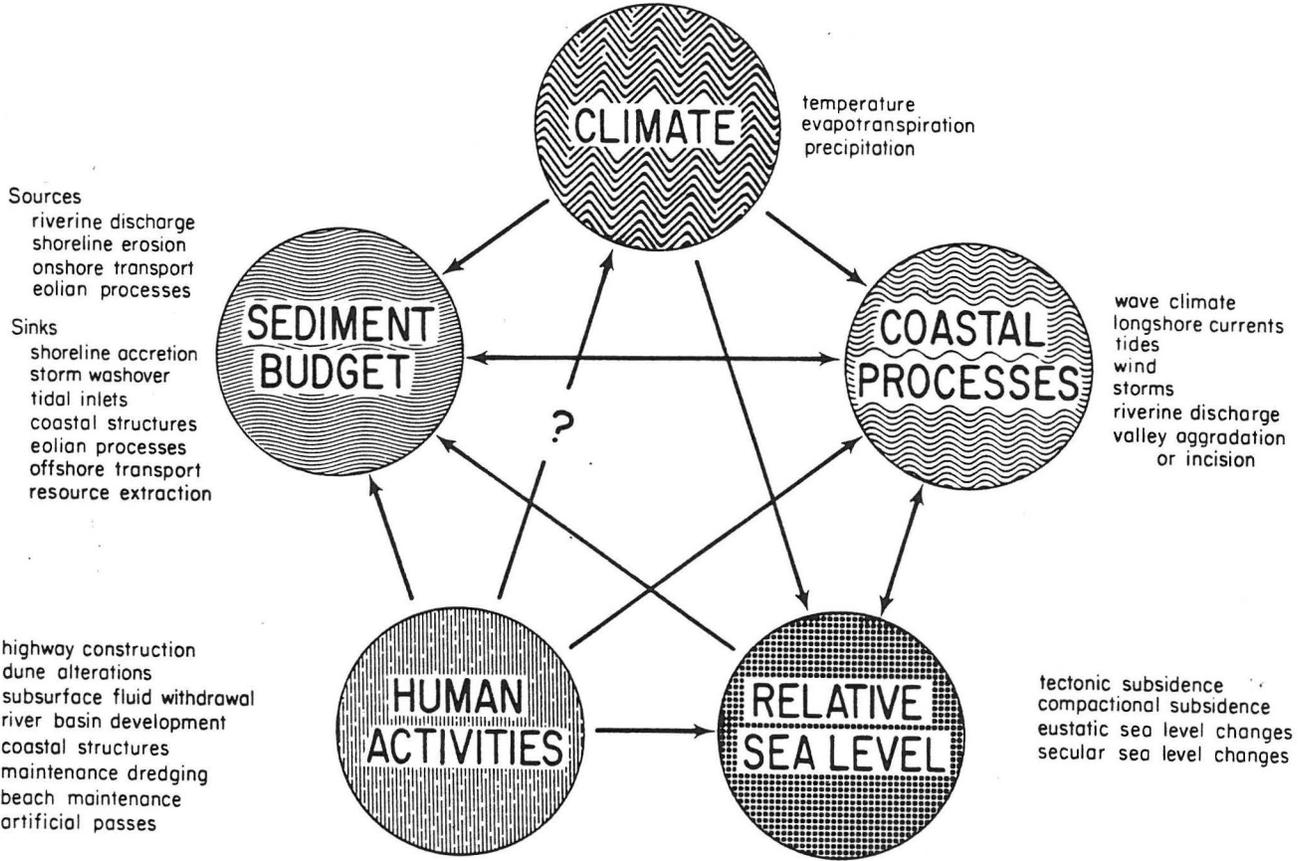
Figure 3-1. Interaction of factors affecting land losses. Arrows point toward the dependent variables: The number of arrows originating from or terminating at a particular factor indicates the relative degree of independence or interaction. For example, human activities are independent of the other factors, but they affect sediment budget, coastal processes, relative sea-level conditions, and perhaps, climate. From Morton (1977).

It is impossible to isolate and quantify each of the factors that cause shoreline changes (fig. 3-1). Despite the difficulties, evaluation of the various factors and their interactions is necessary to understand past shoreline changes and to anticipate future changes.

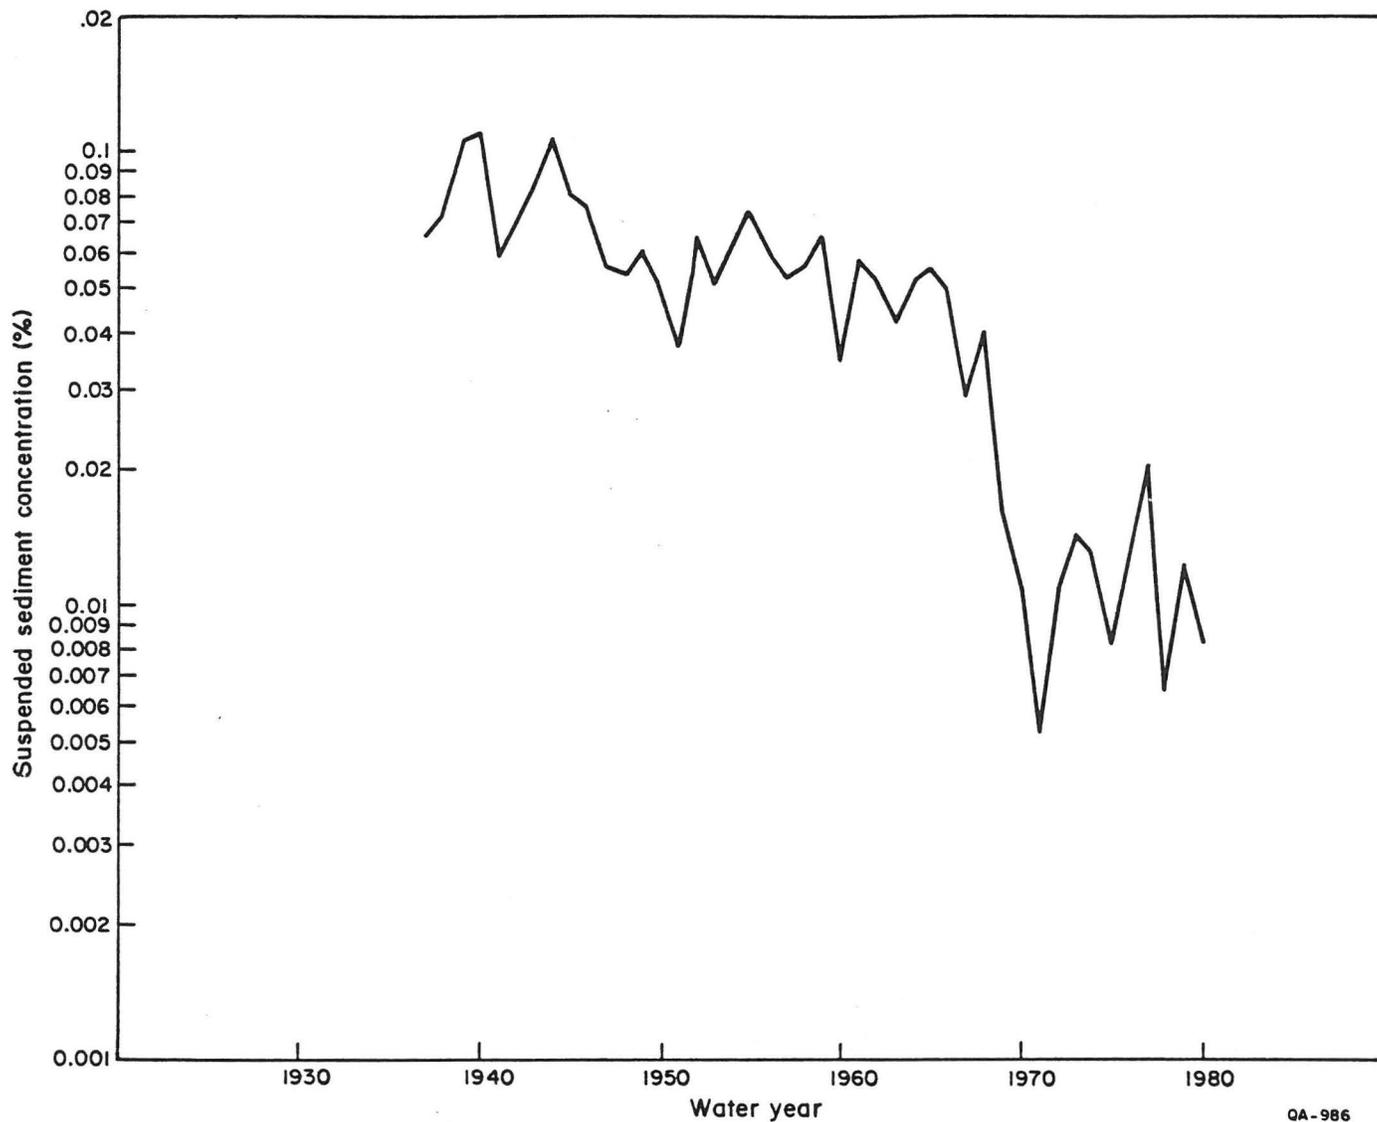
Figure 3-2. Suspended sediment concentraton (by weight) for the Trinity River at Romayor, Texas. Data from the Texas Board of Water Engineers (1961); Texas Water Commission (1964); Texas Water Development Board (1967, 1970, 1974); Texas Department of Water Resources (1979 and unpublished data).

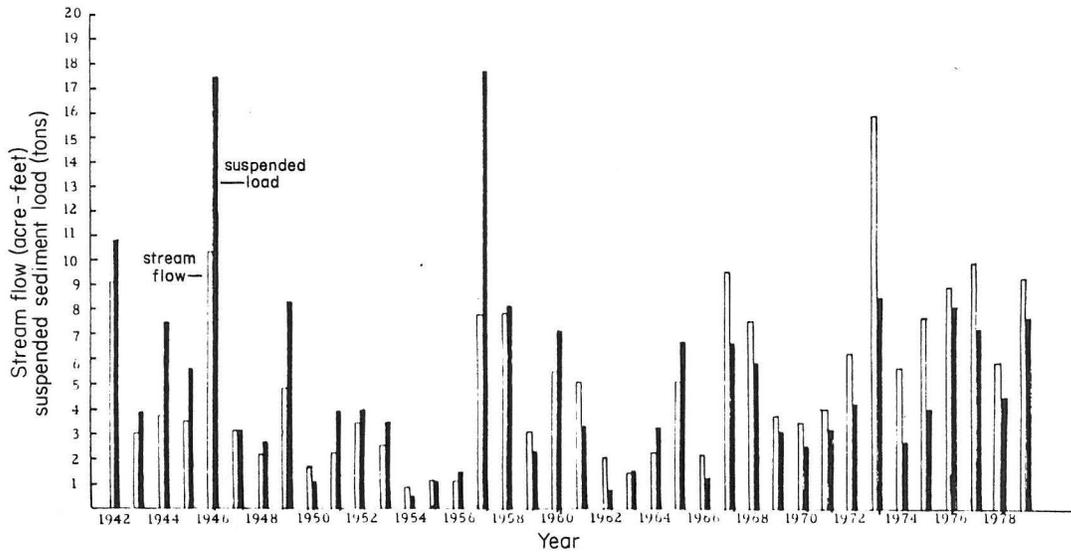
Figure 3-3. Stream flow and suspended load along the San Antonio River at Goliad, Texas.

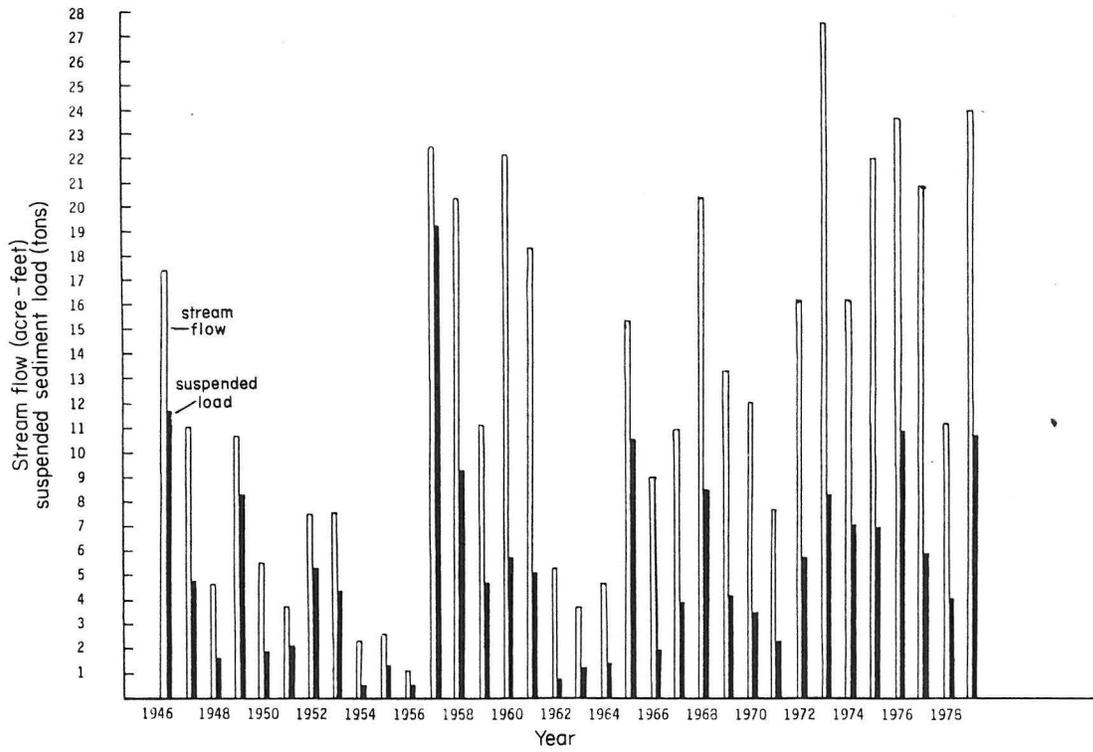
Figure 3-4. Stream flow and suspended load along the Guadalupe River at Victoria, Texas.

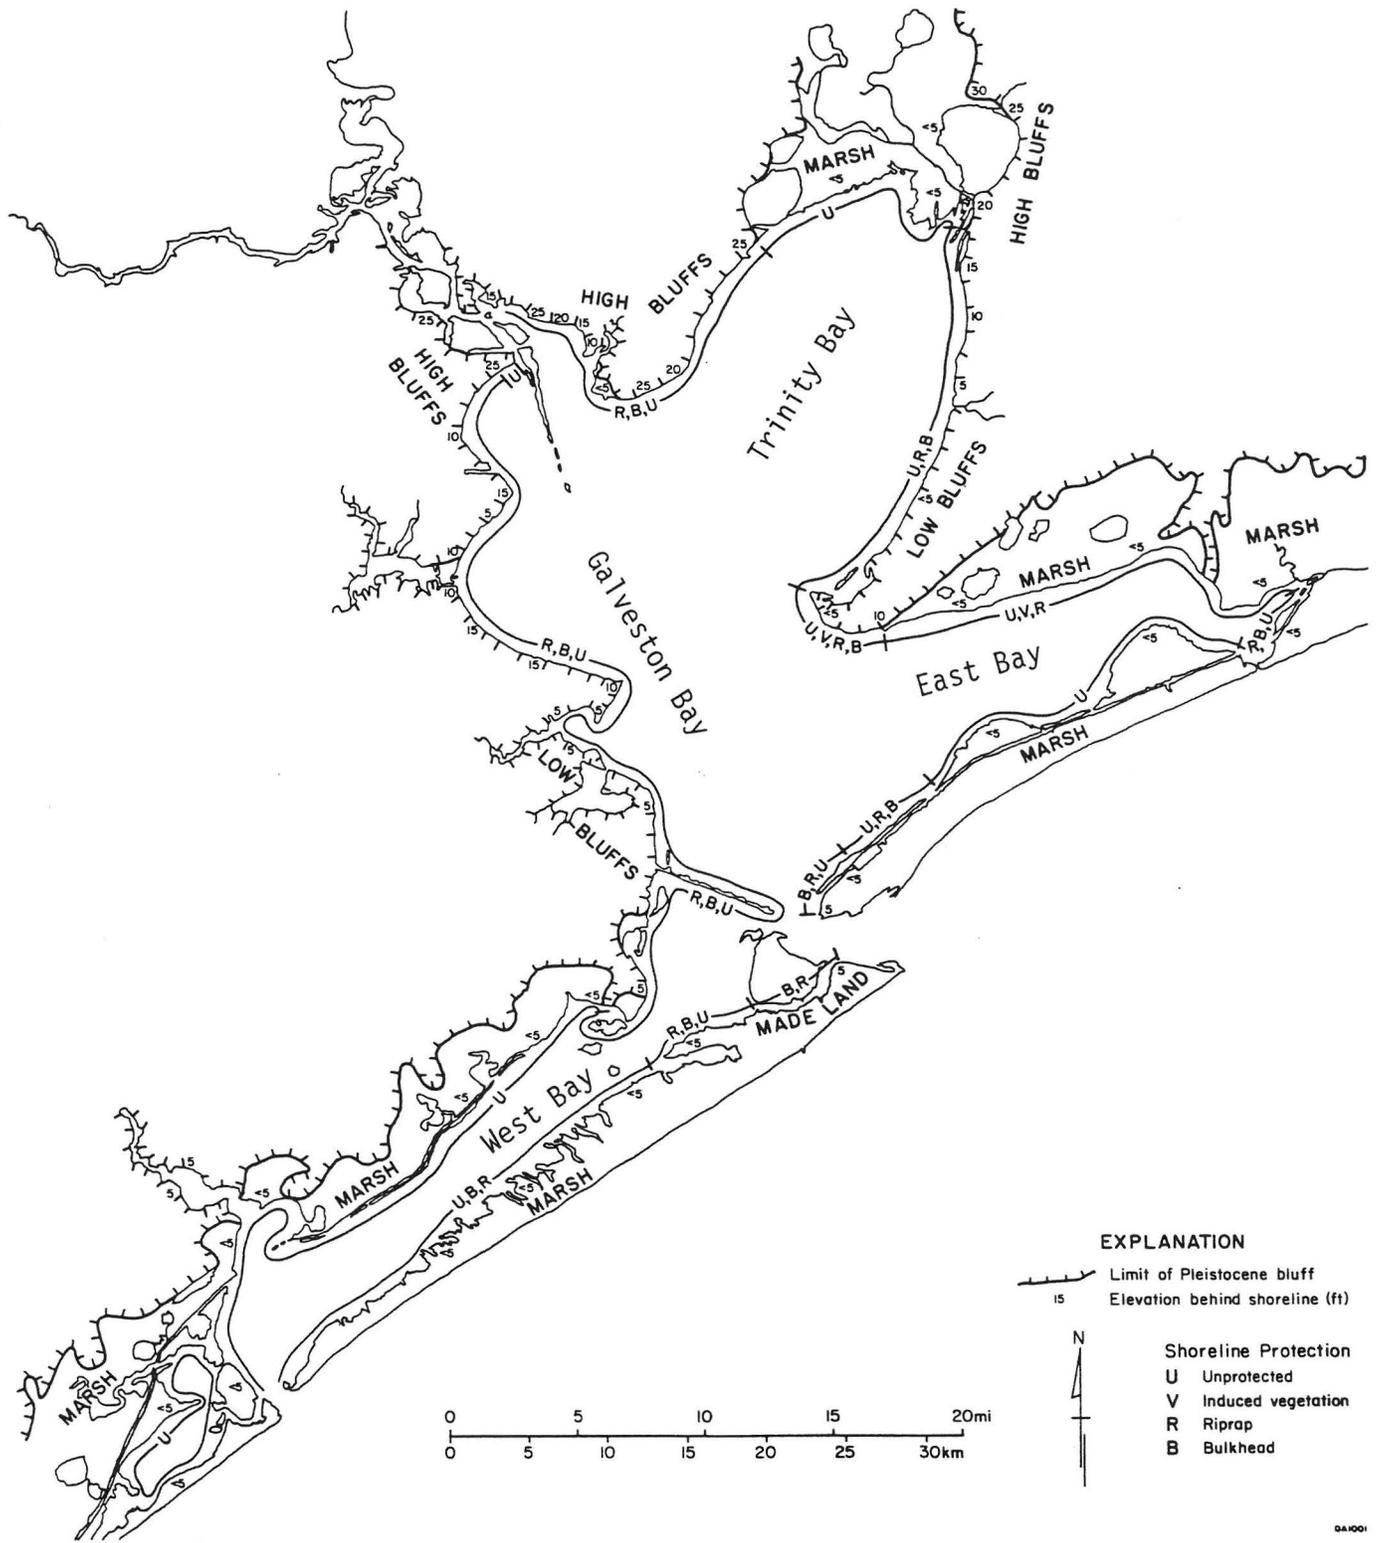
Figure 4-1. Distribution of shoreline types and shoreline protection measures in the Galveston Bay system.

Shoreline changes occurred for all types of shorelines in the Galveston Bay system. Types of shorelines likely to be found around these bays include low to high clay bluffs, fresh-water to salt-water marshes, sandy slopes, sand and shell beaches, and various types of spoil and made land (fig. 4-1). Shorelines have been protected in a variety of ways, including induced vegetation (commonly Spartina alterniflora), riprap, and bulkheads (fig. 4-1).

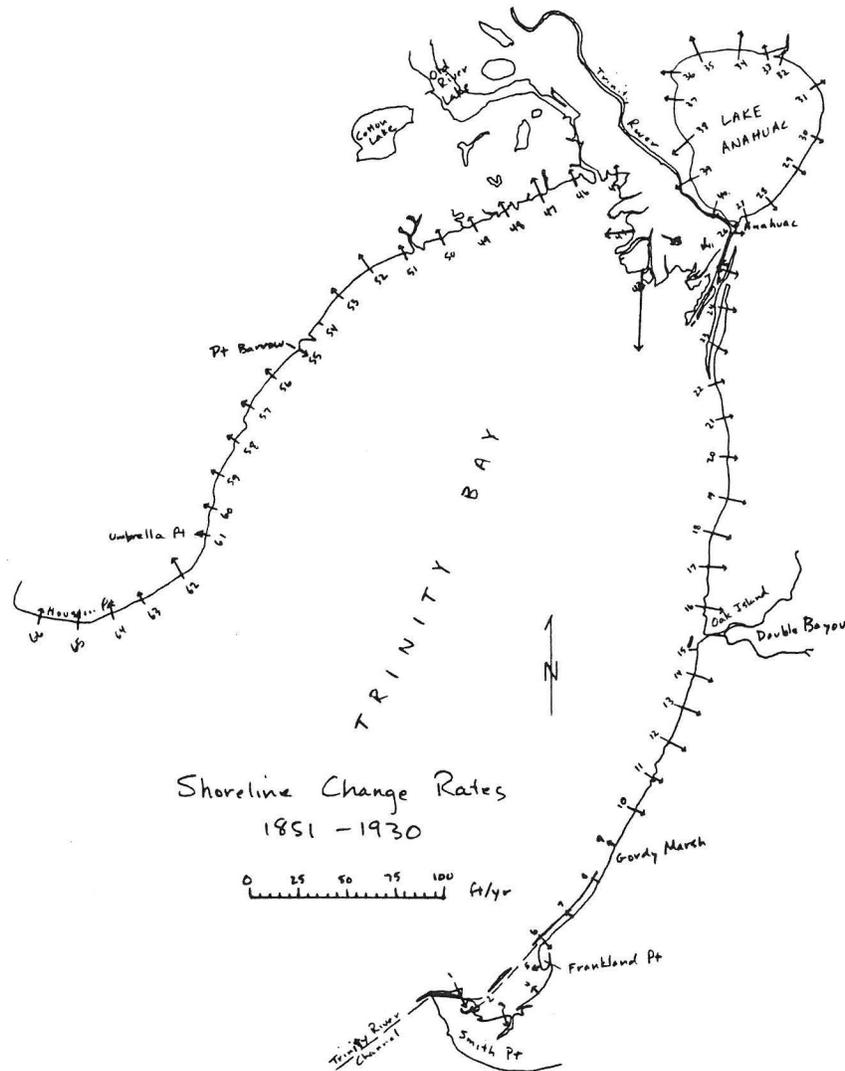
Figure 4-2. Trinity Bay locations, measuring stations, and rates of shoreline change, 1851 to 1930.

Although Trinity Bay shorelines were generally eroding during this period, the highest rates of shoreline change occurred for the accreting portion of the Trinity delta (fig. 4-2). The highest rates of accretion (40 ft/yr) occurred near station 43 on the southern end of the delta; river discharge in other areas near this station caused lower rates of accretion (2 to 12 ft/yr at stations 41, 42, and 44). Erosion was the rule in abandoned parts of the delta, the northeastern portion of the delta in Lake Anahuac recording erosion rates up to 6 ft/yr (stations 36 to 40); erosion rates of 0.5 to 7 ft/yr occurred for the western portion of the delta (stations 45 to 53).

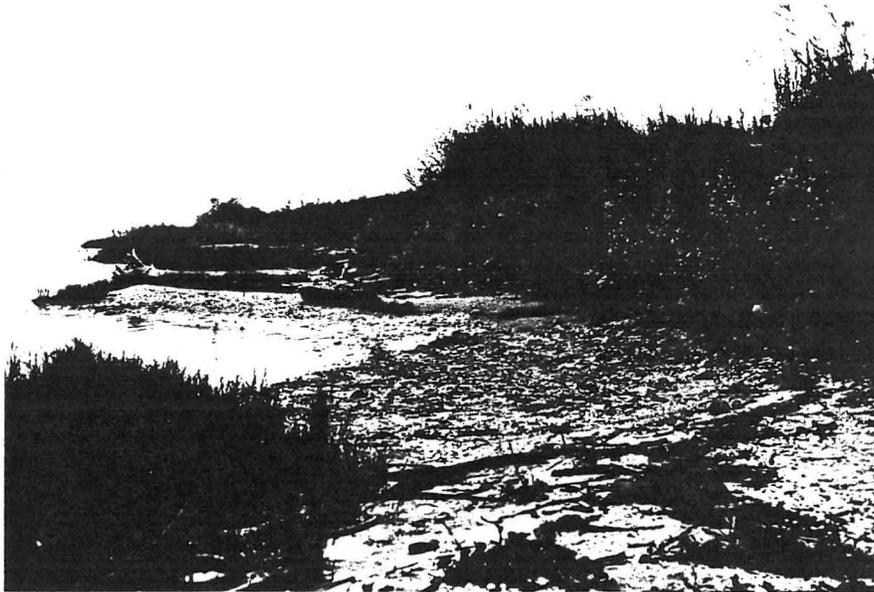
Figure 4-3. Wave-cut face of a spoil island along the Trinity River Channel, Trinity Bay.

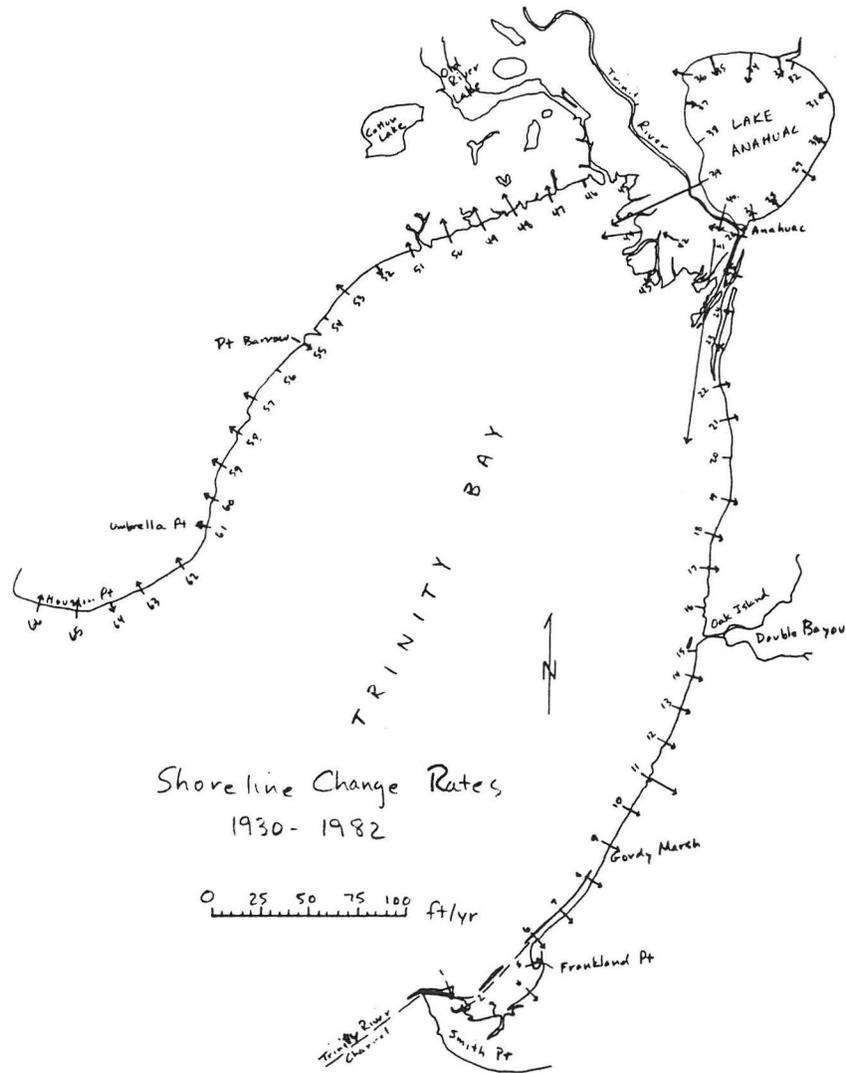
Figure 4-4. Rates of shoreline change for Trinity Bay, 1930 to 1982.

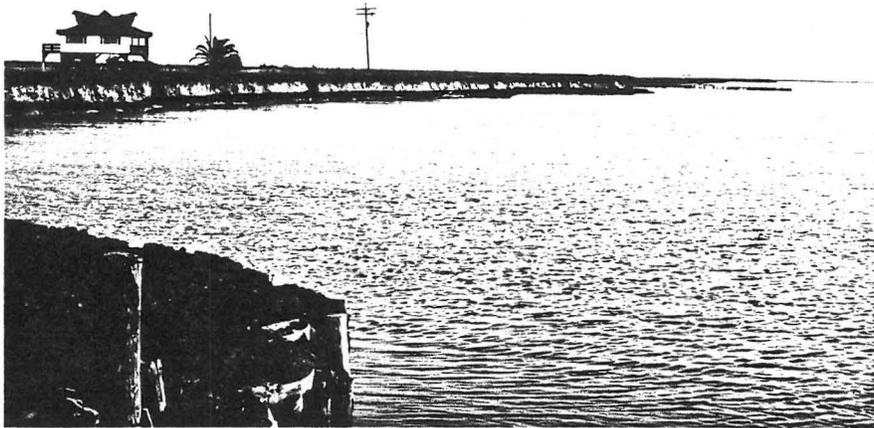
Figure 4-5. Eroding low bluffs along eastern Trinity Bay.

Despite the protection afforded eastern Trinity Bay by the spoil islands, most stations along this stretch recorded net erosion for the period 1930 to 1982 (fig. 4-5). Erosion rates from Smith Point to Gordy Marsh ranged from no change at station 3 to 5 ft/yr at station 10. Anomalously high erosion rates of 13 to 14 ft/yr occurred near station 11. Rates of erosion of less than 5 ft/yr were observed north and south of Double Bayou (stations 12 to 22), and two stations (15 and 16) recorded no net change. Spoil islands persist from station 23 to Anahuac, protecting marshes formed on dredge spoil adjacent to the pre-channel shoreline. This resulted in apparent accretion rates of 0.5 to 15 ft/yr for stations 23 to 26.

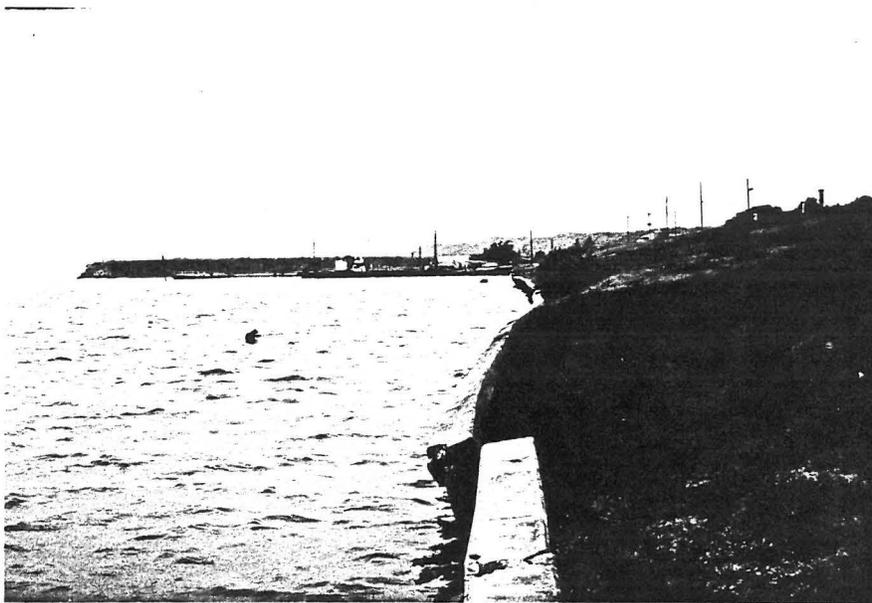
Figure 4-6. Failed bulkhead along western Trinity Bay.

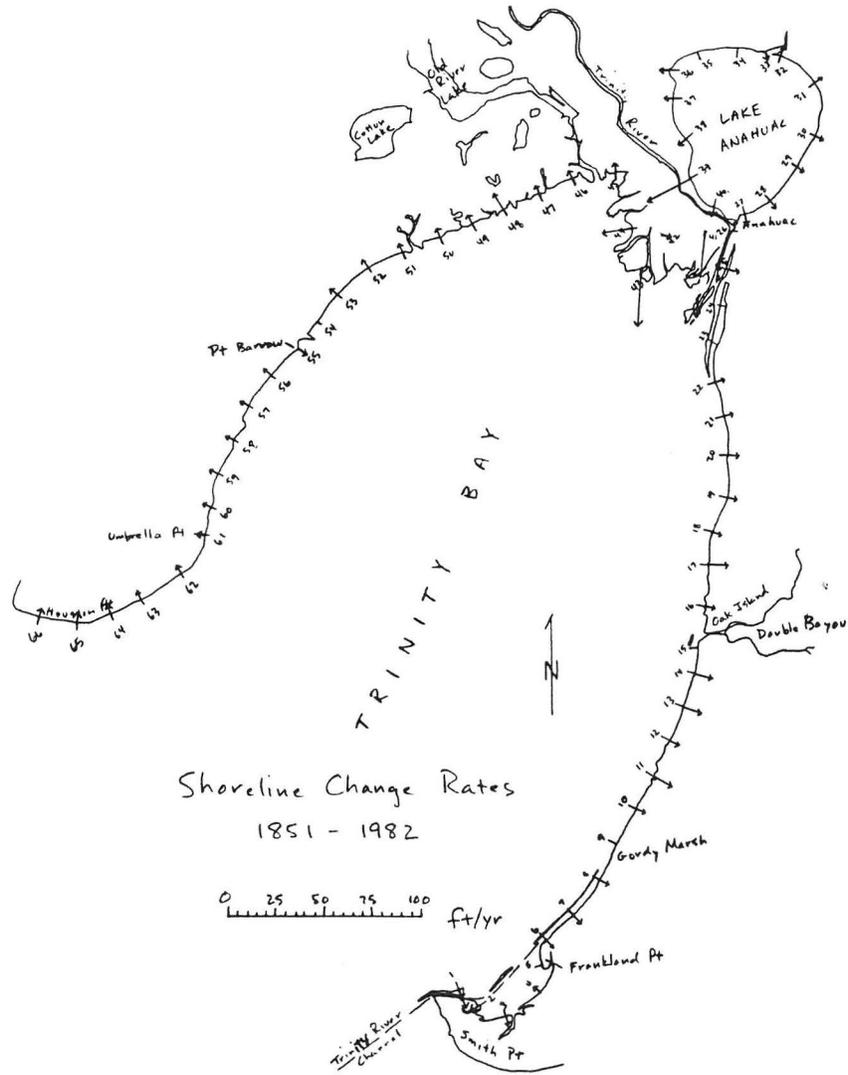
Figure 4-7. Cumulative rates of shoreline change for Trinity Bay, 1851 to 1982.

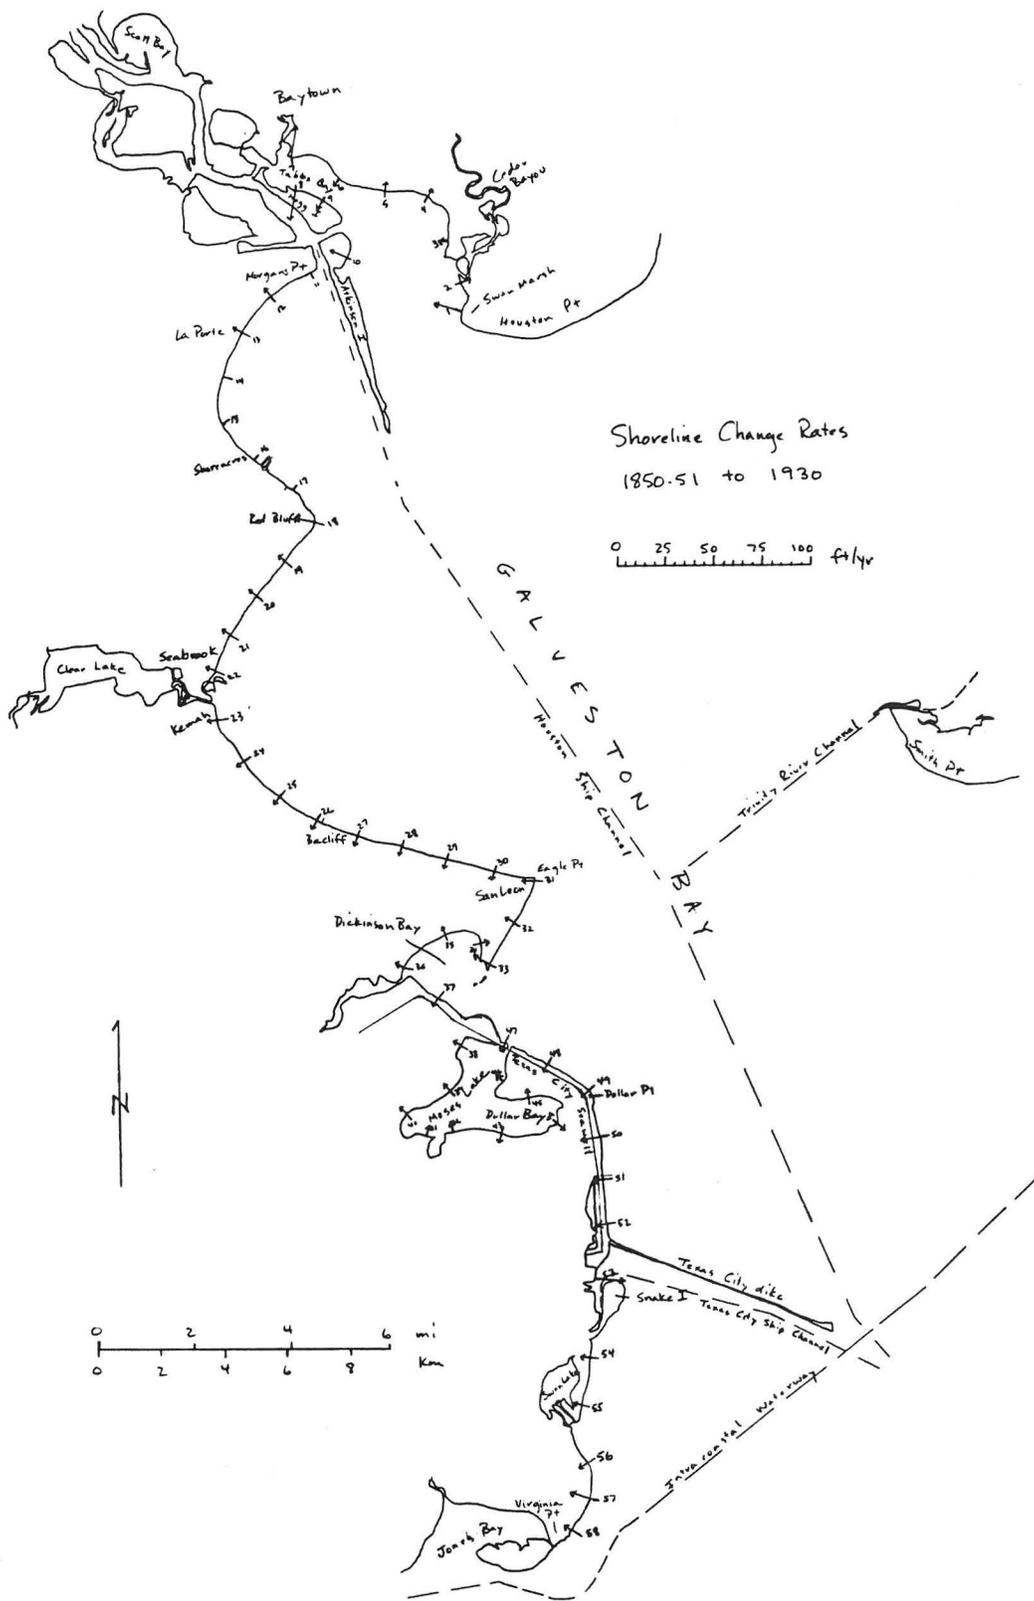
Figure 4-8. Galveston Bay locations, measuring stations, and rates of shoreline change, 1850-51 to 1930.

Shorelines considered here as part of Galveston Bay form an irregular outline (fig. 4-8), beginning at Swan Marsh near Cedar Bayou and including Tabbs Bay, Hogg Island, and the long

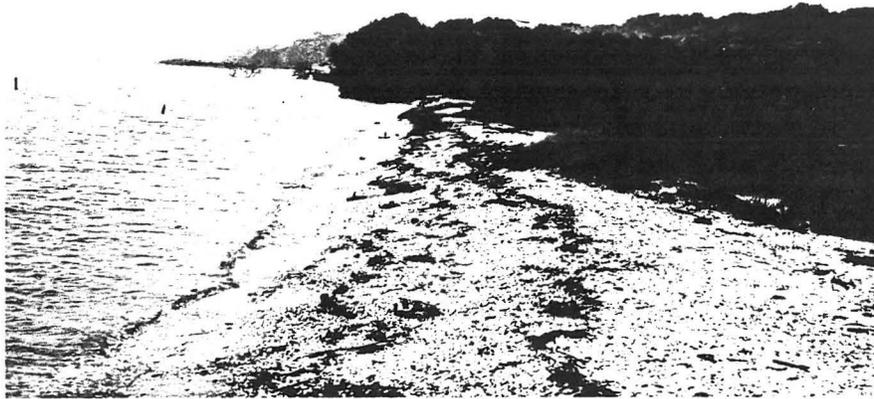
Figure 4-9. Shell berm at Morgans Point, Galveston Bay.

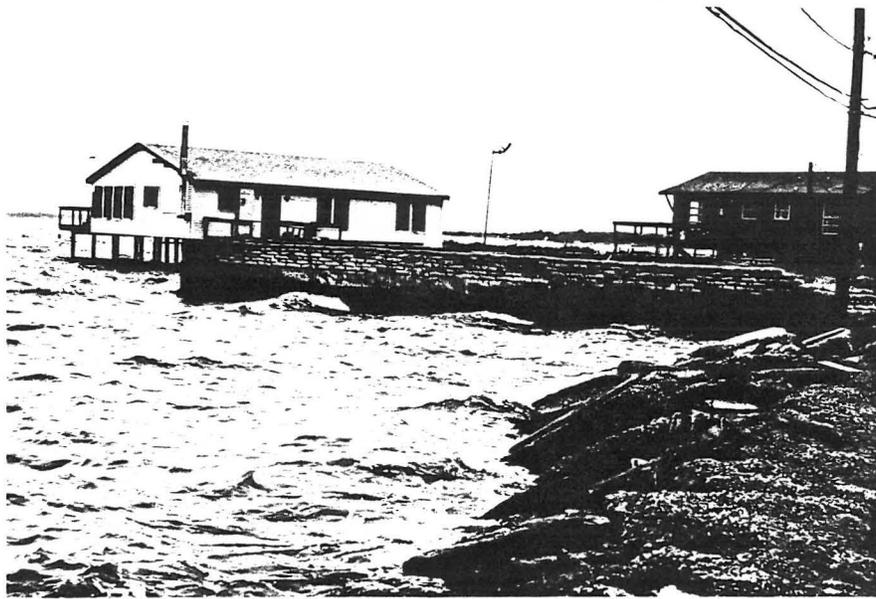
Figure 4-11. Riprap and bulkheads protecting Seabrook, Galveston Bay.

Rates of shoreline change for stations 20 to 30 were similar for this period, ranging from no change (stations 22, 24, and 25) to erosion of up to 3 ft/yr (fig. 4-11). The exception was station 28, located east of the cooling water outlet of the Houston Lighting and Power plant. This station experienced rates of erosion of 5 ft/yr. Erosion rates increased from 2.9 ft/yr at Eagle Point (station 31) to 5.8 ft/yr at the Dickinson Bay inlet (station 33). Station 34 in Dickinson Bay recorded no net change, but all other stations in the bay experienced erosion at rates ranging from 2 to 4 ft/yr.

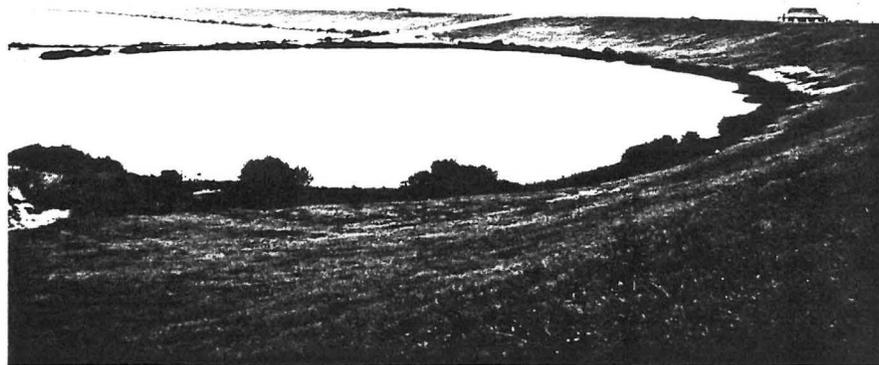
Figure 4-12. Texas City Seawall and holding ponds, Galveston Bay.

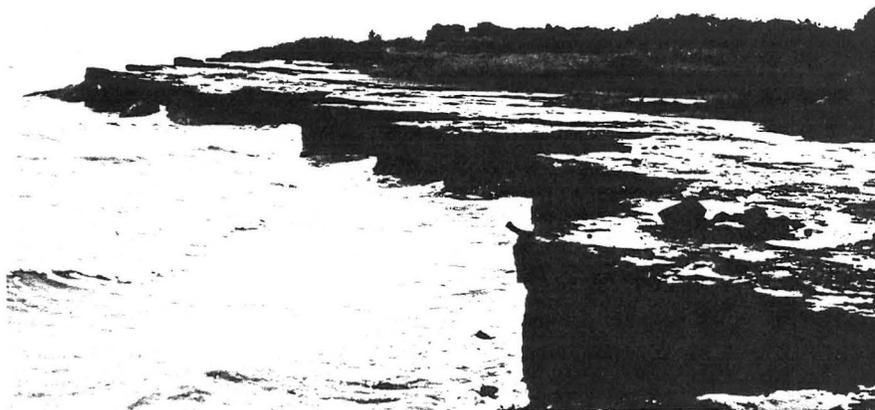
Figure 4-13. Erosion of low bluffs fronting the Texas City Seawall, Galveston Bay.

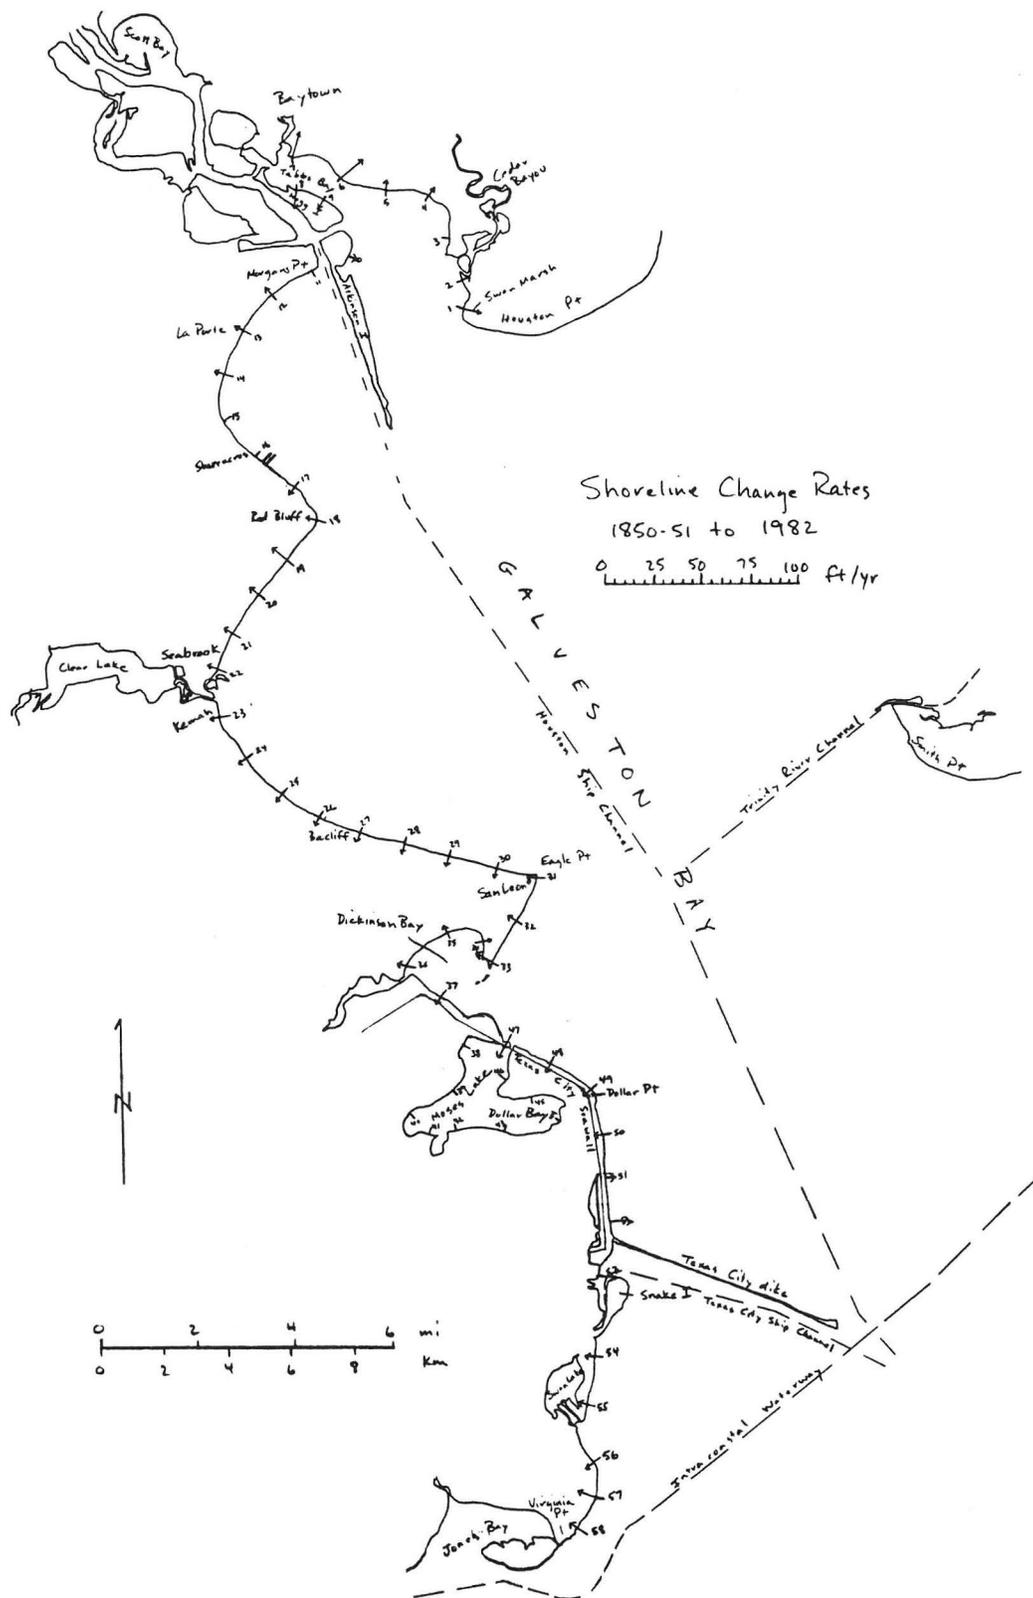
Figure 4-14. Cumulative rates of shoreline change for Galveston Bay, 1850-51 to 1982.

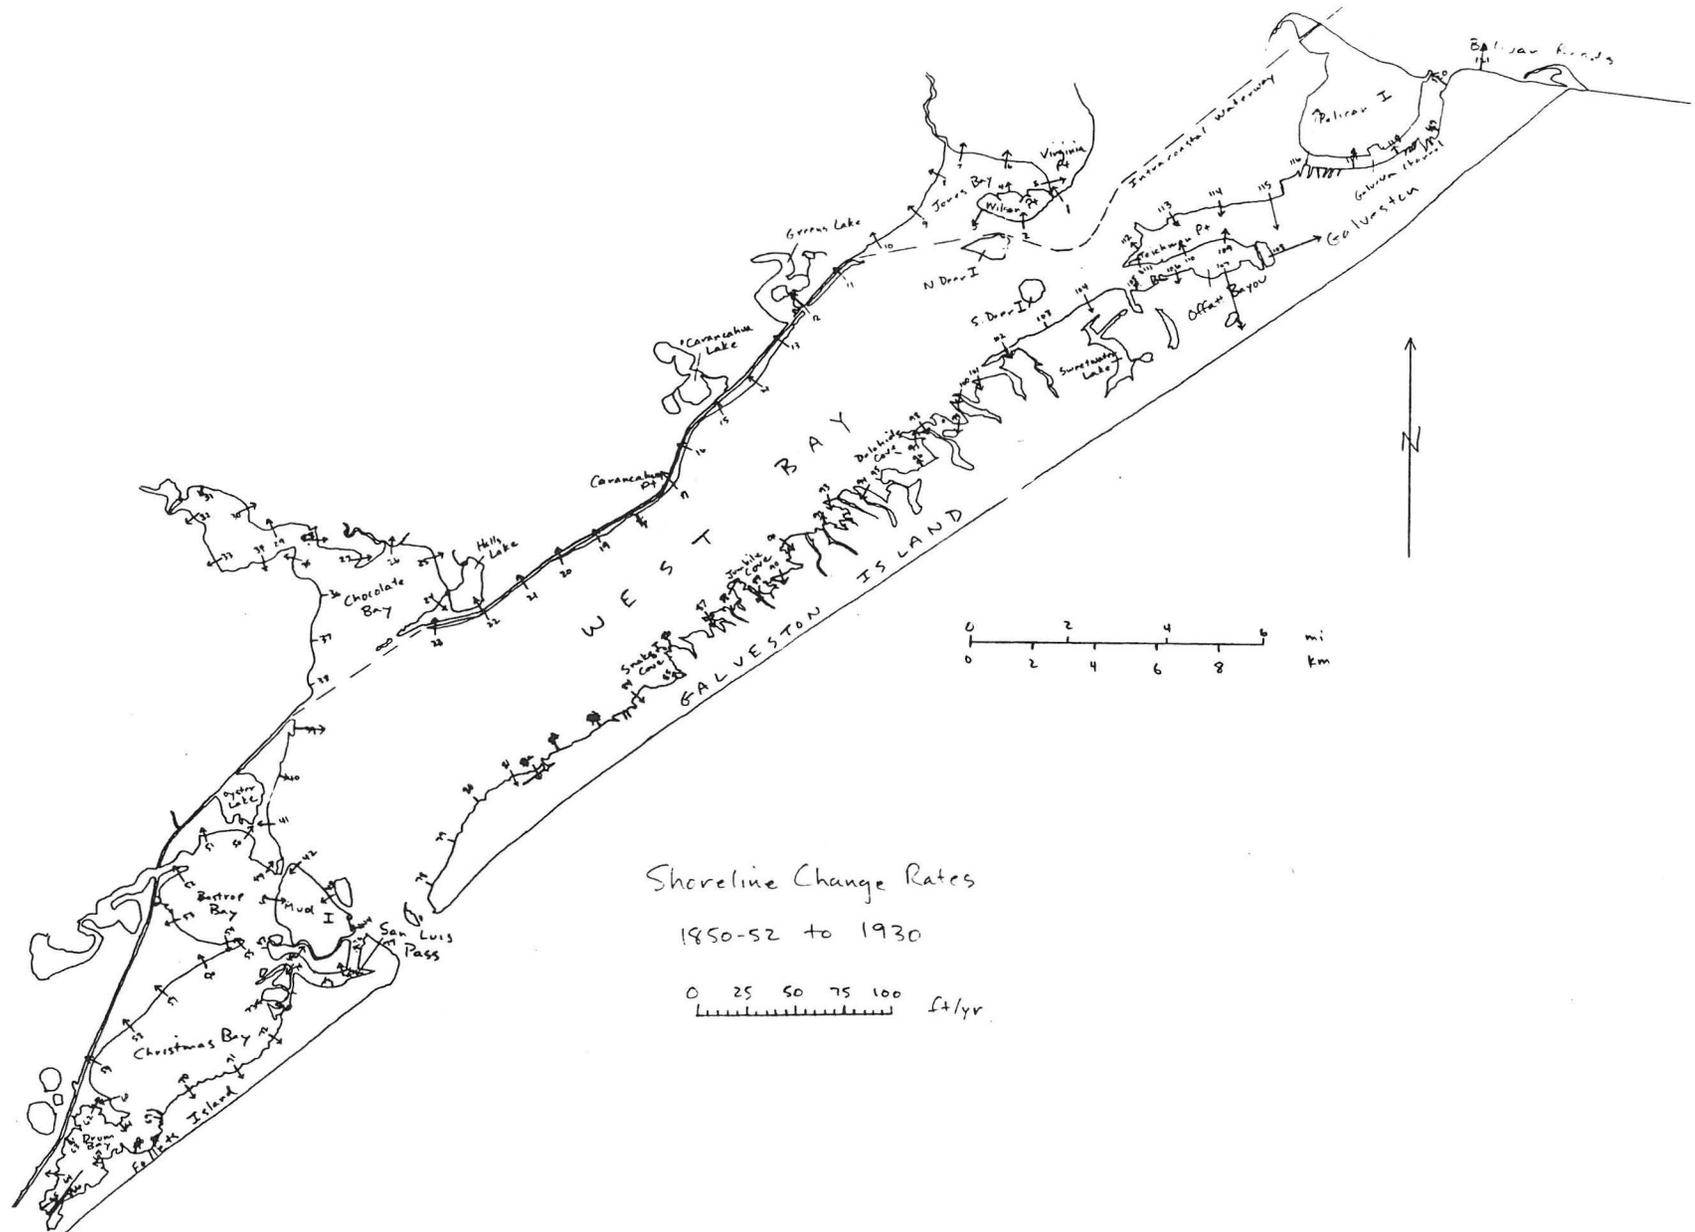
Figure 4-15. West Bay locations, measuring stations, and shoreline change rates, 1850-52 to 1930.

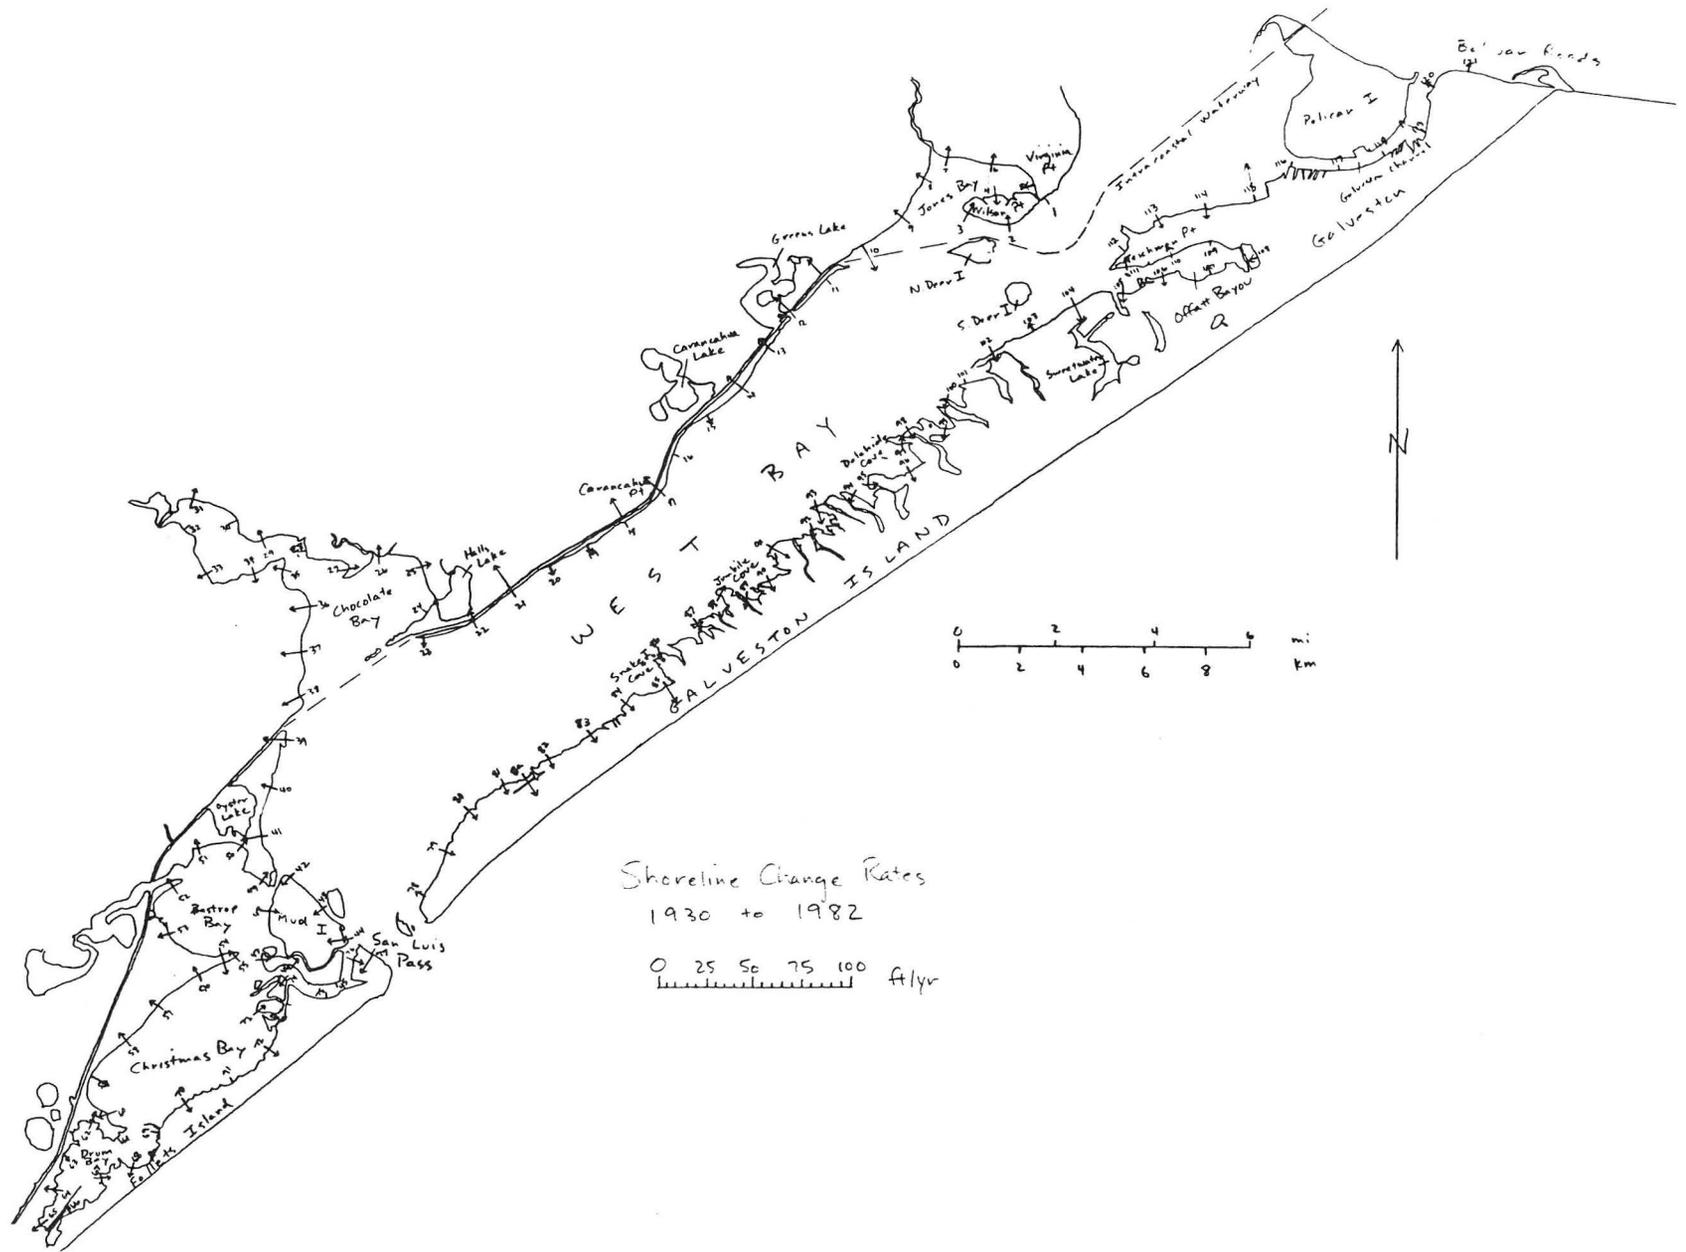
Figure 4-16. Rates of shoreline change for West Bay, 1930 to 1982.
