HISTORICAL SHORELINE
CHANGES IN THE GALVESTON BAY
AND SAN ANTONIO BAY SYSTEMS,
TEXAS GULF COAST

R. A. Morton, J. G. Paine, and W. A. White

Bureau of Economic Geology
The University of Texas at Austin
Austin, Texas 78712

August 1983

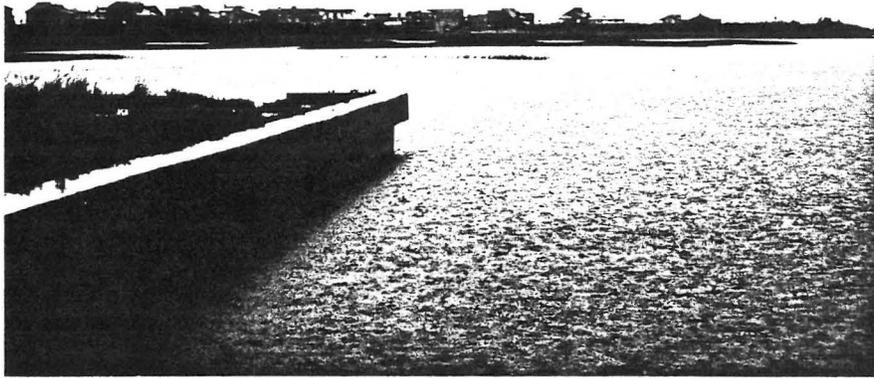
Figure 4-17. A bulkheaded residential development at Delehide Cove, West Bay.

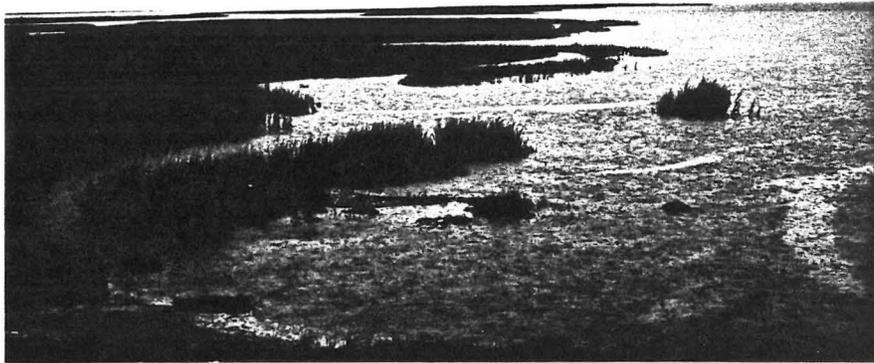
Figure 4-18. Gangs Bayou marsh, West Bay.

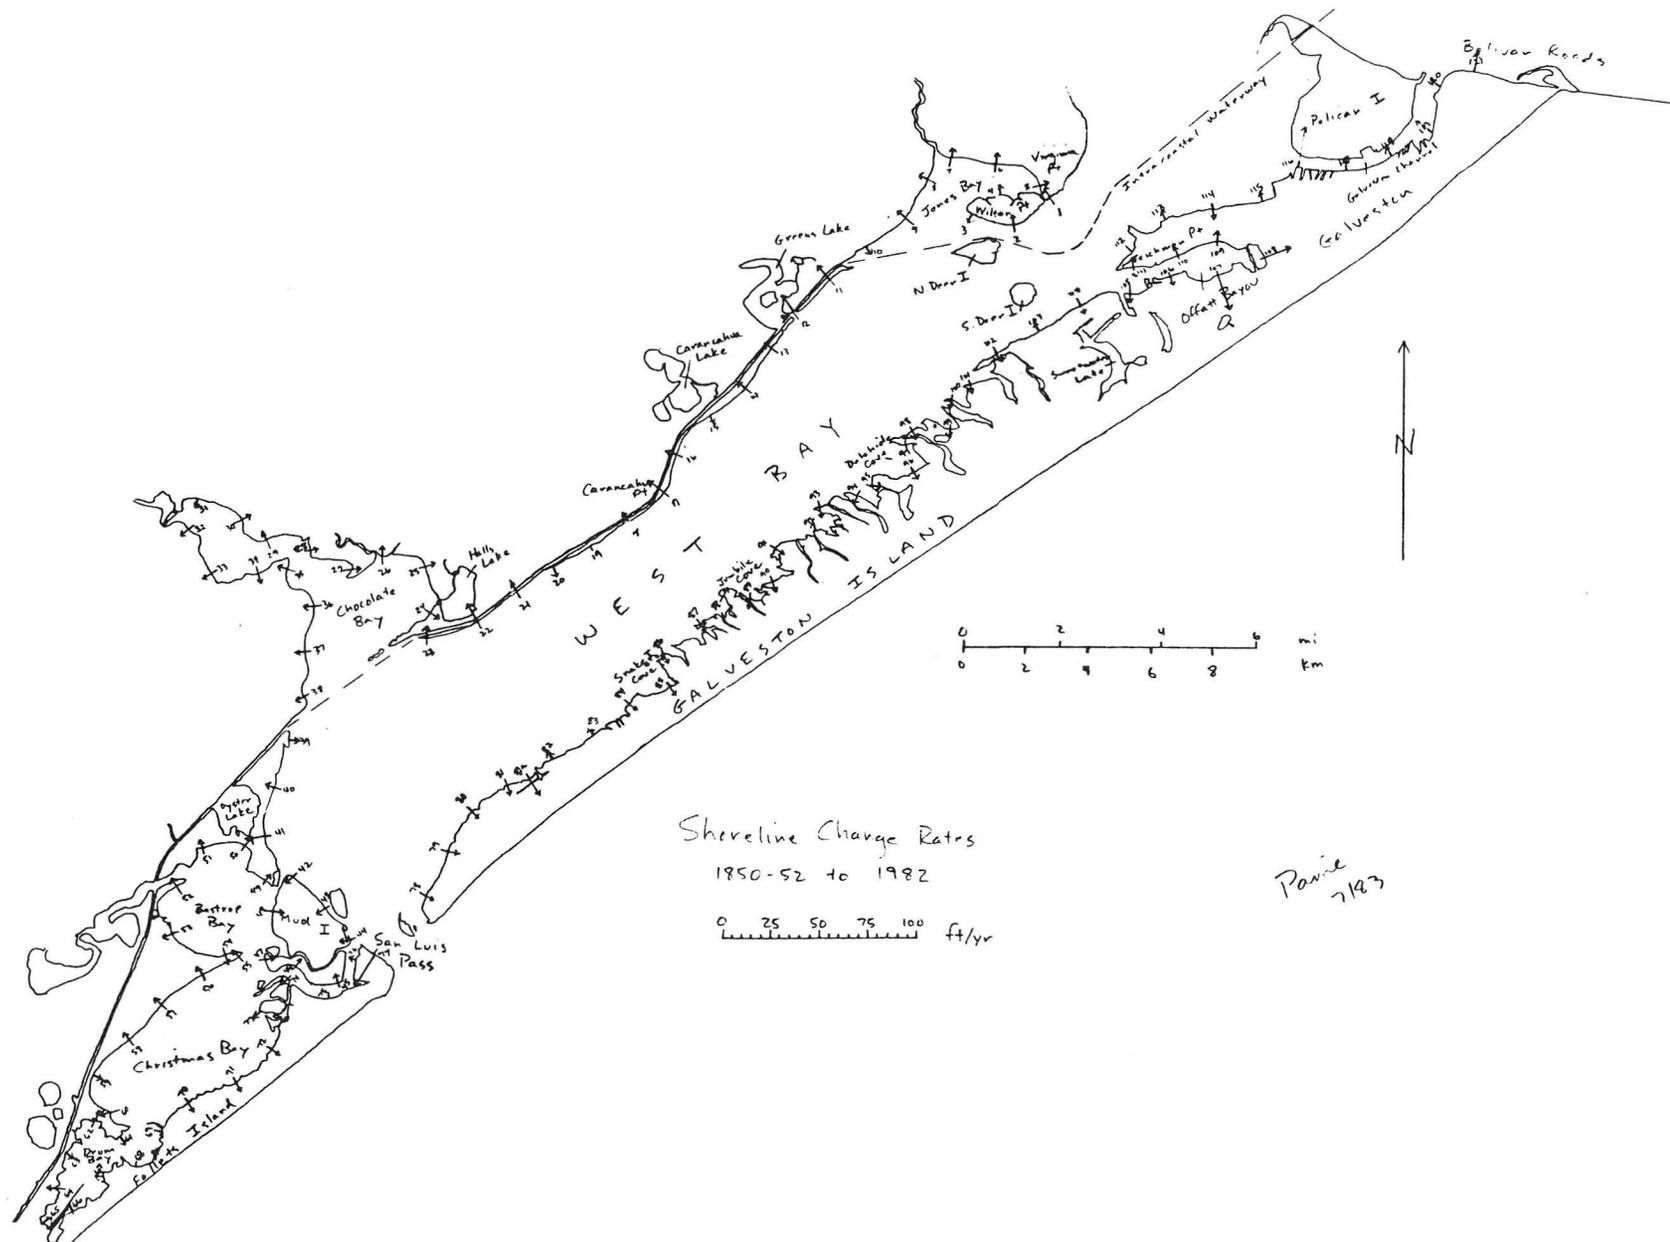
Figure 4-19. Cumulative rates of shoreline change for West Bay, 1850-52 to 1982.

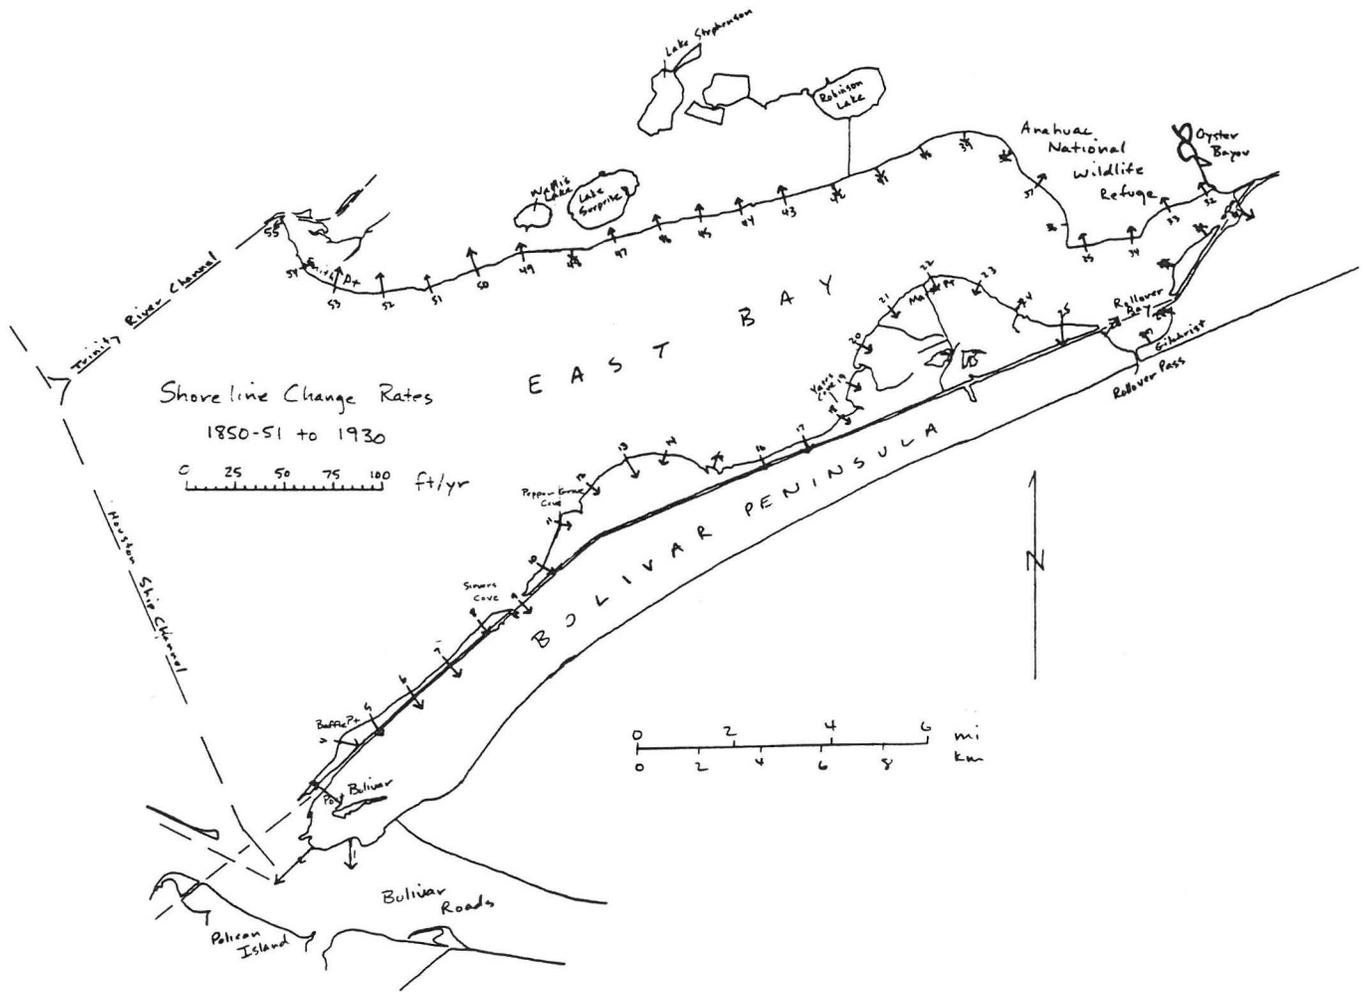
Figure 4-20. East Bay locations, measuring stations, and rates of shoreline change, 1850-51 to 1930.

The most striking shoreline changes for the period in East Bay were at the southwestern tip of Bolivar Peninsula (stations 1 and 2, fig. 4-20), where accretion rates of 11 to 25 ft/yr were recorded. This accretion presumably slowed after the construction of the northern jetty at Bolivar Roads, indicating that accretion rates in this area may have been higher before jetty construction. Widespread erosion during this period occurred along the East Bay shore of Bolivar Peninsula at comparatively lower rates. Erosion between Port Bolivar and Pepper Grove Cove was highest at stations 3 to 5 near Bolivar Roads (8.5 to 10 ft/yr); reduced erosion rates of 0.5 to 7 ft/yr were observed in the slight embayment between Port Bolivar and Pepper Grove Cove (stations 6 to 11). Although this area was somewhat protected, a long northerly fetch across East Bay for these stations produced generally higher erosion rates than for equivalent areas in West Bay.

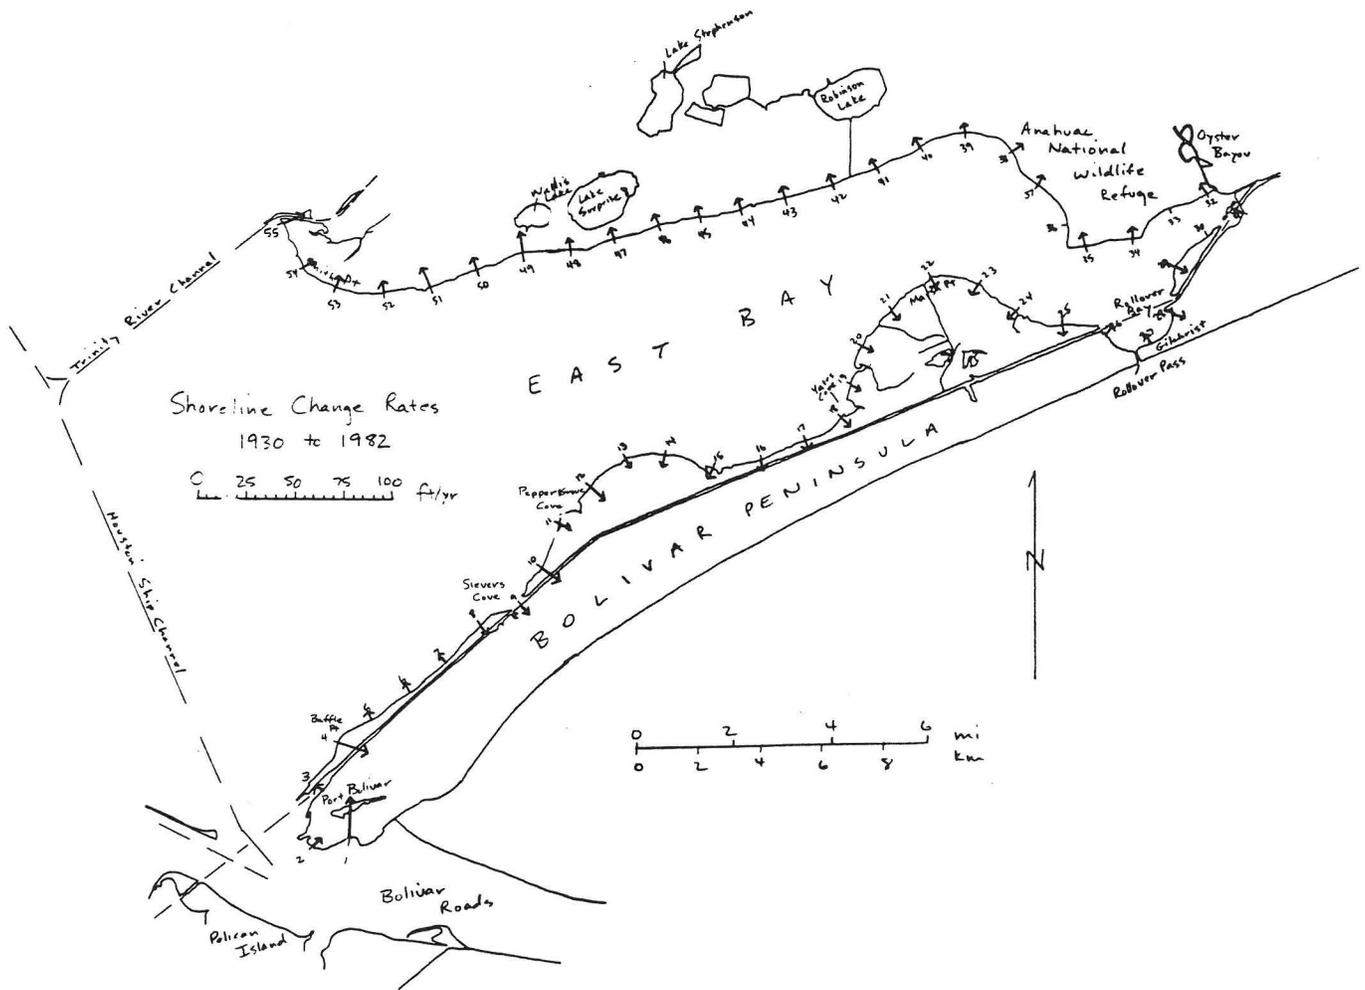
Figure 4-21. Rates of shoreline change for East Bay, 1930 to 1982.

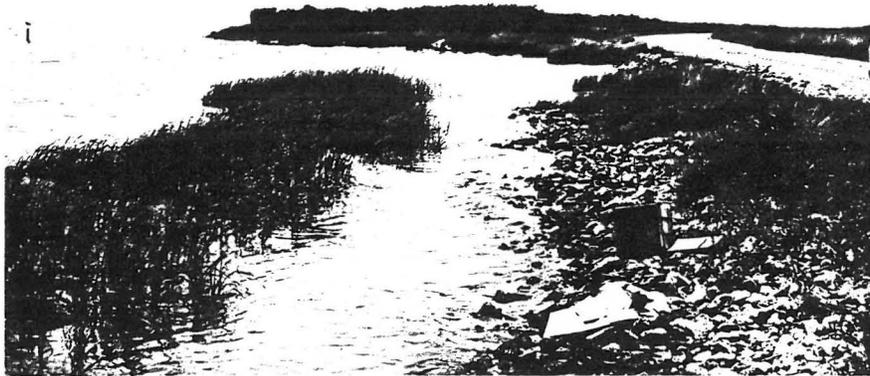
Figure 4-24. Riprap and Spartina alterniflora protecting Anahuac National Wildlife Refuge shoreline, East Bay.

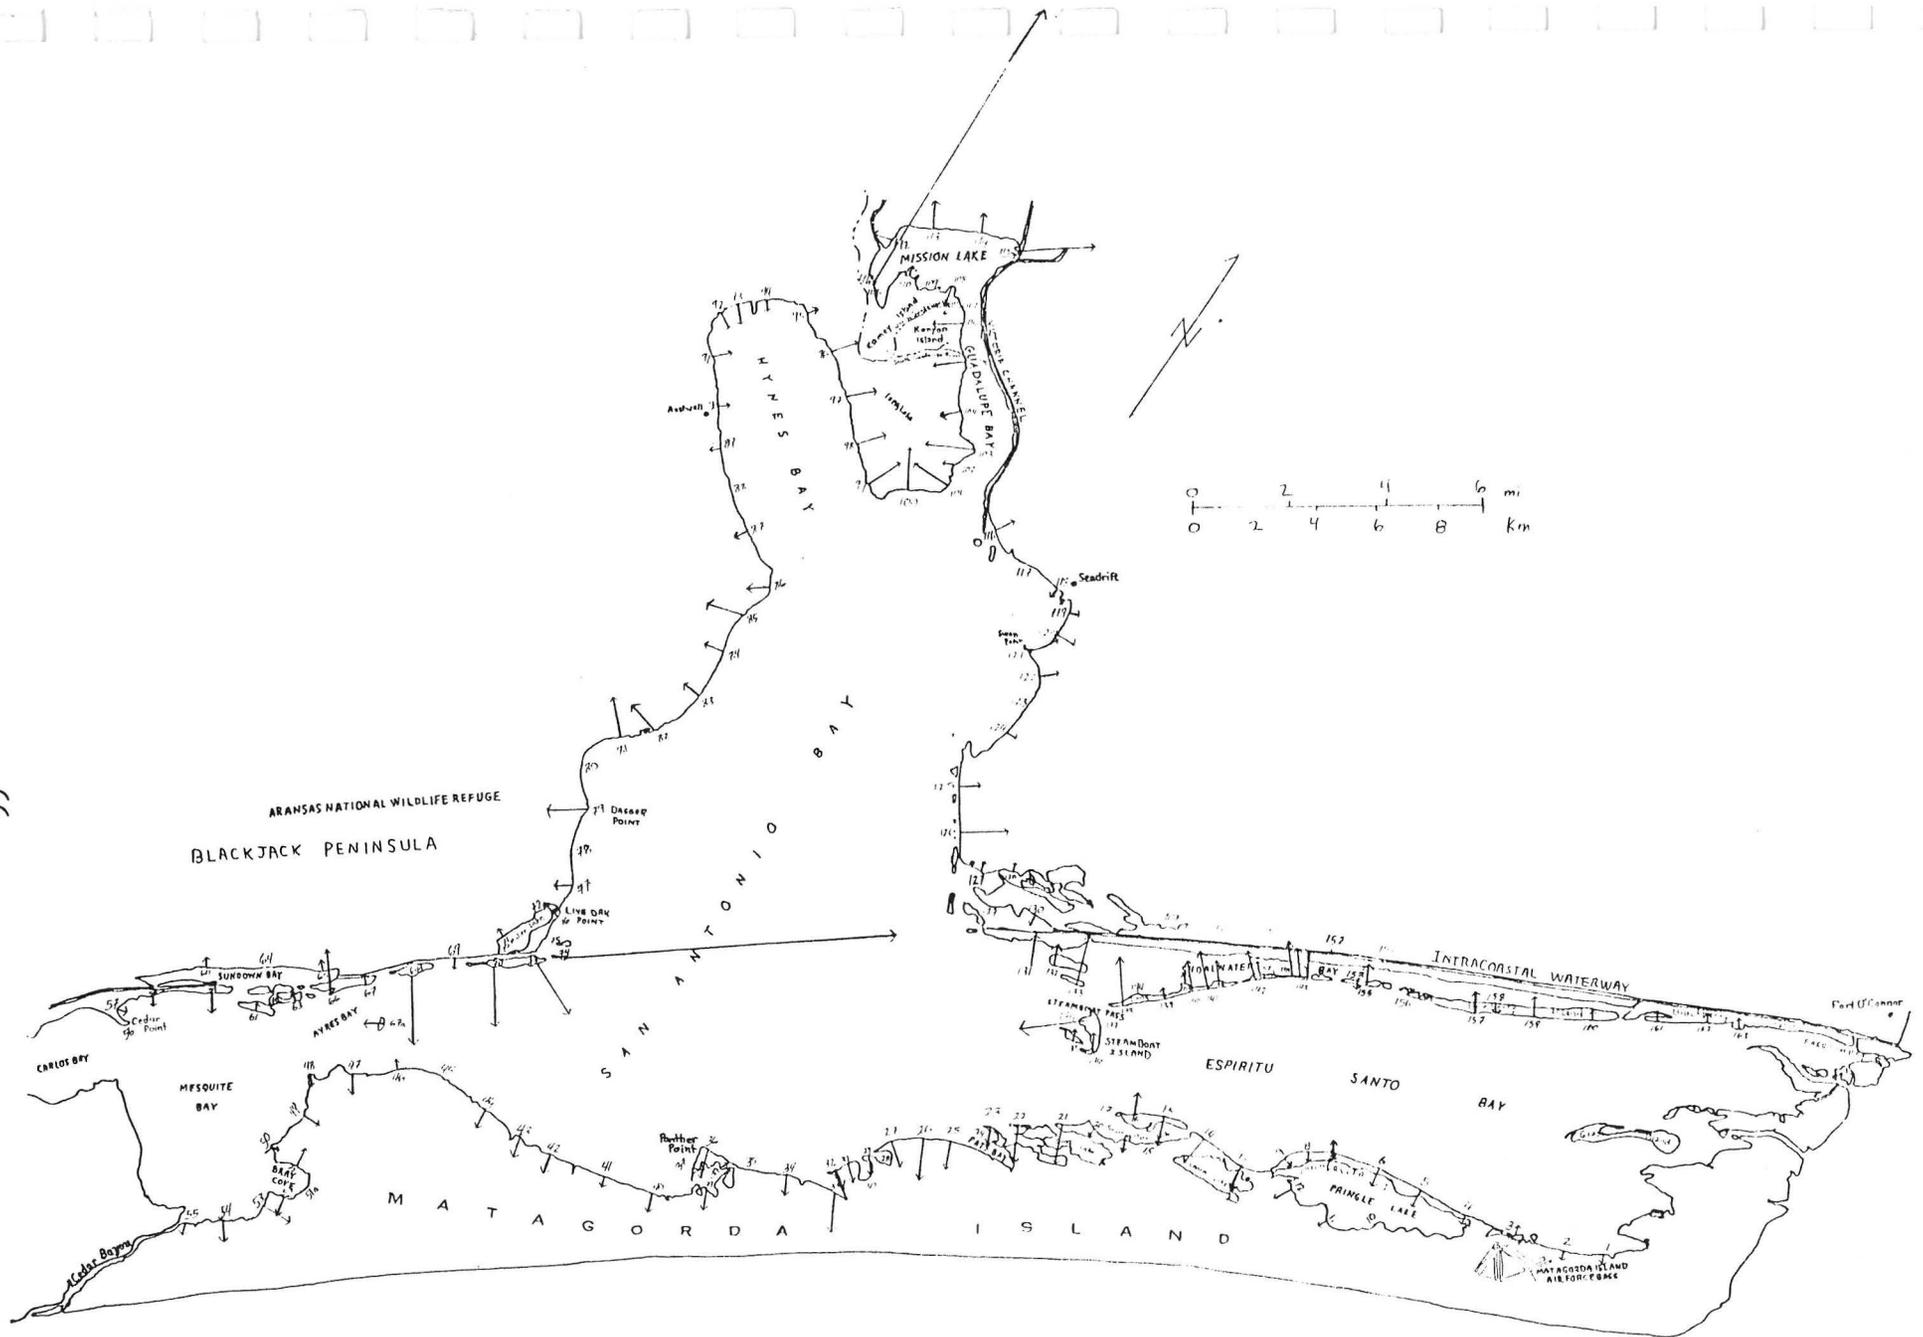
Figure 5-1. Station-location and vector-diagram map of the San Antonio Bay System for the period 1930-37 to 1974-82. Vectors at stations (numbered) indicate the relative rates and directions of movement (whether eroding or accreting) of the shoreline. Vectors are based on data presented in Appendix B.

For discussion purposes, the San Antonio Bay System has been subdivided into six major segments. With reference to figure 5-1, the subdivisions are (1) the bay shoreline of Matagorda Island from near the air force base at the eastern end of the island to Cedar Bayou at the western end (stations 1 to 55, fig. 5-1); (2) the inland shorelines of Mesquite and Ayres Bays, including a portion of San Antonio Bay (stations 56 to 76); (3) the western shoreline of

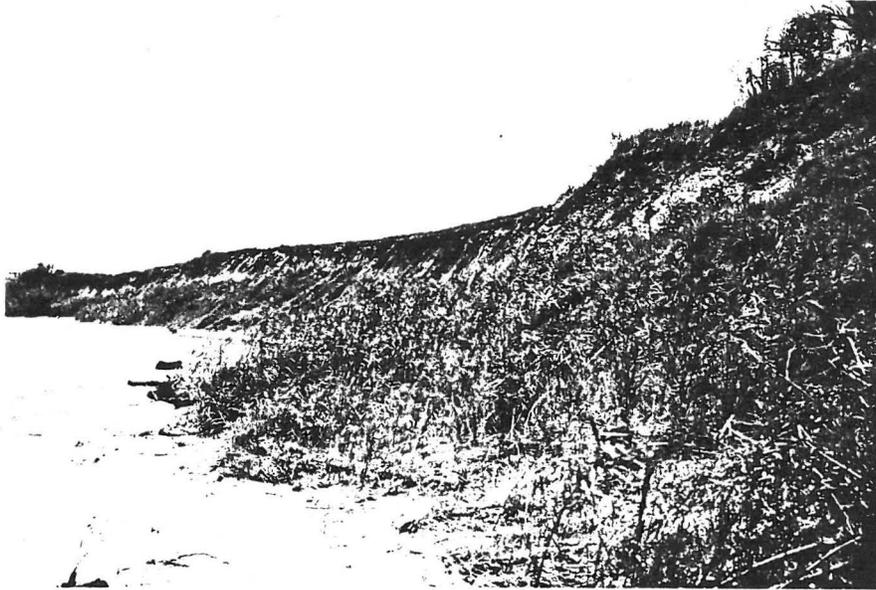
Figure 5-2. Clay bluffs on the western shore of San Antonio Bay near Austwell.

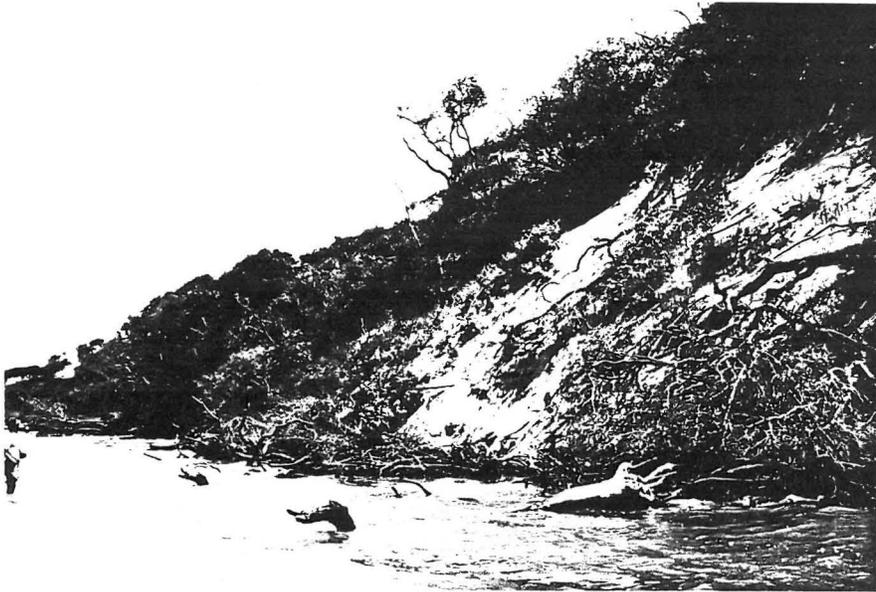
Figure 5-3. Sandy slope on the western shore of San Antonio Bay at Dagger Point, Aransas National Wildlife Refuge.

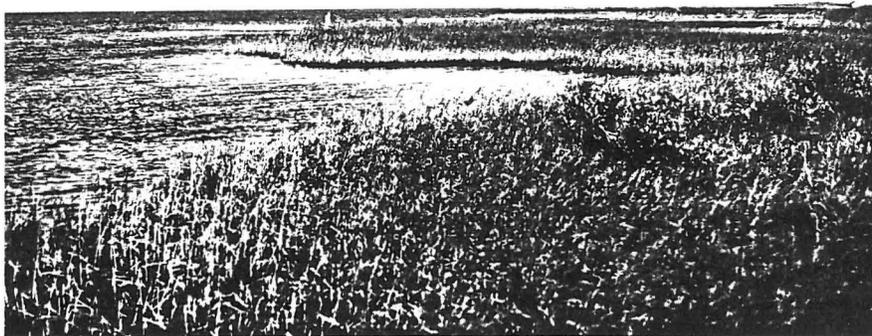
Figure 5-4. Spartina alterniflora marsh along the shoreline of Matagorda Island Air Force Base.

Most of the bay shoreline along Matagorda Island is composed of either shell berms and ridges (fig. 5-6) or marshes (fig. 5-4). Common in the marsh areas are numerous circular to elliptical-shaped bodies of water and tidal flats in a wide range of sizes. Not much of the shoreline has been modified through human activity except for a few minor segments near Matagorda Island Air Force Base and an area near the west end of the island where a dike/road complex parallels the shoreline. Also a few channels have been dredged into some of the small embayments and lakes that occur along shore.

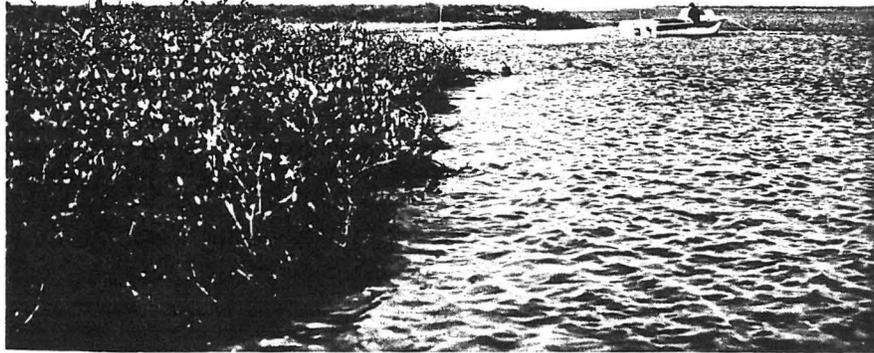
Figure 5-5. Mangrove marsh along an island shoreline in Espiritu Santo Bay near Pass Cavallo.

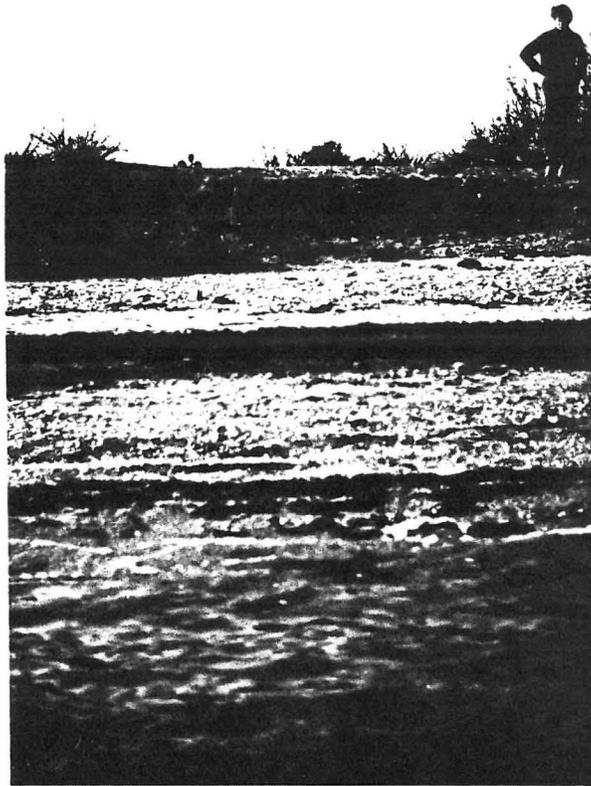
Figure 5-6. Storm berm composed predominantly of shell material along the Matagorda Island - Espiritu Santo Bay shoreline.

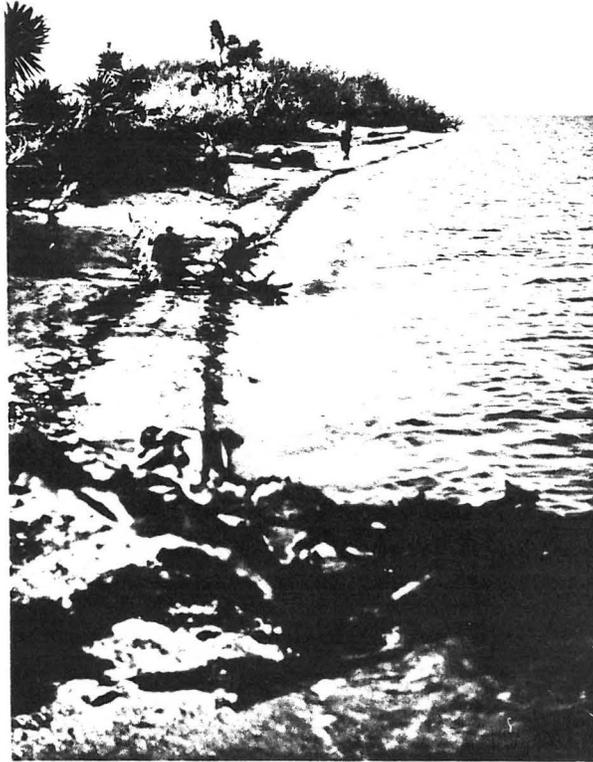
Figure 5-7. Shell beach and berm on Vanderveer Island (a spit along the bay shoreline of Matagorda Island). Uprooted Yucca and other shrubs are evidence of erosion.

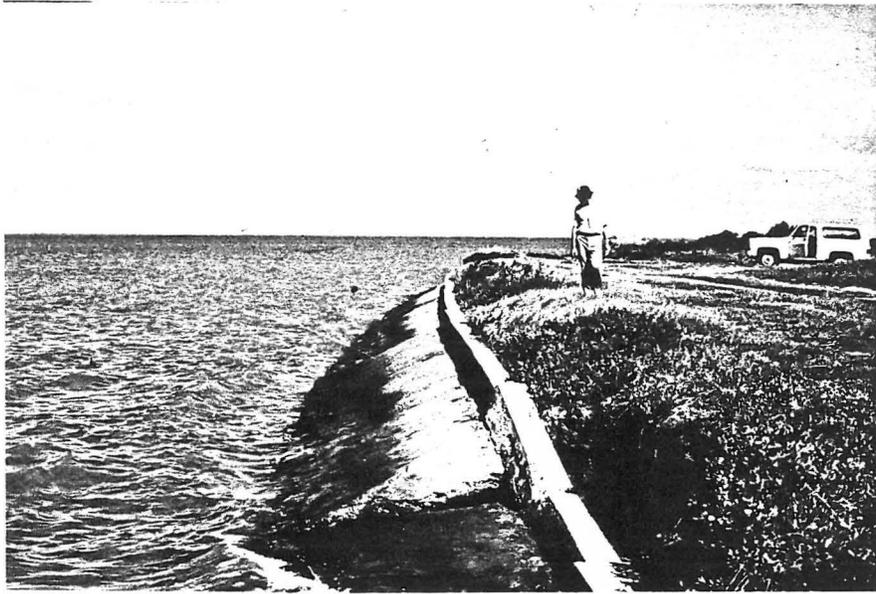
Figure 5-8. Cement bulkhead along the eastern shore of San Antonio Bay south of Seadrift.

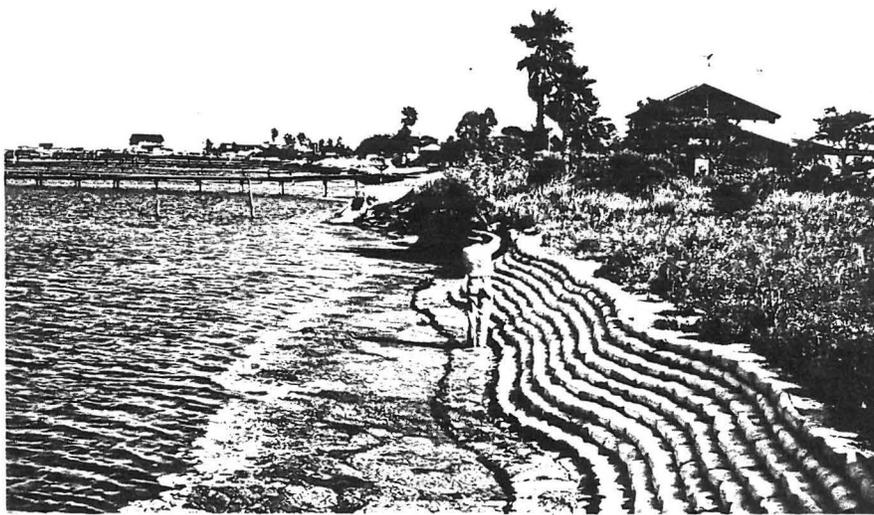
Figure 5-9. Shoreline terraced with Portland Cement bags along the eastern shore of San Antonio Bay south of Seadrift.

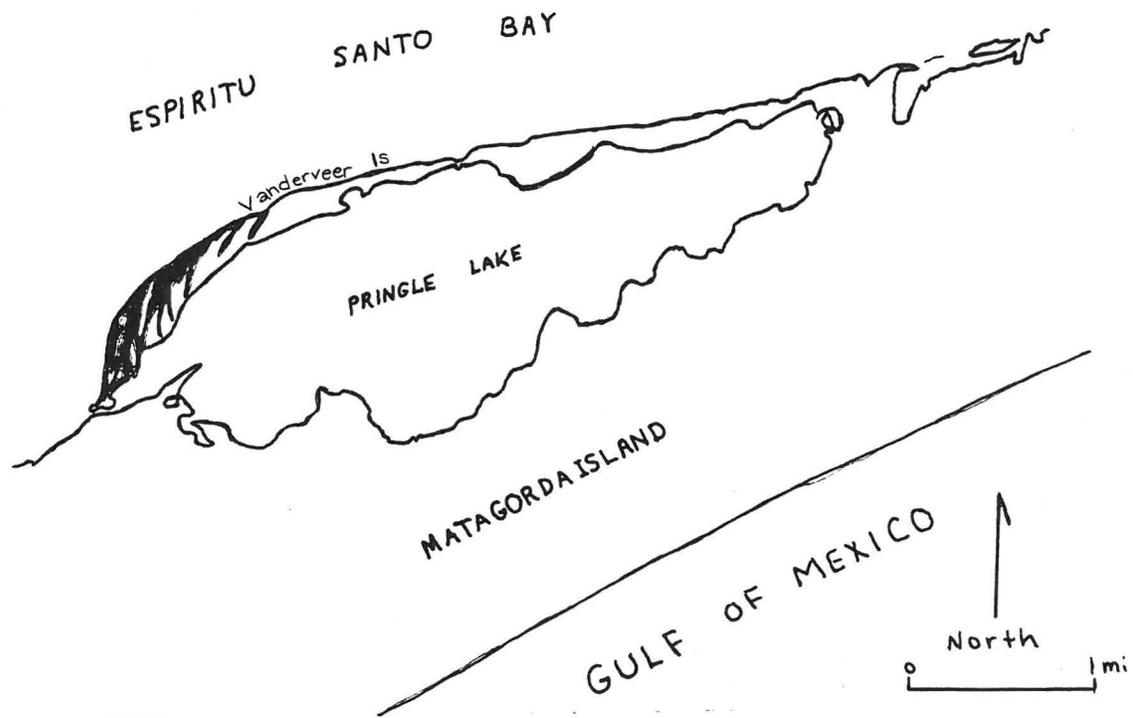
Figure 5-10. Accretionary ridges, shown in black, along the compound spit--Vanderveer Island.

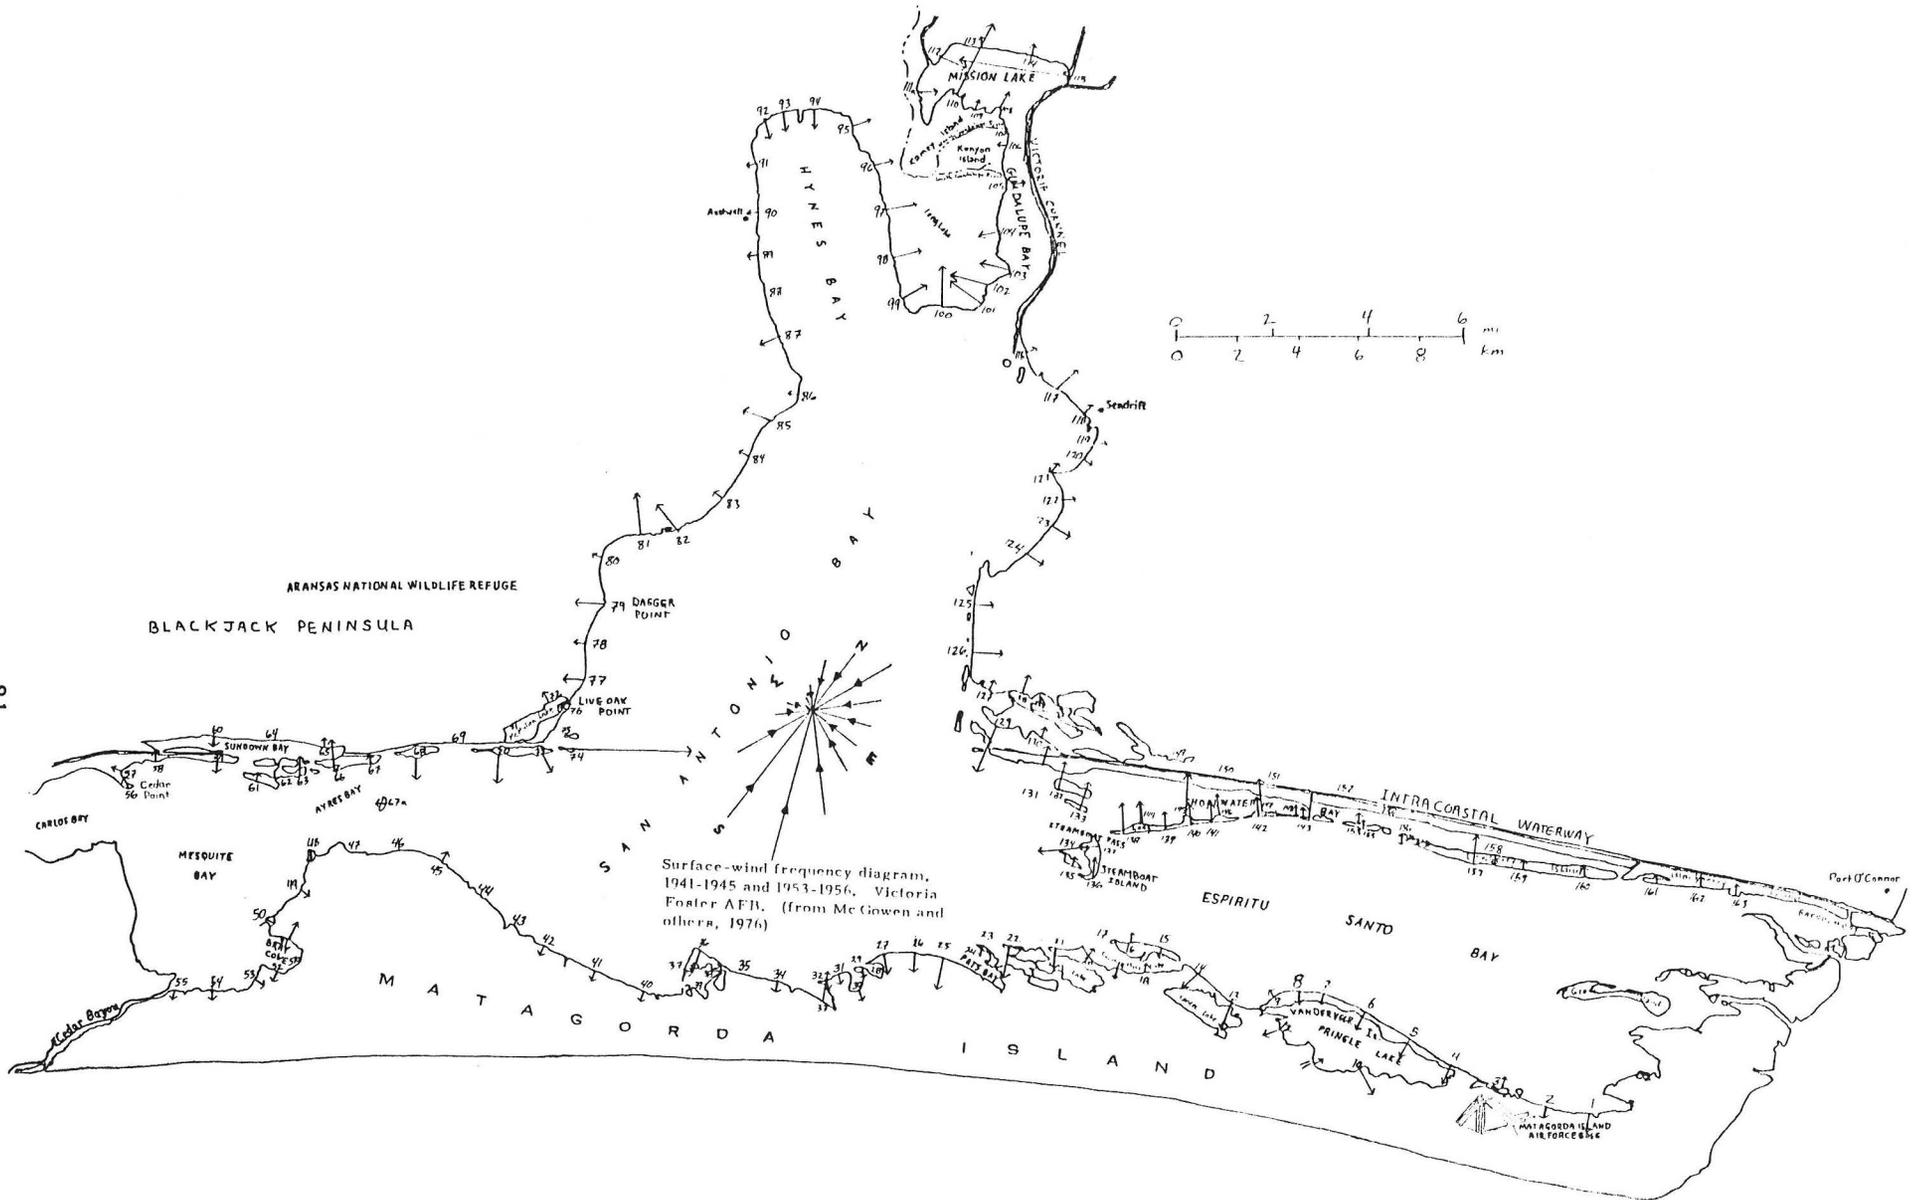
Figure 5-11. Station-location and vector-diagram map of the San Antonio Bay System for the period 1859-60 to 1974-82. Vectors indicate relative rates and directions of movement (whether eroding or accreting) of the shoreline at the numbered stations. Vectors are based on data presented in Appendix B.

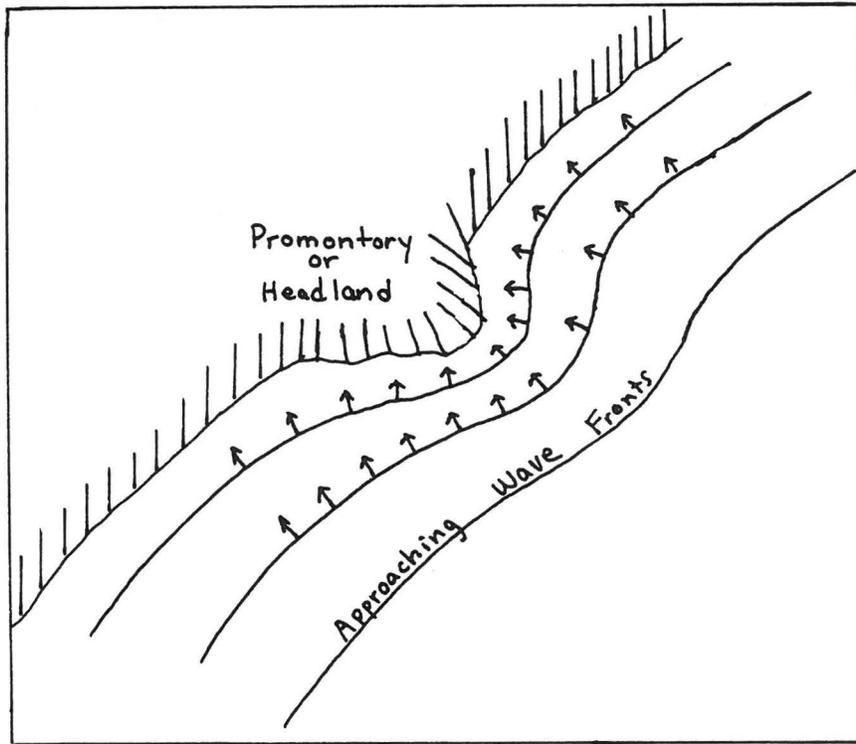
Figure 5-12. Wave refraction along a promontory. Waves approaching a promontory or headland are slowed by shallower water and refracted, thereby focusing more energy on the headland and accelerating erosion. This phenomenon was noted by D. W. Johnson in 1919.

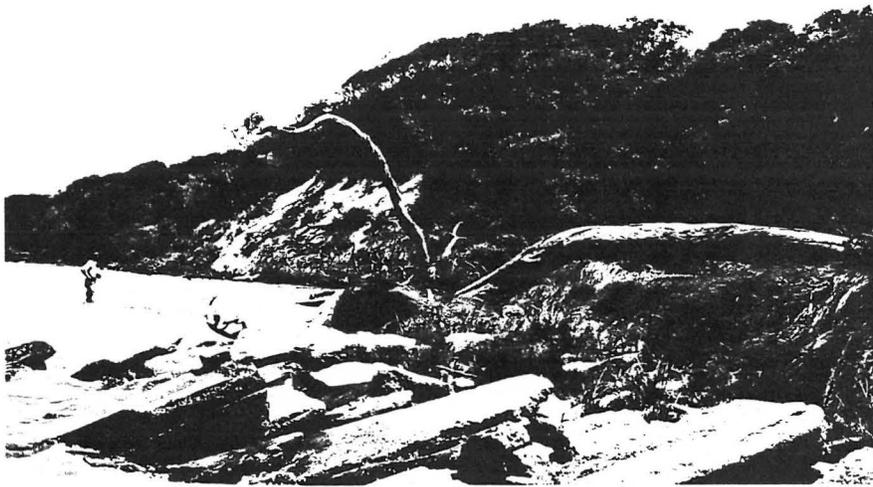
Figure 5-13. Wrack from house near Dagger Point destroyed by Hurricane Carla. (Photograph from Aransas National Wildlife Refuge interpretive station.)

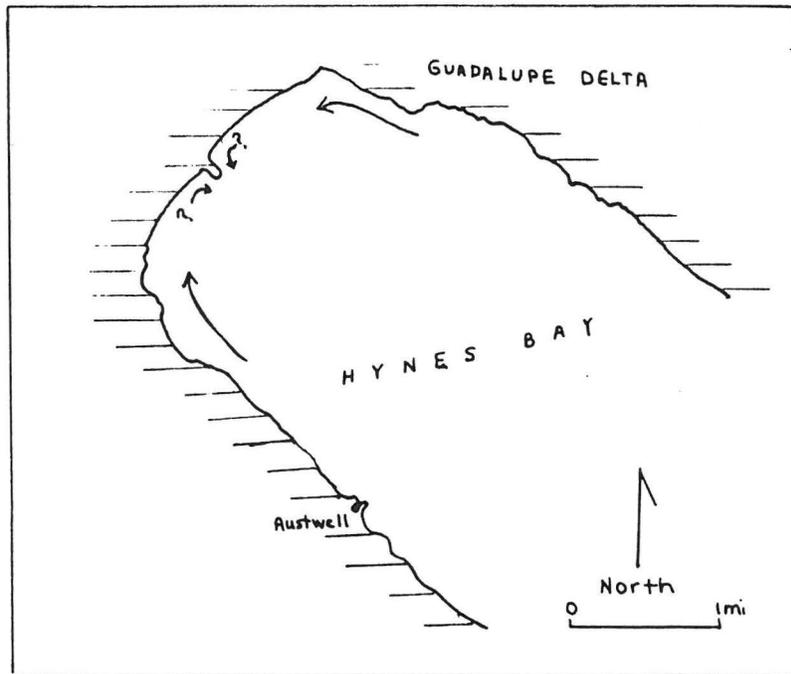
Figure 5-14. Converging currents, depicted by arrows, in Hynes Bay. Wave trains generated by prevailing southeasterly winds may produce littoral currents (by wave refraction along the opposite shorelines) that converge at the head of the bay.

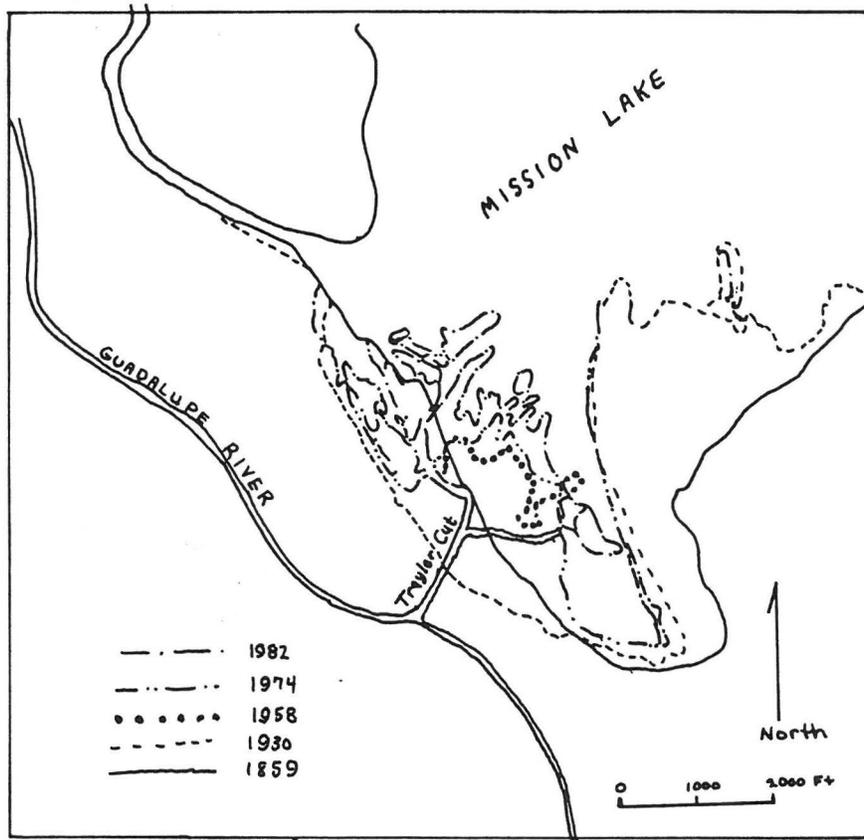
Figure 5-15. Historical shoreline changes of the Traylor Cut lobe of the Guadalupe Delta.

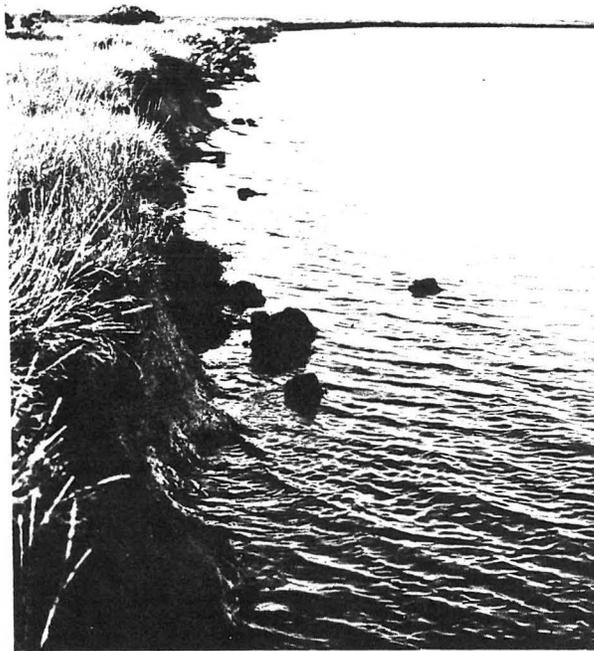
Figure 5-16. Overhanging clay bluff along the eastern shore of San Antonio Bay near station 124 (fig. 5-1).

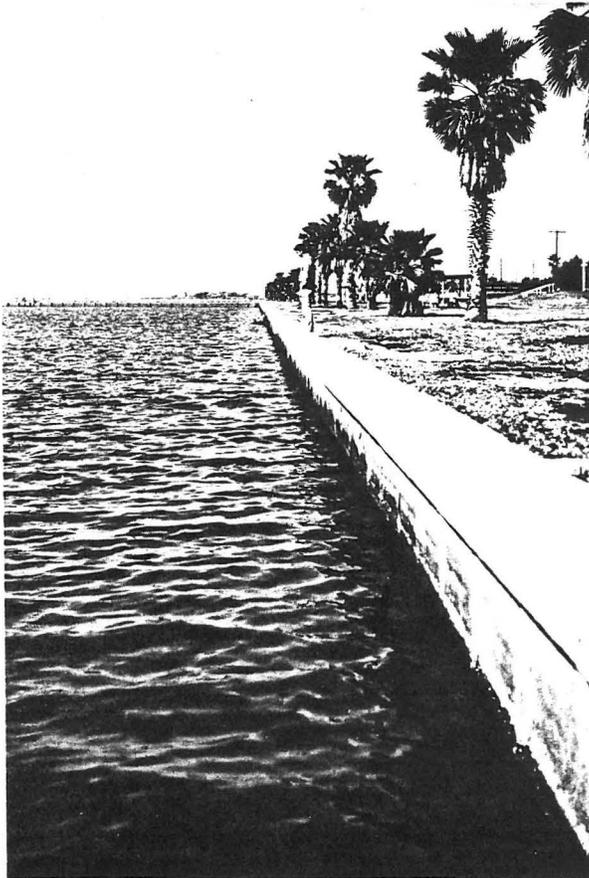
Figure 5-17. Cement bulkhead constructed in 1961 along the shoreline of San Antonio Bay at Seadrift.

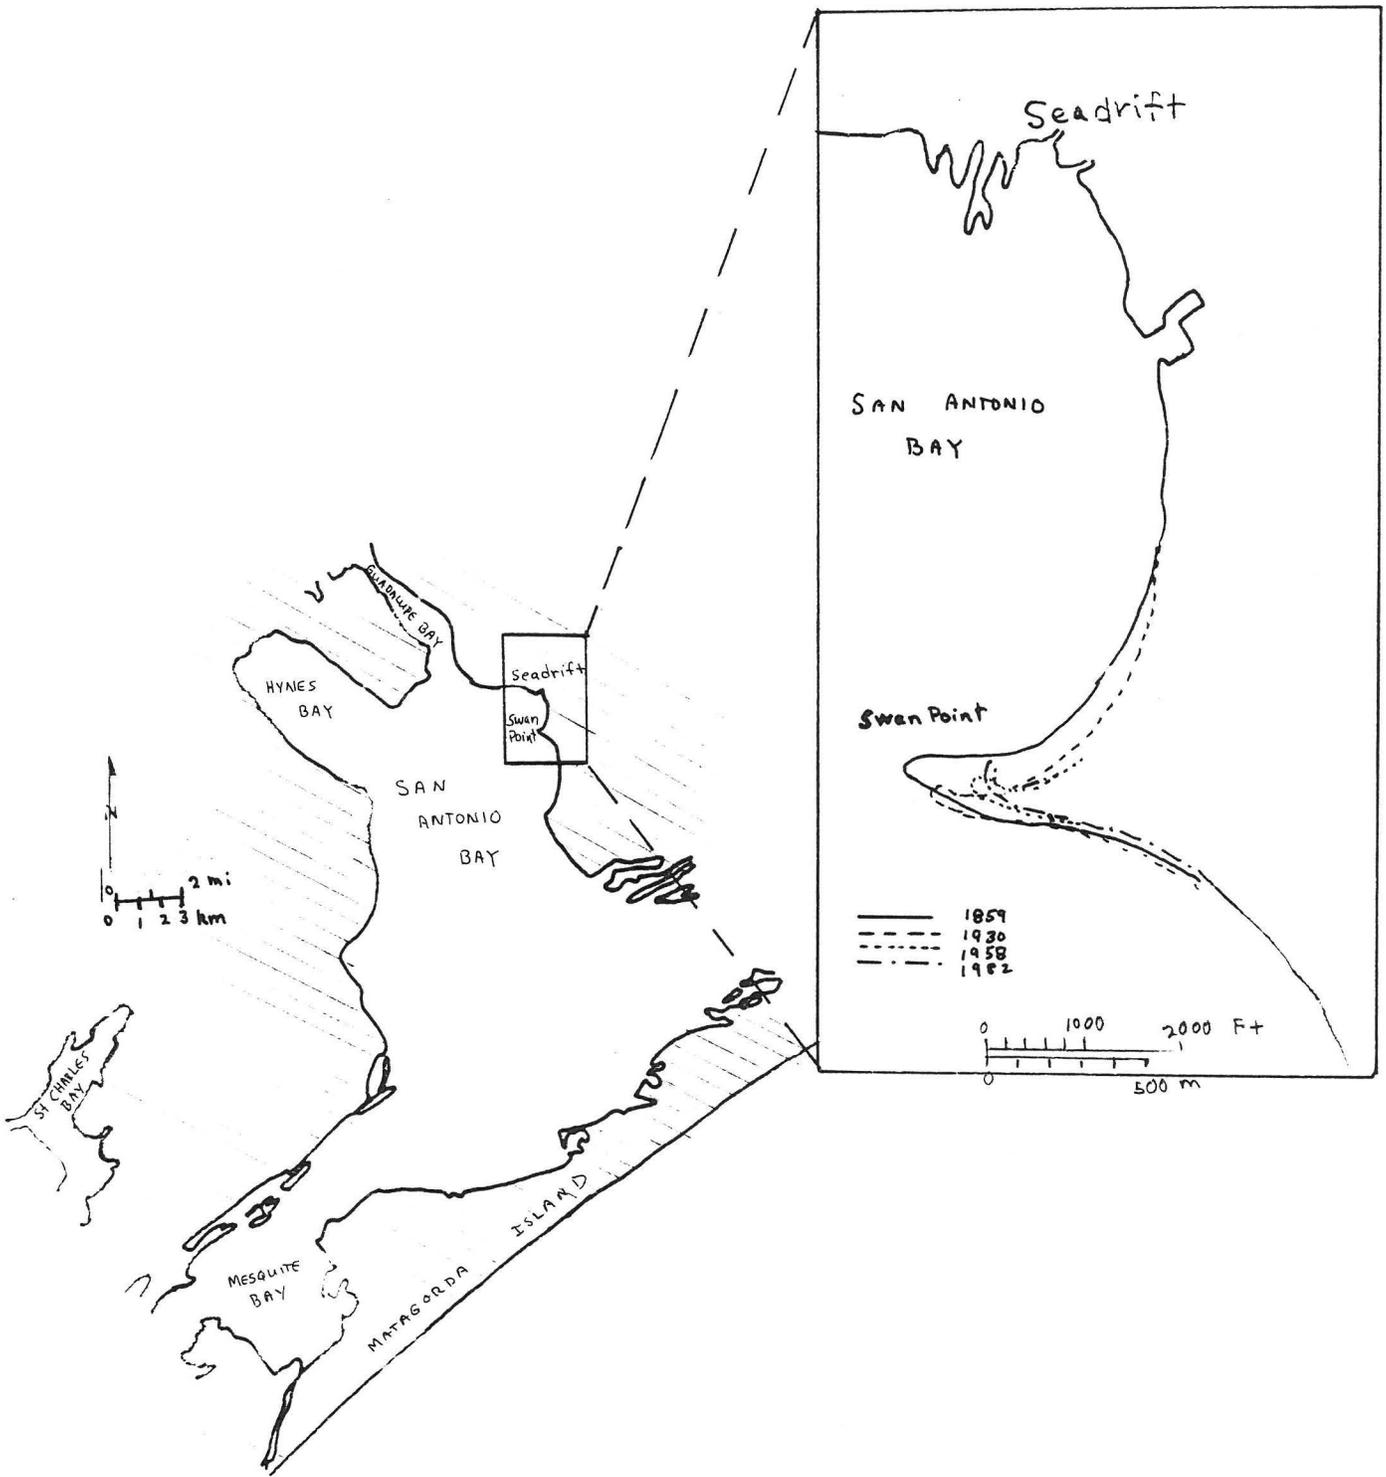
Figure 5-18. Historical changes of Swan Point, 1859 to 1982. Note the clockwise rotation of the spit from 1930 to 1982.

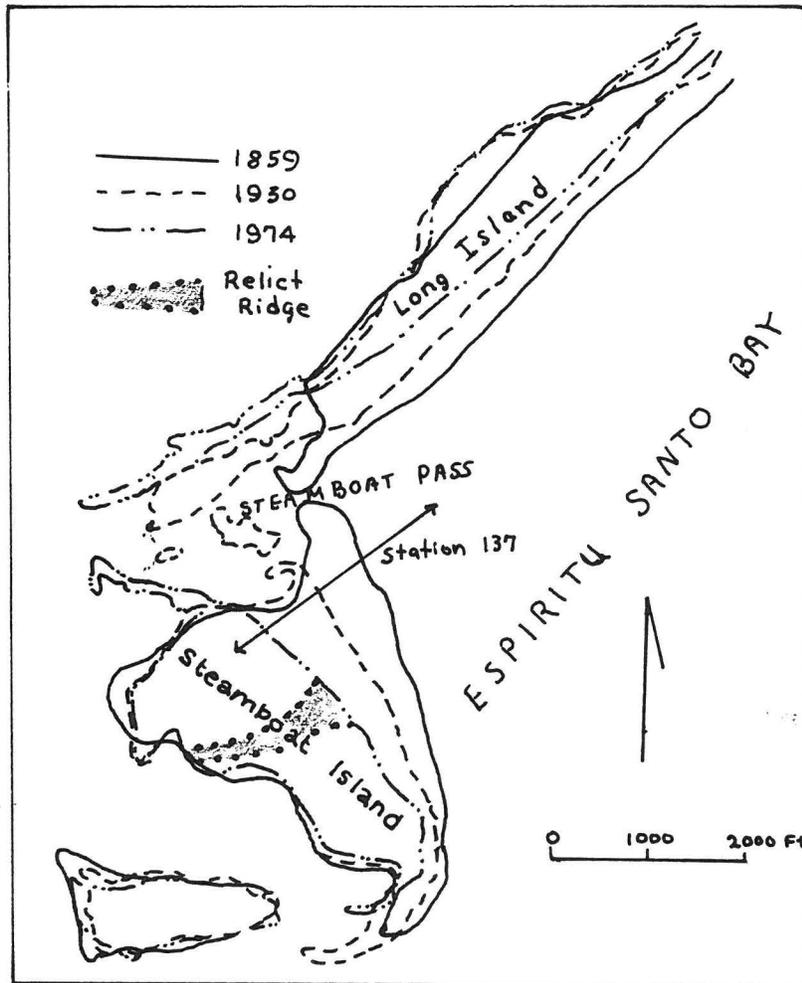
Fig. 19. Historical changes of Steamboat Island and Steamboat Pass near the eastern end of Espiritu Santo Bay.
