**DECLINE OF SUBMERGED VEGETATION IN THE GALVESTON BAY SYSTEM:  
CHRONOLOGY AND RELATIONSHIPS TO PHYSICAL PROCESSES**

**Warren M. Pulich and William A. White**

Prepared as part of a Cooperative Agreement  
between the  
**Texas Parks and Wildlife Department**  
and  
**Bureau of Economic Geology**

Bureau of Economic Geology  
W. L. Fisher, Director  
The University of Texas at Austin  
Austin, Texas 78713

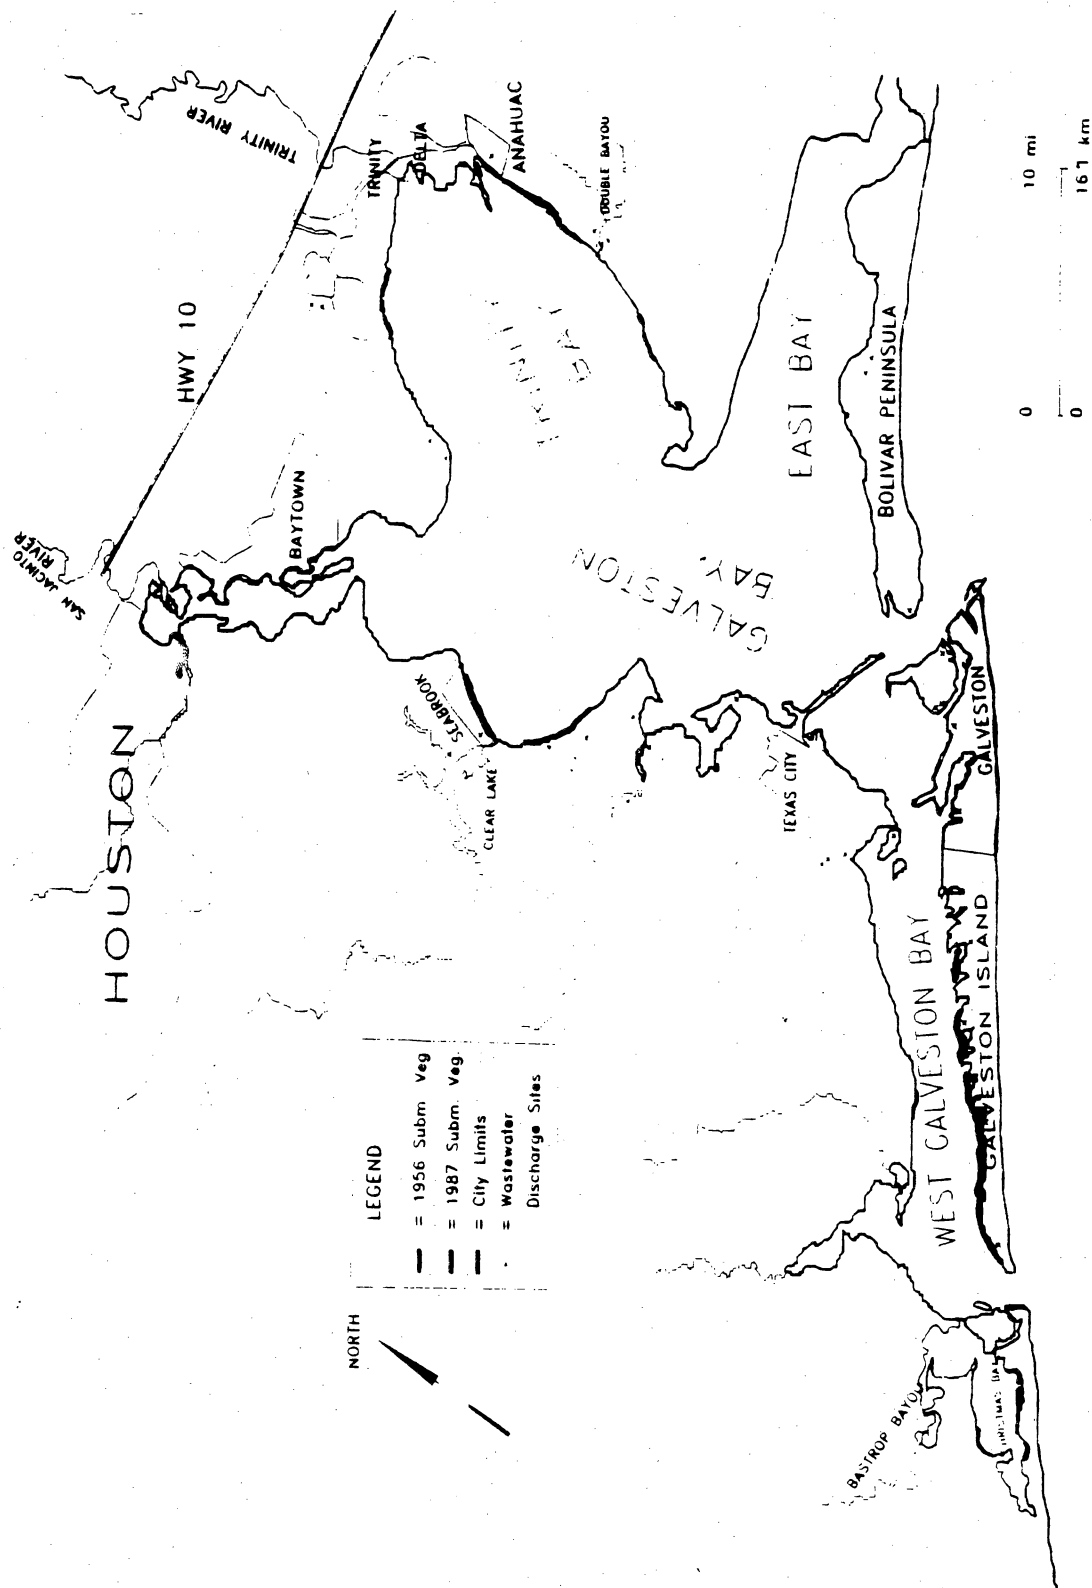
Figure 1. Map of the Galveston Bay system comparing 1956 and 1987 locations of submerged vegetation. Wastewater discharge sites compiled from 1988 records in Texas Water Commission permits section.

SV distribution along the Trinity Bay shoreline (exclusive of the Trinity River Delta proper from Anahuac to Old River Pass) is compared with that along the Seabrook shoreline on the west side of the bay in Figure 1. The Seabrook area was mapped from 1956 photographs, while the Trinity Bay

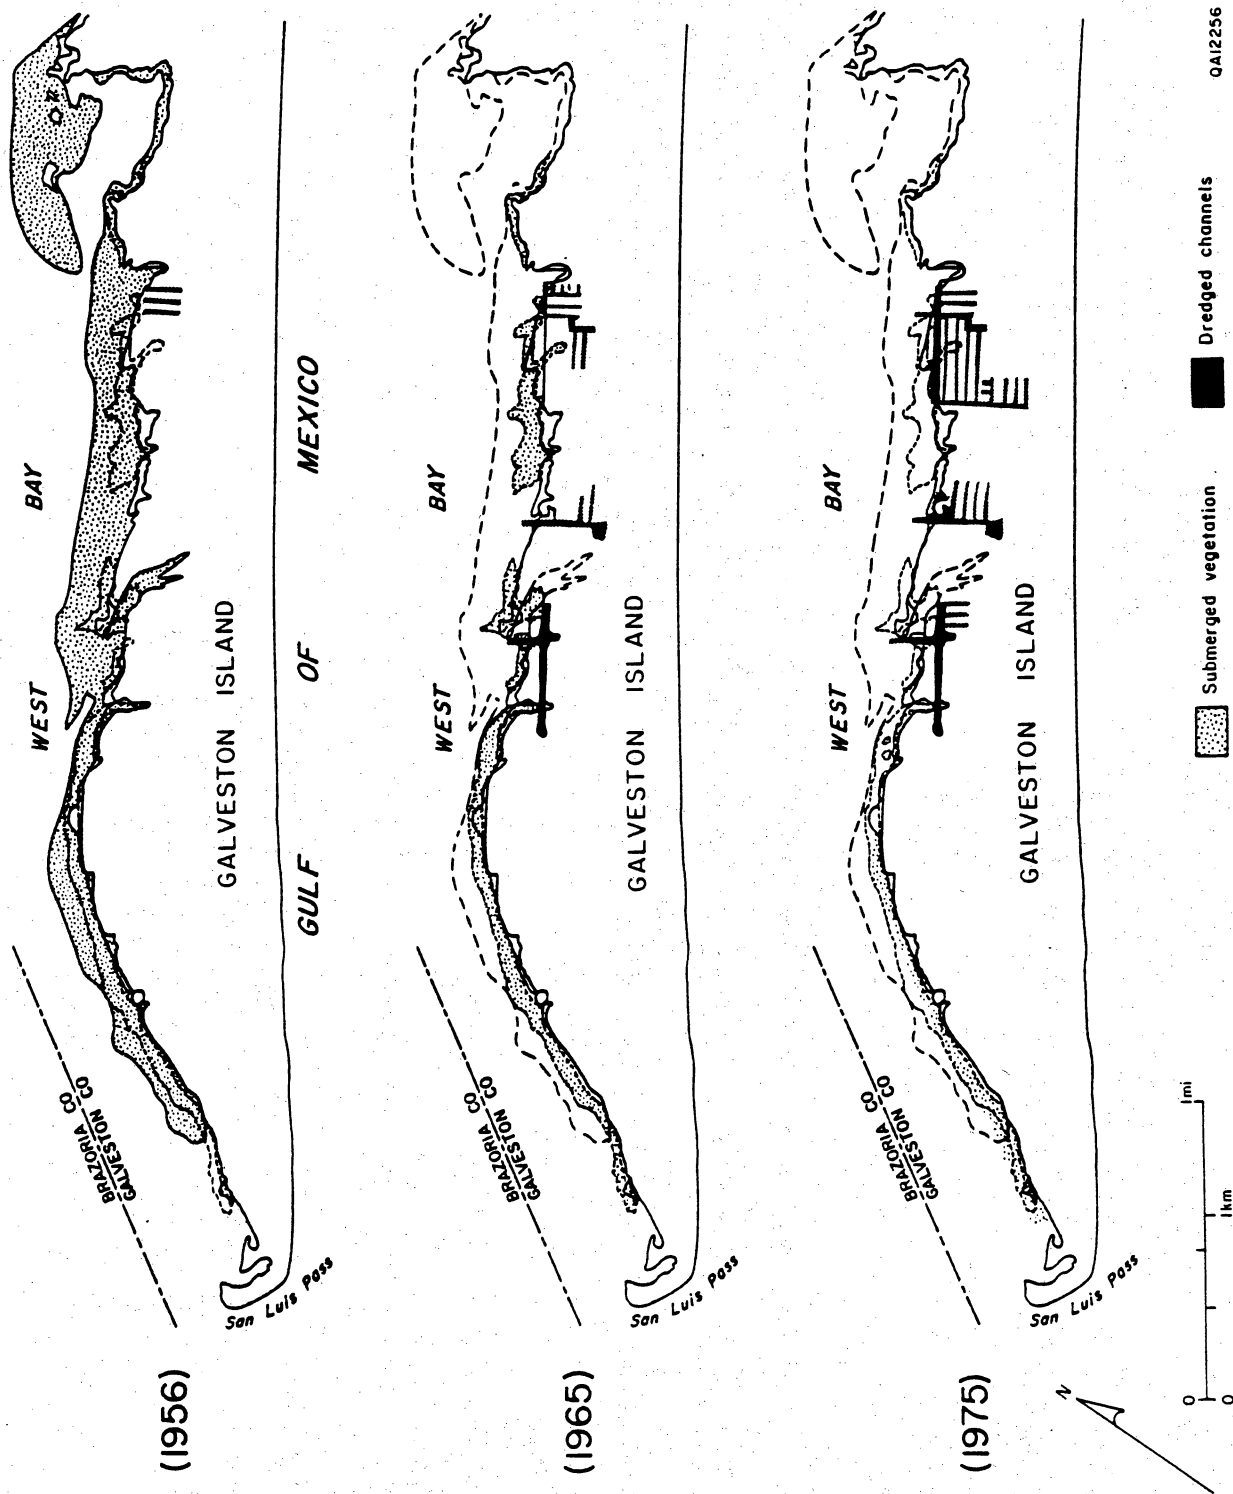
Figure 2. Historical changes in the distribution of seagrass and dredged channels along the western half of Galveston Island, West Bay.

Analysis of aerial photographs from 1956, 1965, 1975, and 1987 substantiates the progression of seagrass loss for Lower West Bay (Fig. 2). Reports by West (1973), Gilmore and Trent (1974) and area scientists (Sammy Ray, Texas A&M University at Galveston; Kirk Strawn, Texas A&M University; Roger Zimmerman, National Marine Fisheries Service, Galveston; personnel

communication) further corroborate the occurrence and decline of Halodule from the West Bay area. After a dramatic decrease in seagrasses from approximately 1,100 to 300 acres between 1956 and 1965, the remainder of the reduction appears to have occurred gradually (Fig. 2).

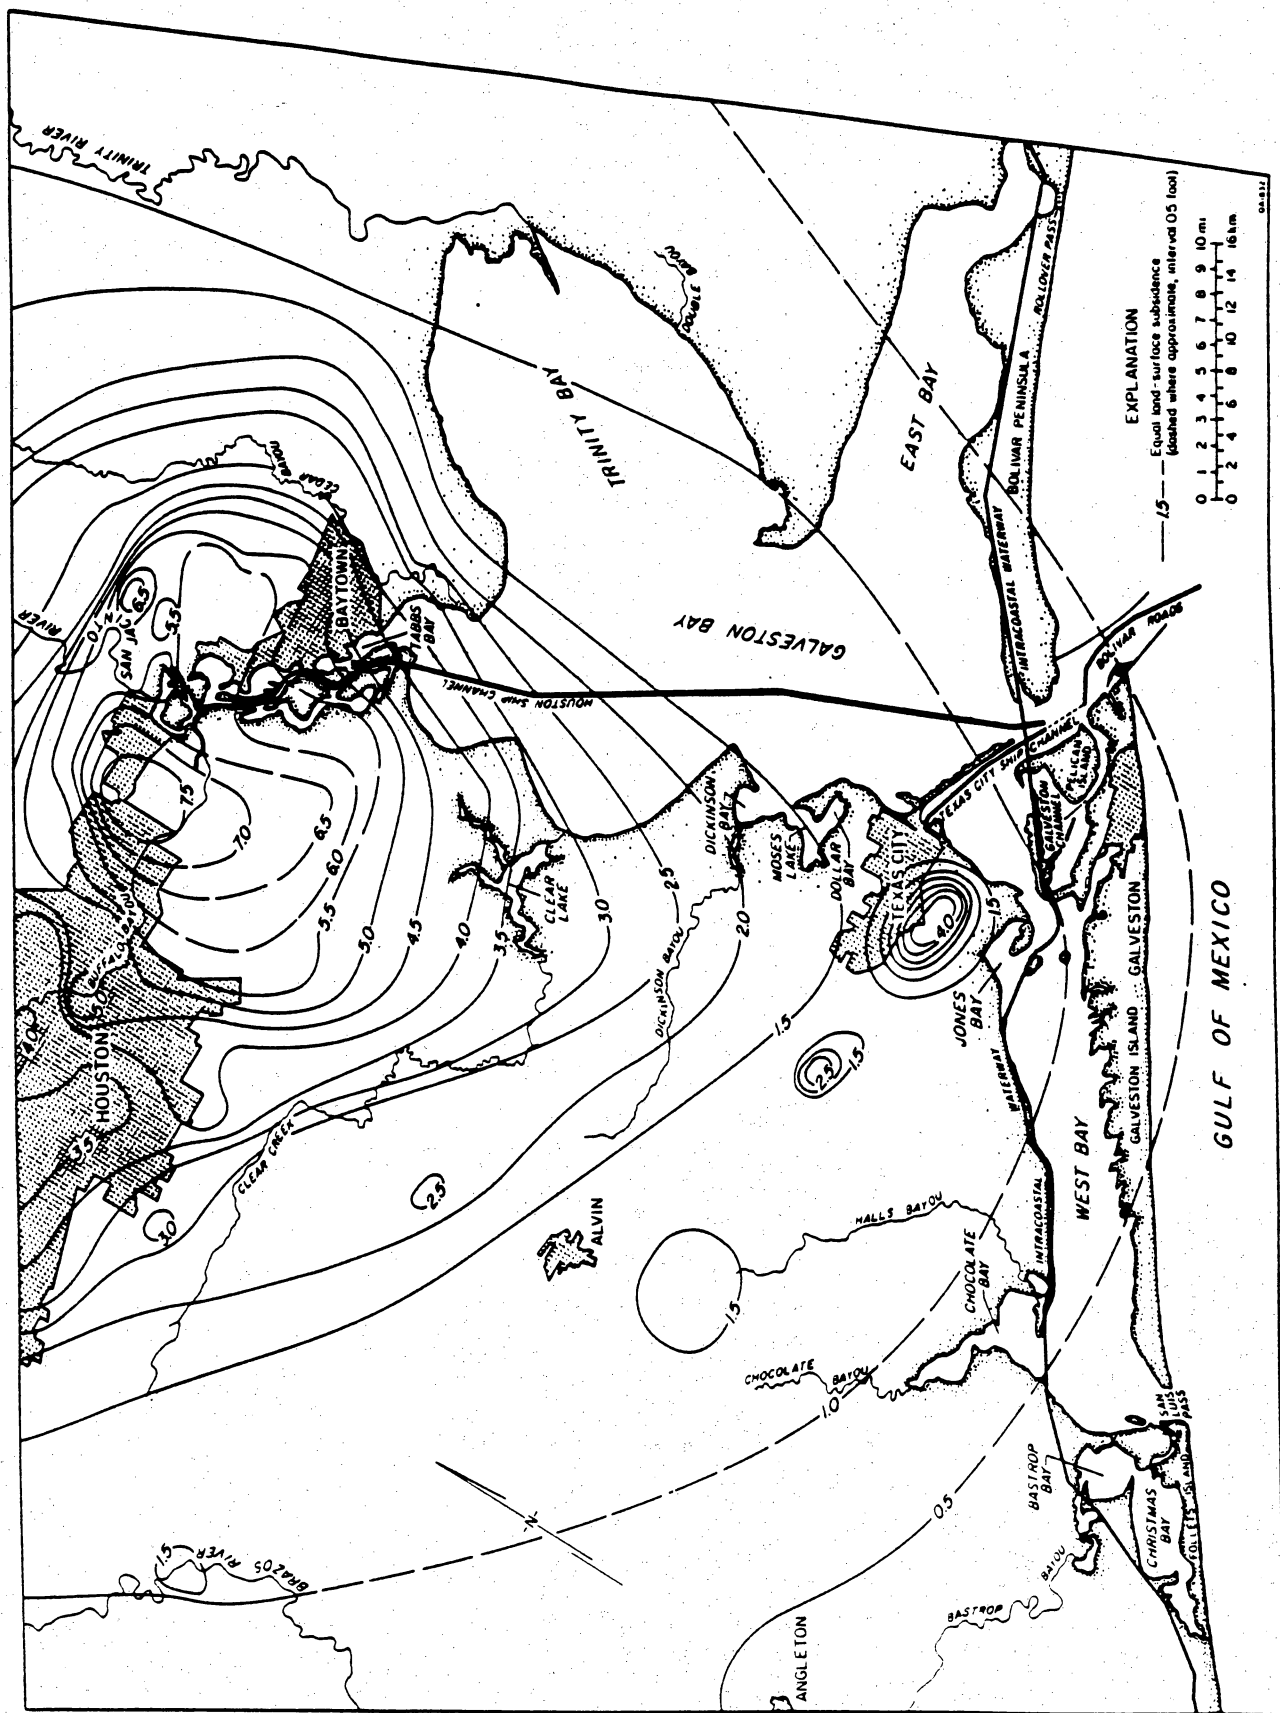
Figure 3. Land-surface subsidence in the Houston-Galveston area, 1943-1973. (From Gabrysch and Bonnel, 1975.)

The SV area affected most by subsidence is on the west side of Galveston Bay near Seabrook (Fig. 3). Historical trends in subsidence in the Seabrook area indicate that rates increased after 1943 and reached a maximum of about 6 cm/yr for the period 1964-1973 (Fig. 4). Subsidence in the Seabrook area between 1943 and 1973 was approximately 0.9 m, and from 1943 to 1978 it exceeded 1.2 m (Gabrysch, 1984). Water depths near shore possibly increased by as much as 30 to 60 cm between 1968 and 1977 (Morton and McGowen, 1980). The amount of subsidence in other SV areas is considerably lower than in the Seabrook area, ranging from less than 0.5 m in upper Trinity Bay to less than 0.4 m in West Bay and 0.2 m in Christmas Bay for the period 1943 to 1973 (Fig. 3). In the eastern part of Trinity Bay and in the southwest part of West Bay, subsidence during the period 1943 to 1978 was less than 0.3 m (Gabrysch, 1984).

The significance of sea-level rise in the 1960's and 1970's due to subsidence was examined by reviewing Figure 3. For the most part, high subsidence rates occurred only along the mainland side of Upper West Bay. However, the north end of Galveston Island showed a moderate decrease in elevation since 1943 (Fig. 3). It appears that subsidence was not a significant factor in the loss of sub-

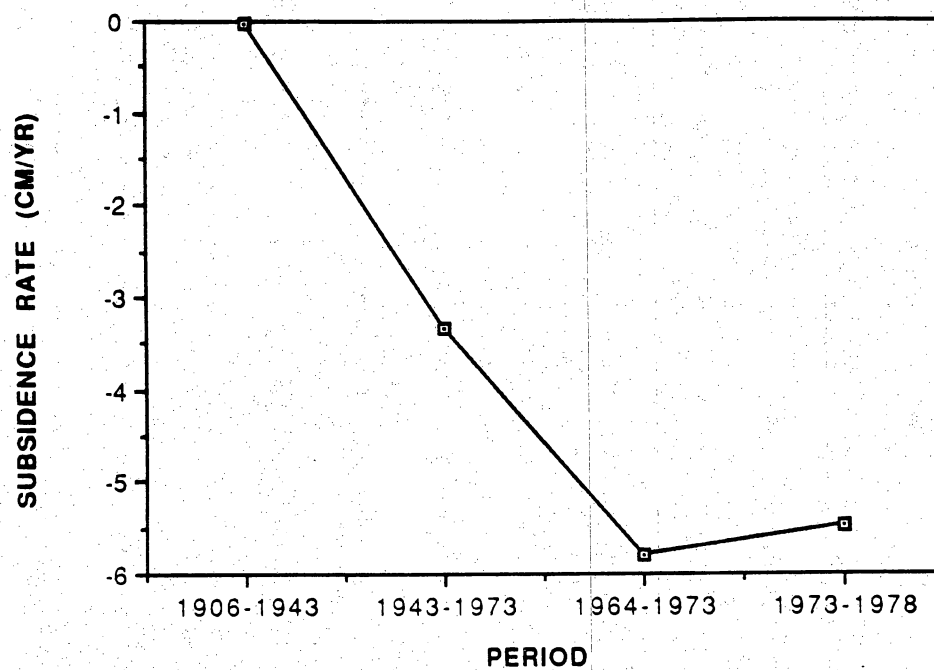
Figure 4. Subsidence rates along the Galveston Bay margin in the Seabrook area. (Based on data from Gabrysch and Bonnet, 1975, and Gabrysch 1984.)

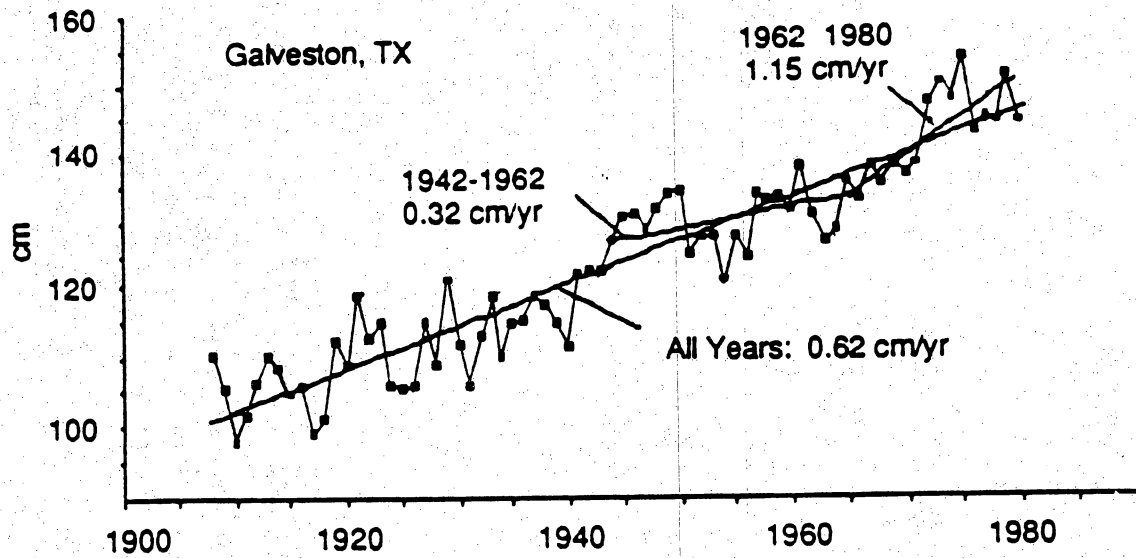
Figure 5. Annual changes in water level based on tide gauge records at Galveston (Pier 21), with variations in rates of rise indicated for different periods. (Modified from Turner, 1987.)

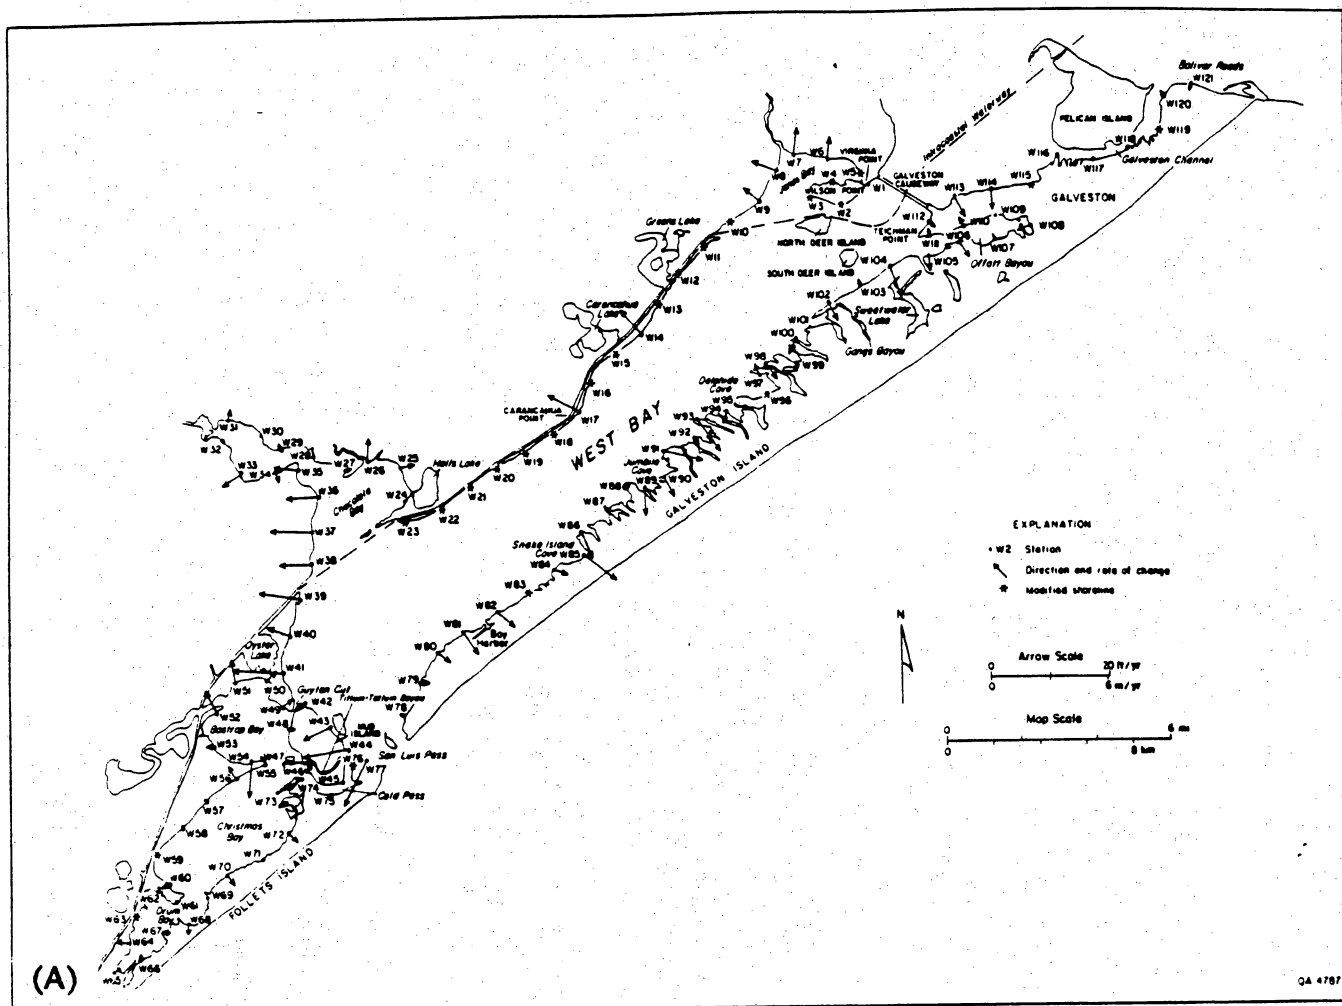
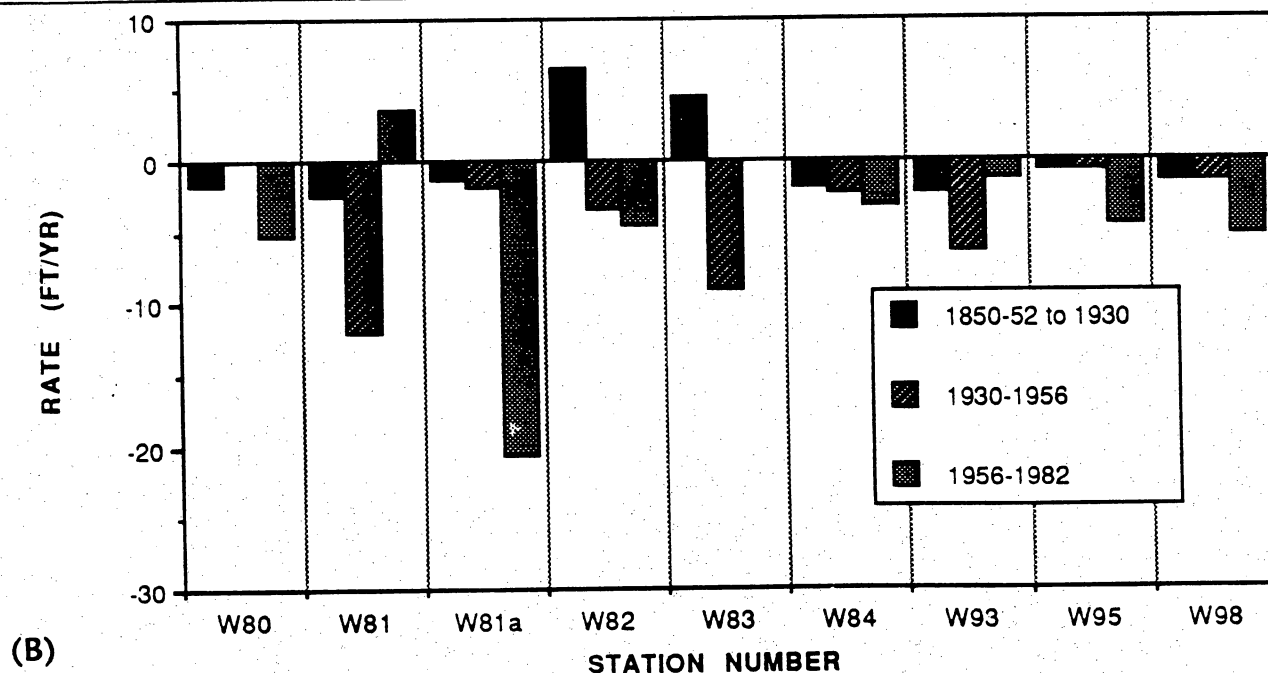
Figure 6. Bay shoreline changes along Galveston Island during specified periods. (A) Station location map and rates of shoreline change along West Bay, 1930 to 1982 (From Paine and Morton, 1986) and (B) rates of shoreline change for specified periods (From unpublished BEG data).

As mentioned previously, the Galveston Island shoreline in West Bay is one of two areas where rates of erosion have increased during more recent periods (Table 2). In fact, the average rate of erosion during the period 1930 to 1982 is about 2.5 times the average rate during 1850-52 to 1930. More specific analysis of shoreline changes over three time periods along Galveston Island indicates that rates of erosion in general were higher during the period from 1956 to 1982 than during earlier periods (Fig. 6). This latter period coincides with the time during which submerged vegetation declined and disappeared. Although loss of grasses may contribute to higher rates of erosion (Orth and Moore 1983), rates can also be accelerated as a result of human activities (Paine and Morton, 1986). Dredging of channels in nearshore areas can increase erosion by producing deeper water in which larger more destructive waves can reach shore. The larger waves may also contribute to increased turbidity through erosion, and through resuspension of silt and clay that has settled in channels.

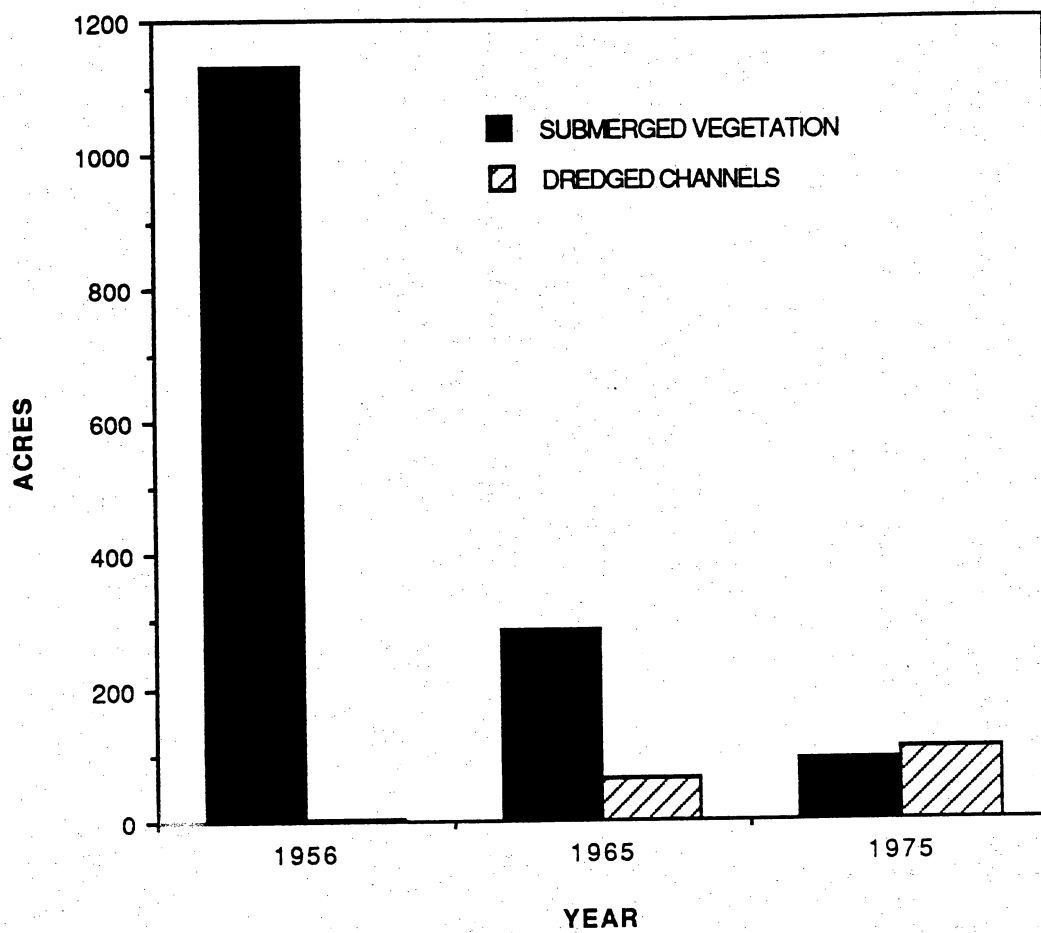
Figure 7. Changes in areas of submerged vegetation and dredged channels along the western half of Galveston Island, West Bay, 1956-1975.

The increase in Galveston Island residential and commercial waterfront developments follows closely the chronological decline of seagrasses in West Bay. Many of these construction projects represent classical examples of "dredging and filling" of wetlands. When the progression of dredged channels, bulkheaded marinas and resort housing is charted from aerial photographs, such areas show substantial increases between 1956-1965 and 1965-1975, as demonstrated by dredged channels in Figure 7. Dredged channels in the Lower West Bay physically displaced many acres of seagrasses over the 20 year period. In addition, spoil material from dredging was often disposed of in open water areas, burying adjacent seagrass beds and producing high levels of turbidity.

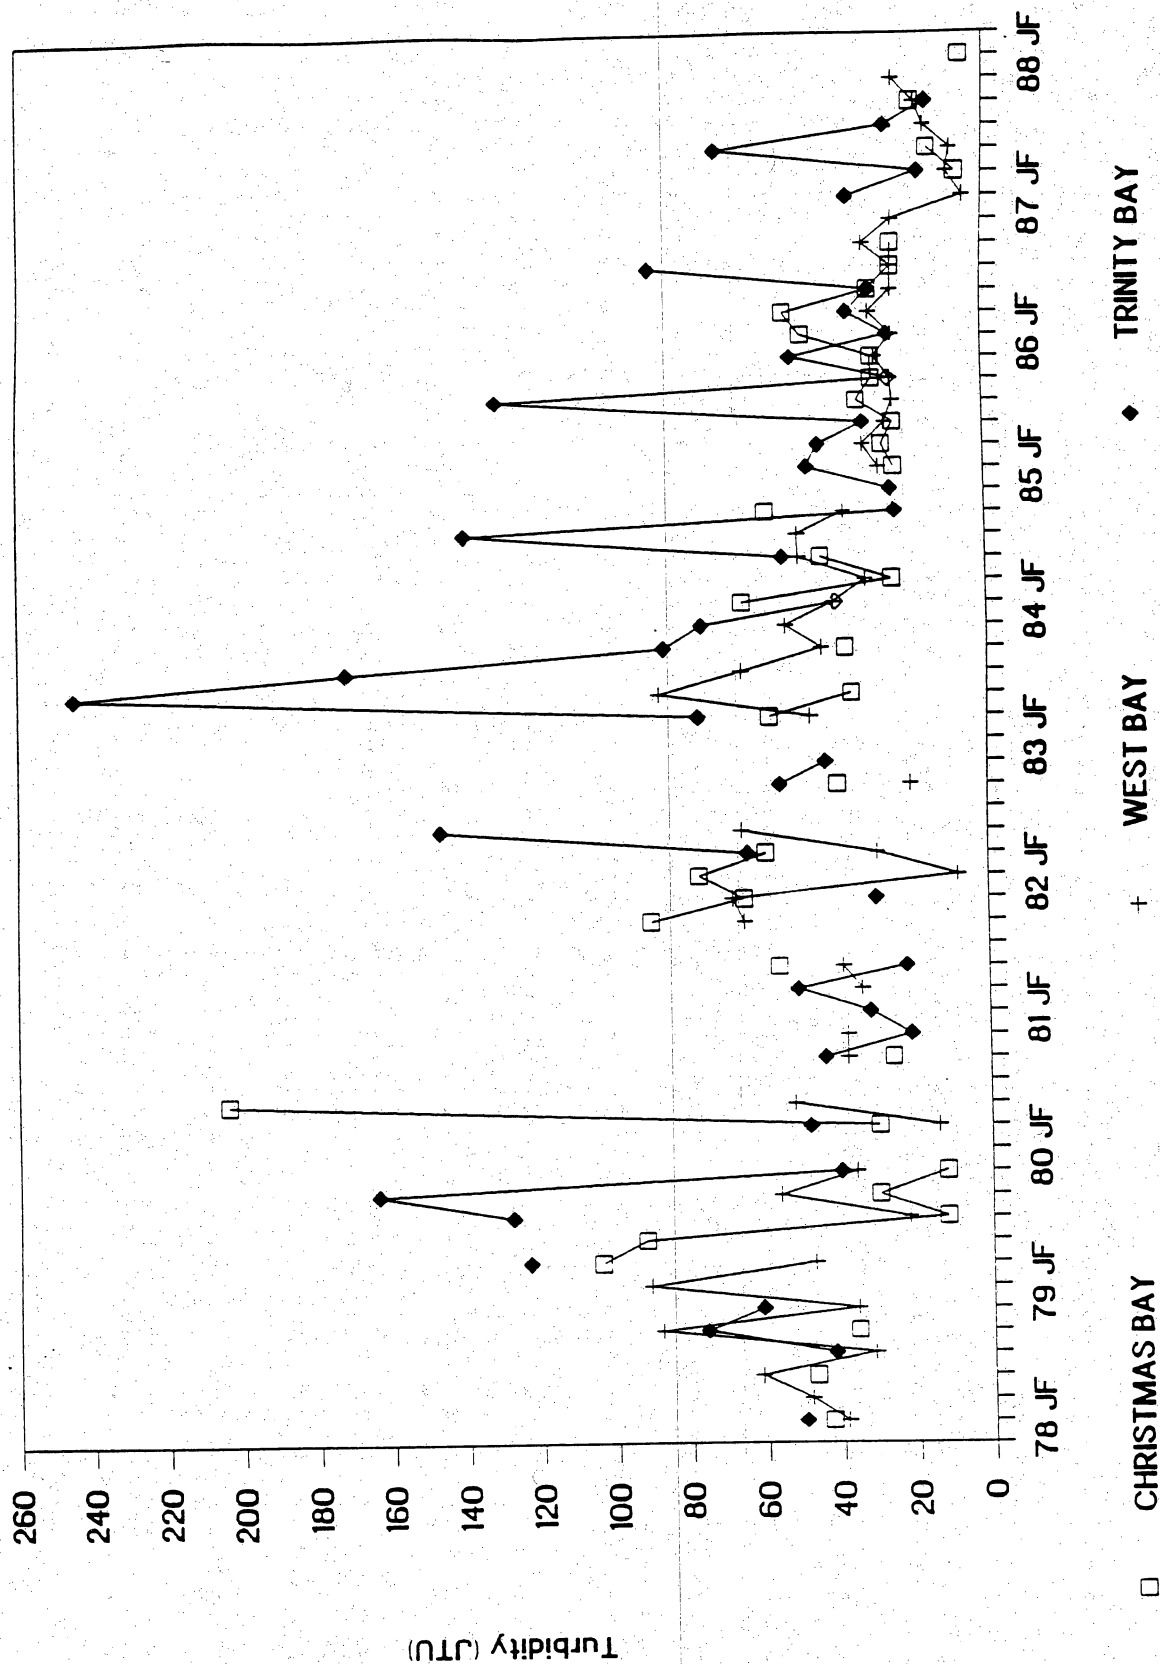
# BIMONTHLY MEAN TURBIDITY REGIMES

WEST GALV., CHRISTMAS, & TRINITY BAYS

Figure 8. Mean turbidities in areas of submerged vegetation in Christmas, West, and Trinity Bays.

West Bay and Christmas Bay water were not appreciably different at this time. When bimonthly means were compared (Fig. 8), the two areas showed essentially similar turbidity regimes over this ten year period. The current SV sites on the east shore of Trinity Bay also serve as controls for the lower bay turbidity regimes. Although these areas experience higher turbidities than the lower bay areas, due to freshwater inflows from the Trinity River, Ruppia still grows well at this higher turbidity level.

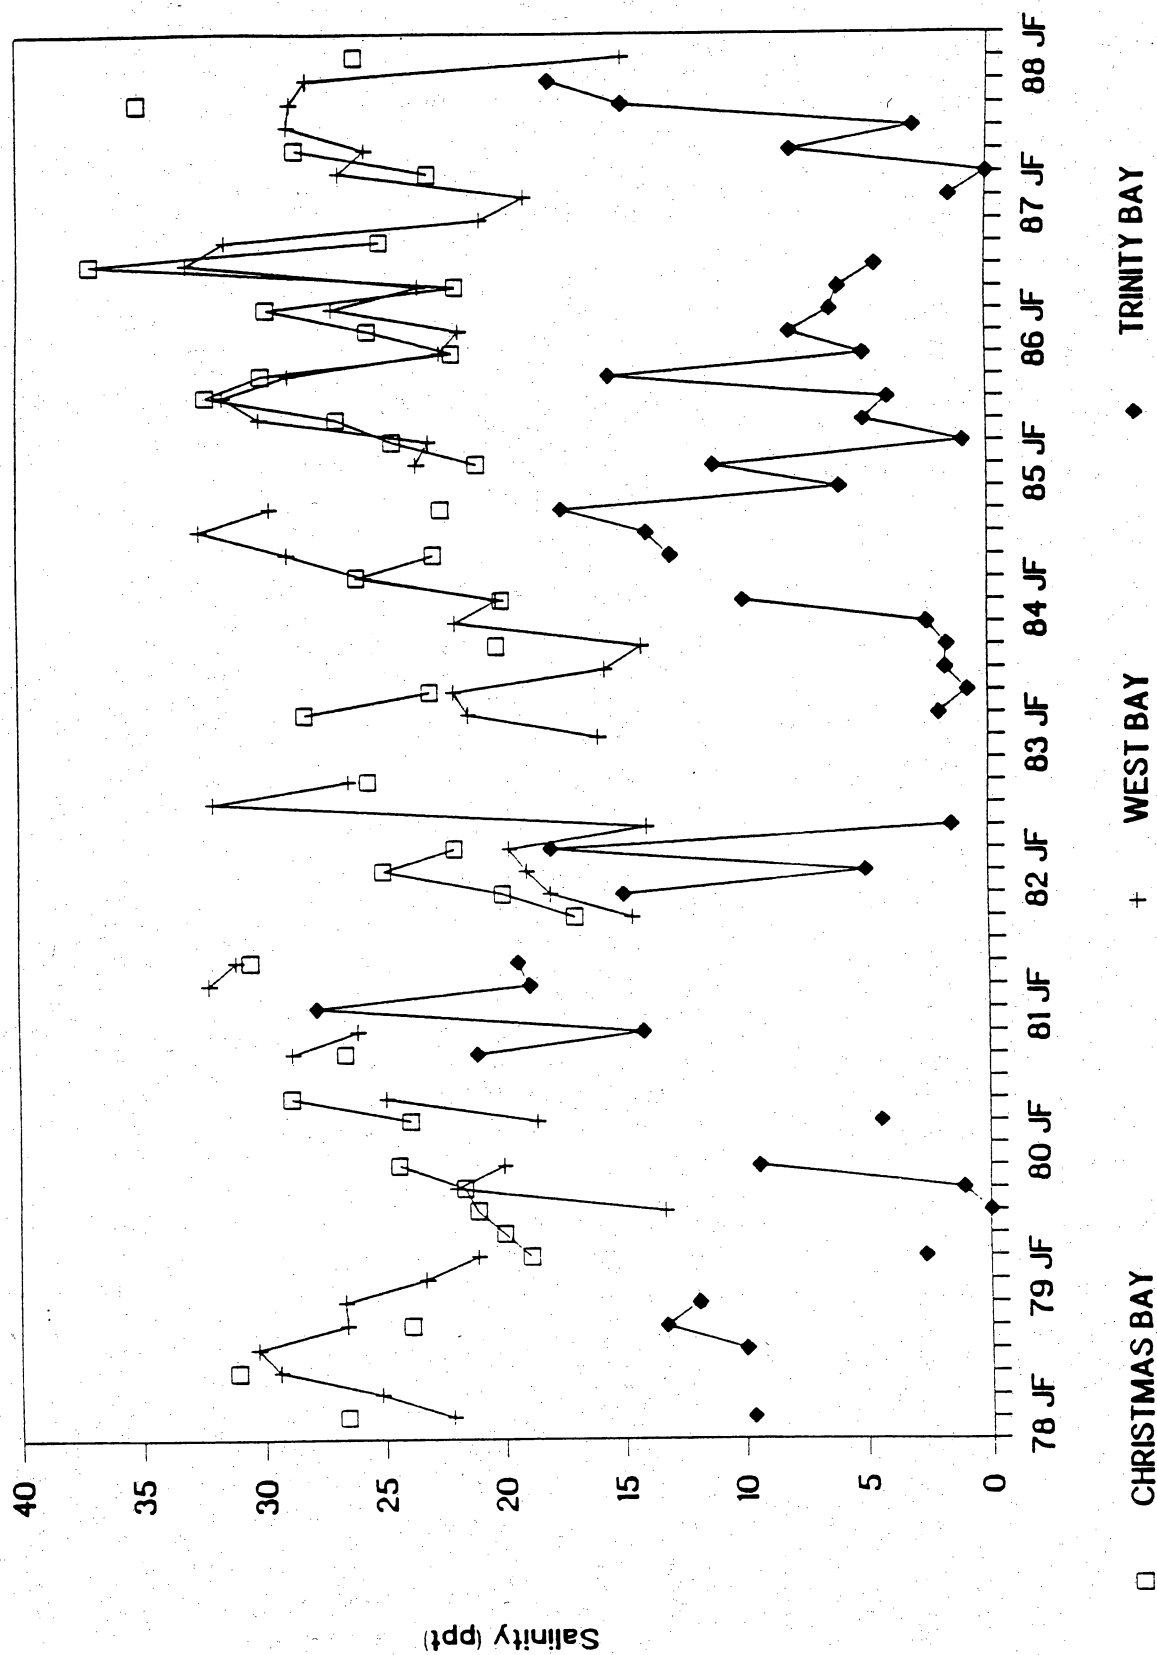
# BIMONTHLY MEAN SALINITY REGIMES

WEST GALV., CHRISTMAS, & TRINITY BAYS

Figure 9. Mean salinities in areas of submerged vegetation in Christmas, West, and Trinity Bays.

Mean salinities in West, Christmas, and Trinity Bays are compared in Figure 9. There is no evidence to suggest that salinity regimes have contributed to a decline in SV areas. Salinities in Christmas Bay, where seagrasses are relatively abundant, are similar to salinities in West Bay where seagrasses have disappeared.
