**EVALUATION OF MARSH CREATION AND RESTORATION  
PROJECTS AND THEIR POTENTIAL FOR LARGE-SCALE  
APPLICATION, GALVESTON-TRINITY BAY SYSTEM**

William A. White<sup>1</sup>, Thomas R. Calnan<sup>2</sup>, and Robert A. Morton<sup>1</sup>

<sup>1</sup>Bureau of Economic Geology  
The University of Texas at Austin  
University Station Box X  
Austin, TX 78713

August 1998

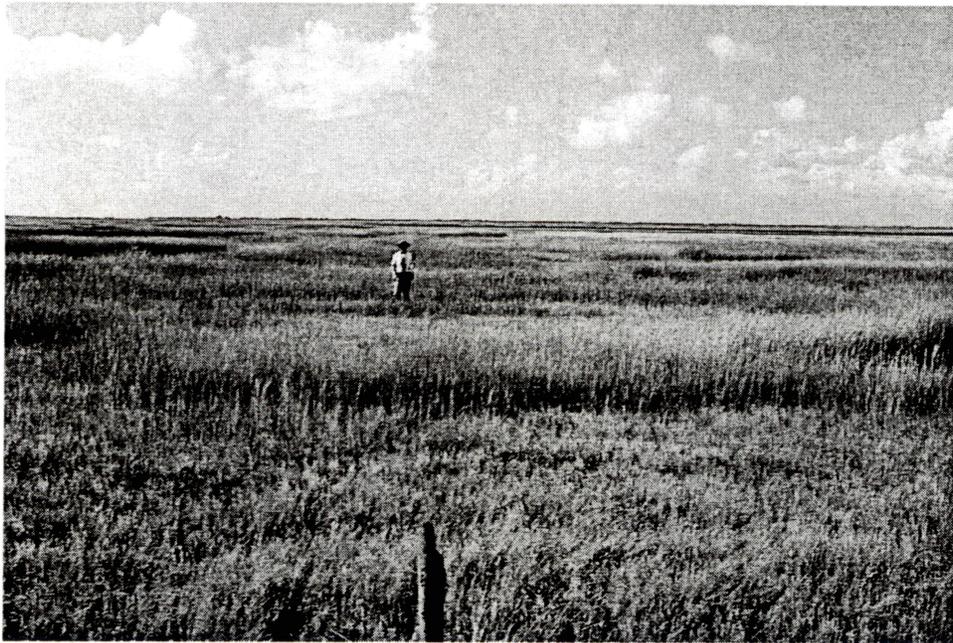
Figure 10. Photograph of ridge-and-swale like topography on the restored well pad at transect 300, Sandefer marsh. Vegetation in swales is dominated by *S. alterniflora* and on the ridges by *Salicornia virginica*.

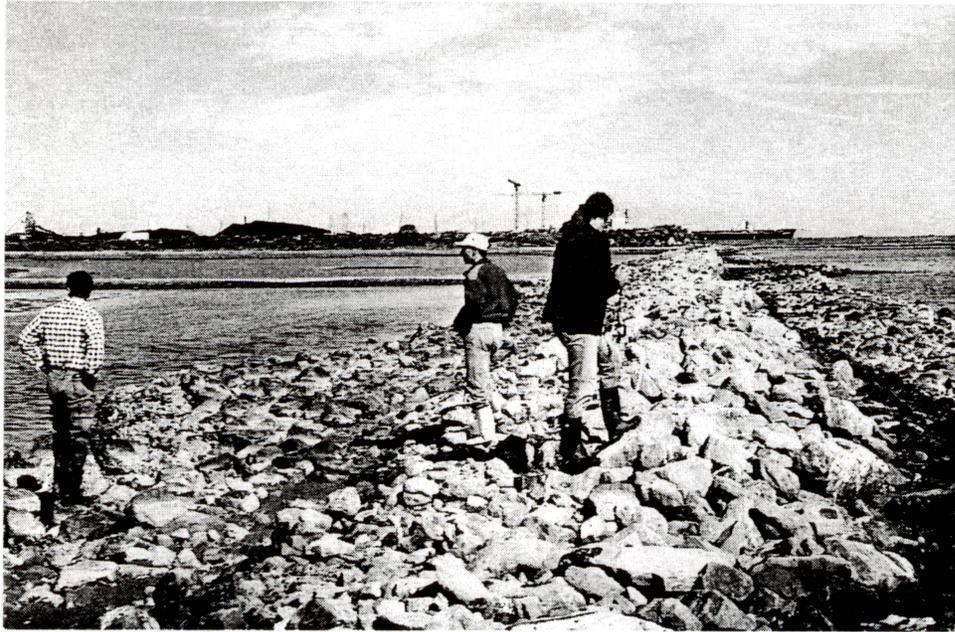
Figure 32. Photograph of wave barrier, Swan Lake marsh. View is north; Galveston Bay is on right. Note buildup of sediment in riprap on protected (left) side.

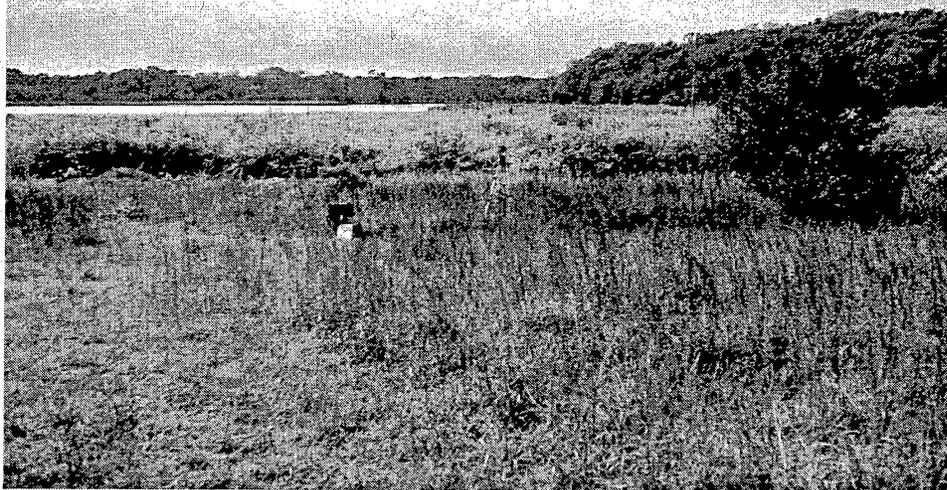
Figure 34. Photograph of Armand Bayou marsh. The marsh is between Armand Bayou, in distance, and prairie grasslands in foreground.

The Armand Bayou marsh was created as part of a cooperative effort of the Clear Lake Marsh Restoration Task Force, composed of the Galveston Bay Foundation, U.S. Fish and Wildlife Service, Texas Parks and Wildlife Department, Texas General Land Office, Texas Department of Transportation, Houston Lighting and Power, Port of Houston Authority, Armand Bayou Nature Center, National Marine Fisheries Service, and Army Corps of Engineers (USACE, 1995). The site is located on the margin of the bayou and adjacent to land owned by the Armand Bayou Nature Center in Harris County (Figs. 34 and 35). The approximate location is Latitude is 29° 35' 10" and Longitude 95° 04' 15".

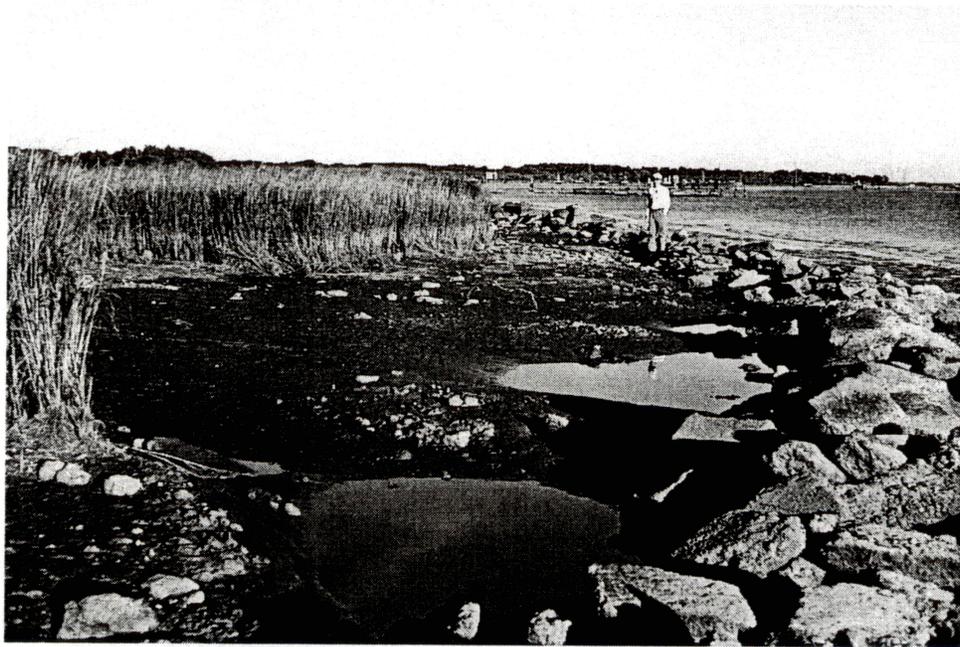
Figure 61. Photograph of scoured area and uprooted plants behind riprap between transects 300 and 400, Bayland Park Marina marsh.

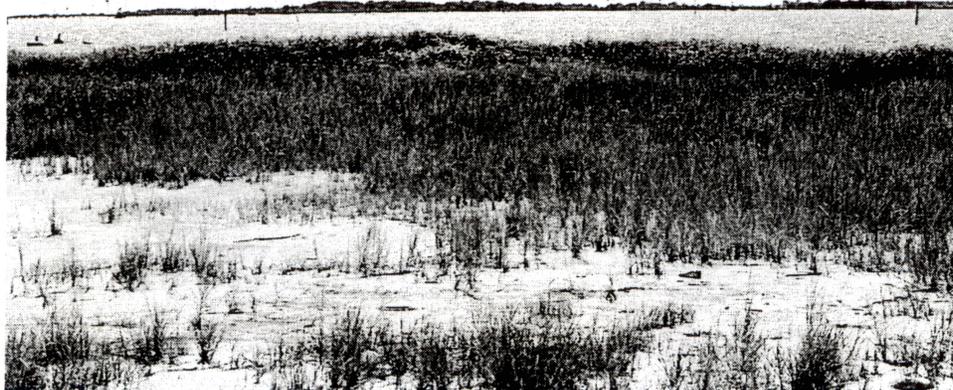
Figure 63. Photograph of transect 500, Bayland Park Marina marsh. Note differences in vegetation height at water's edge in distance and on higher surface in foreground. There is a very high exponential correlation between *Spartina* height and surface height at this transect (see Fig. 62).

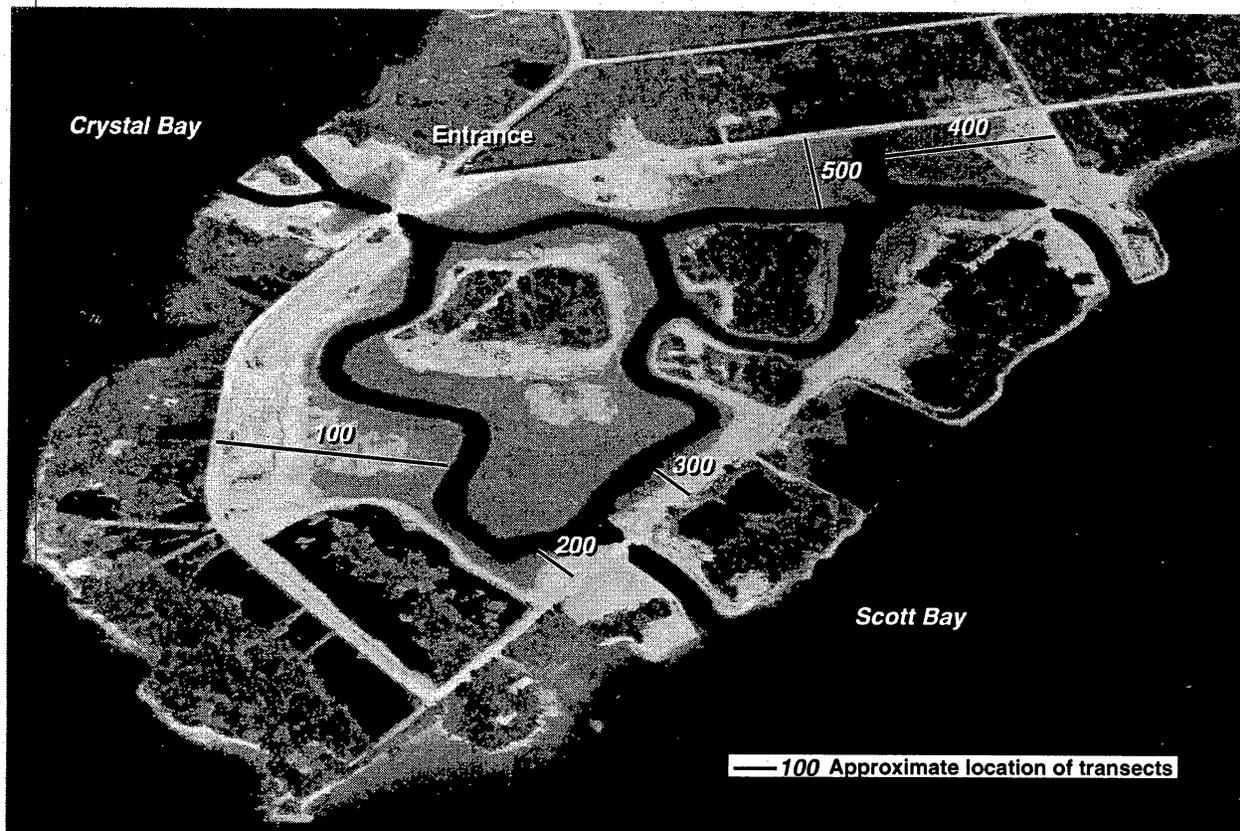
Figure 64. Photograph of Brownwood site taken in 1996, and approximate location of marsh transects. Photograph from Crouch Environmental Services, Inc.

An approximately 24.3 ha wetlands/open water area was created by scraping down uplands on the site of the former Brownwood subdivision (Fig. 64). Concrete house foundations, debris, and most existing roads were removed. Concrete rubble from the house foundations was used to stabilize the shorelines around the channel cuts. Three tidal-exchange channels (one to the north and two to the south) were created to open into the bays surrounding Brownwood peninsula. The channels are 0.9 m deep and cover an area of approximately 5.7 ha. Topsoil excavated from the site was used for site contouring. Approximately 100,578 m<sup>3</sup> of soil was cut to create the tidal marsh and channels, and 42,943 m<sup>3</sup> of fill was used for island habitat, inlet breakers, and site recontouring. Two islands were created in the center of the wetlands, and primarily native tree/shrub species were planted on the islands and along the perimeter of the created wetlands.

Total areas of habitats were not determined during the field surveys, but observations indicated that the physical layout of the wetland complex (Figs. 64 and 65) was in agreement with design plans. Lengths of transects (Figs. 66-70) match well with estimated distances based on photographs and planning maps (Crouch Environmental Services, Inc. 1996). Slopes of graded surfaces vary from highs of 3 to 4 percent on
