The Texas High School Coastal Monitoring Program is a research and outreach program at the Bureau of Economic Geology, part of the Jackson School of Geosciences at The University of Texas at Austin, where we partner with students and teachers in the study of the Texas coastal environment. This project has the dual benefit of enhancing the science education of the student participants while providing valuable data on the dynamic Texas coastline. This presentation examines data from every THSCMP study site to highlight the variability in geomorphology and coastal issues found along the Texas coast.

THSCMP was started in 1997 with three stated goals. The first to provide high school students with a real-world learning experience studying the Texas beach and dune environment. Eight schools along the Texas coast participate in 3 field trips each academic year collecting beach and dune monitoring data. Our second goal is to help scientists and decision makers gain a better understanding of the relationship between coastal processes, beach morphology and shoreline change along the Texas coast through this long-term data collection program. A lot of scientific studies are short term. We h

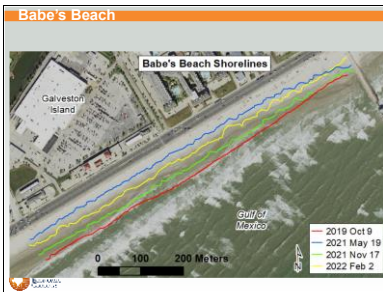
Students collect GPS mapped shoreline positions from a section of Babe's Beach (between 61<sup>st</sup> and 69<sup>th</sup> Streets) that is periodically nourished.

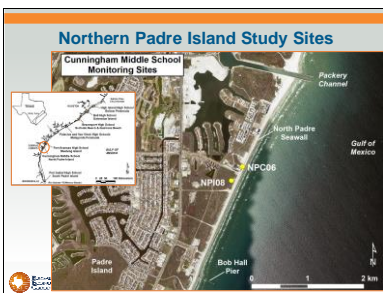
Cunningham eighth grade students collect data at two sites on northern Padre Island, NPI08 and NPC06. NPI08 monitors a very active foredune crest and maintained beach. NPC06, on the North Padre Island seawall, monitors beach restoration and maintenance activities seaward of the seawall.
