GEOTUBES ALONG THE GULF SHORELINE OF THE UPPER TEXAS COAST: OBSERVATIONS DURING 2001

**A Report of the Texas Coastal Coordination Council pursuant to National Oceanic
and Atmospheric Administration Award No. NA97OZ0179
GLO Contract Number 01-597 R**

**Bureau of Economic Geology
Scott W. Tinker, Director
The University of Texas at Austin
Austin, Texas 78713-8924**

March 2002

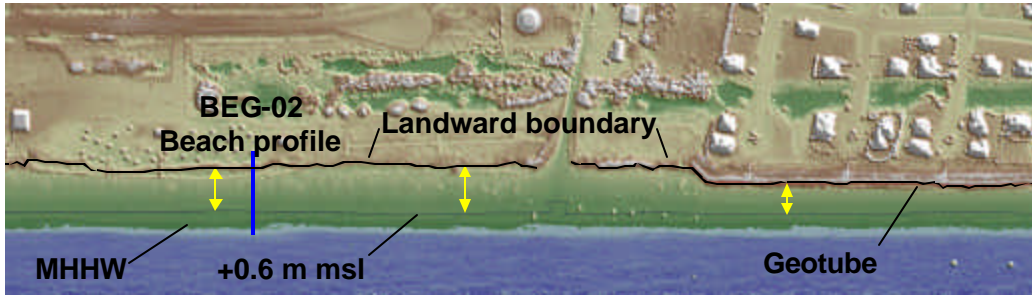
Figure 8. Lidar topographic image of the southwest end of the Pirates Beach geotube project and the northeast end of Galveston Island State Park. Double-ended arrows demonstrate beach width measurement between the 0.6 m level and the landward boundary.

Any interruption in the alongshore transport or supply of sand will result in increased erosion rates in the down drift direction. Increased erosion of beaches down drift of the geotube projects will occur if there is not adequate beach nourishment and if the geotubes do not allow the erosion of sand behind them. Inspection of the alongshore shape of the 1.97 ft (0.6 m) MSL contour line and back beach elevations is used to indicate if beaches adjacent to the geotubes are experiencing enhanced erosion rates. A landward deviation of the contour line at the end of the geotube or a lower than normal back beach would indicate negative effects.

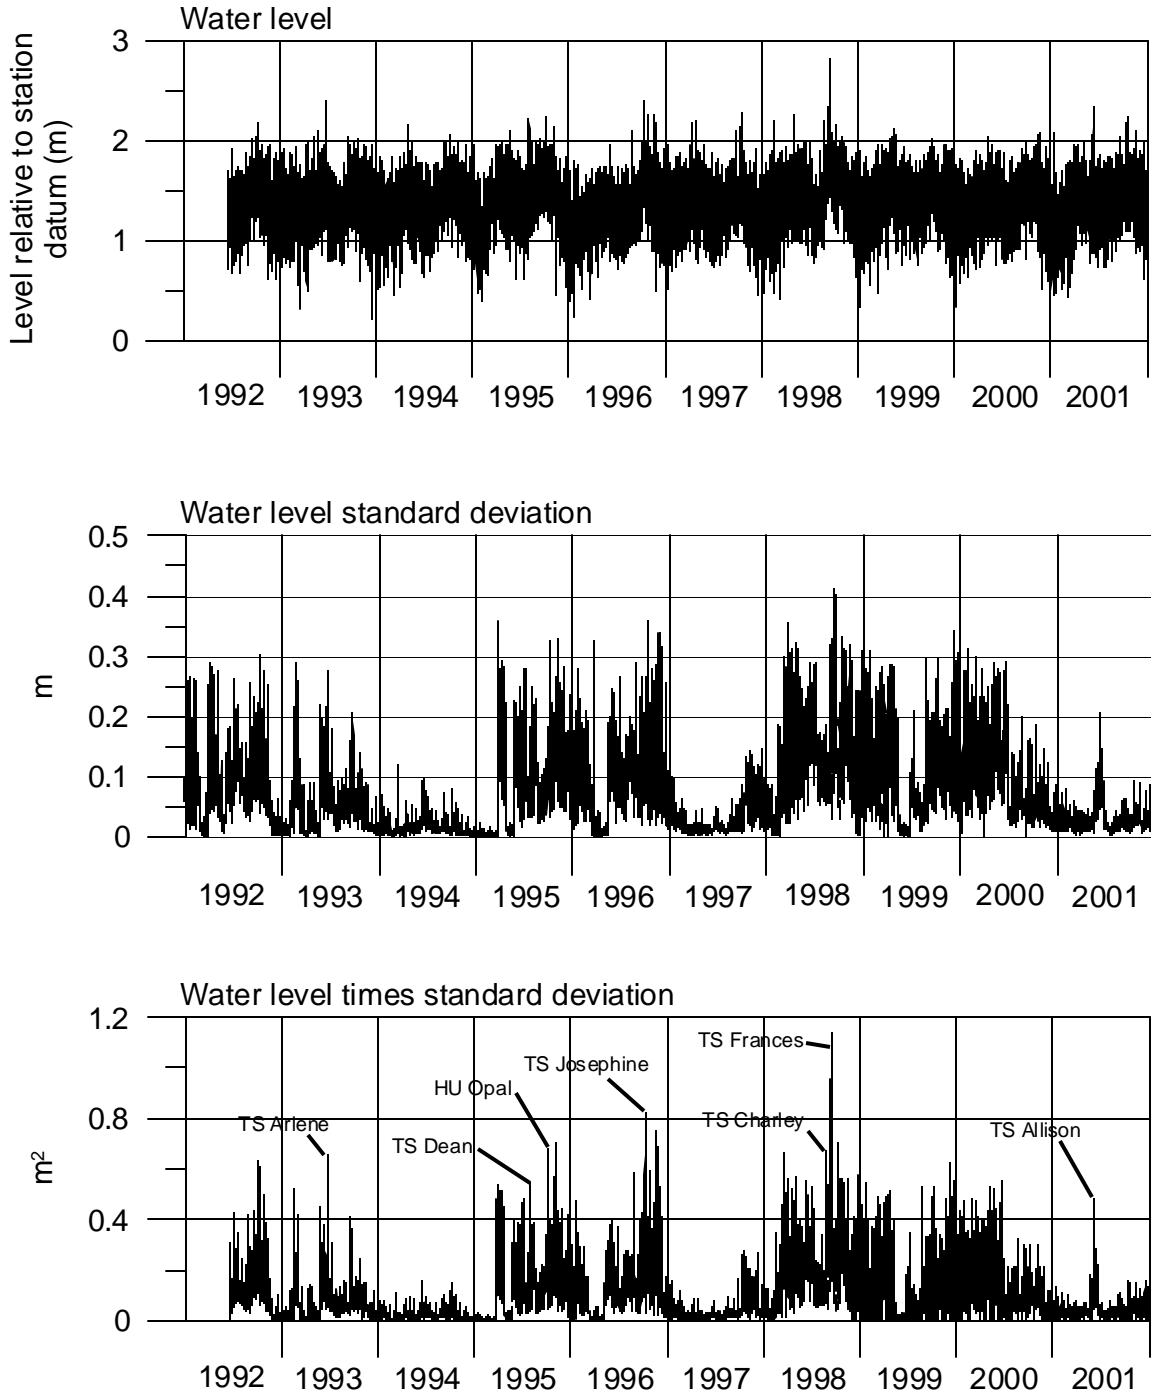
Figure 9. Time series of water level, water level standard deviation (WLSD), and the product of water level and WLSD from the Pleasure Pier tide gauge.

Figure 9 is a time series plot of water level, WLS, and the product of water level and WLS acquired by the open-coast tide gauge at the end of Pleasure Pier in front of the Galveston Seawall. High values for the product of WLS and water level indicate periods of high wave energy coincident with high-water levels. TS Josephine and Frances are prominent peaks in this plot. Other tropical storms and hurricanes that affected the northern and western Gulf of Mexico caused peaks in the time series, but based on beach profiles and field observations, Gibeau and Gutierrez (1999) determined that prior to 1999 only Tropical Storms Josephine and Frances caused significant dune erosion and vegetation line retreat. Based on the Josephine conditions and the other storms that did not cause significant erosion, it was estimated that threshold conditions for episodic erosion and vegetation line retreat are water levels that exceed 2.95 ft (0.9 m) MSL and WLS that

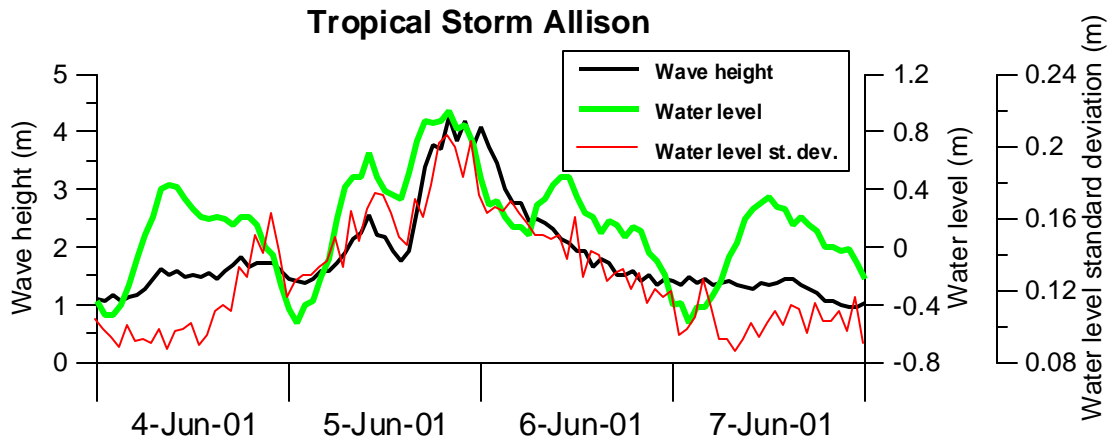
Figure 10. Water level and wave conditions during Tropical Storm Allison. Water level and Water level standard deviation (WLSD) measured at Pleasure Pier tide gauge. Wave heights measured by National Data Buoy Center buoy #42035 located 20 miles offshore Galveston.

On June 5, Tropical Storm Allison made landfall near Freeport, Texas approximately 14 mi southwest of the Treasure Island geotube projects, 30 mi southwest of the Galveston Island projects, and 60 mi southwest of the Gilchrist projects. Figure 10 shows water levels, WLS D, and wave heights measured by the offshore buoy during Allison. The peak water level was 3.12 ft (0.95 m) MSL, the peak WLS D was 0.69 ft (0.21 m), and the peak wave height was 13.94 ft (4.25 m). Wave heights that exceeded 9.84 ft (3 m) coincided with water levels exceeding 2.95 ft (0.9 m) for a period of only 1 hour. Furthermore, the product of water level and WLS D peaked at only 0.5 m^2 during Allison, considerably less than Tropical Storms Josephine and Frances in 1996 and 1998, respectively (Fig. 9). This analysis shows that TS Allison was not a “threshold” event expected to cause significant dune erosion and vegetation line retreat. Pre- and post-Allison beach profiles at the Galveston Island State Park (BEG02 location, Fig. 6) show that Allison did not cause significant erosion (Fig. 11). At this location, which has no geotubes, the back beach was eroded but significant vegetation remained. A small, sparsely vegetated incipient foredune created with the aid of sand fencing seaward of the foredune ridge, survived.

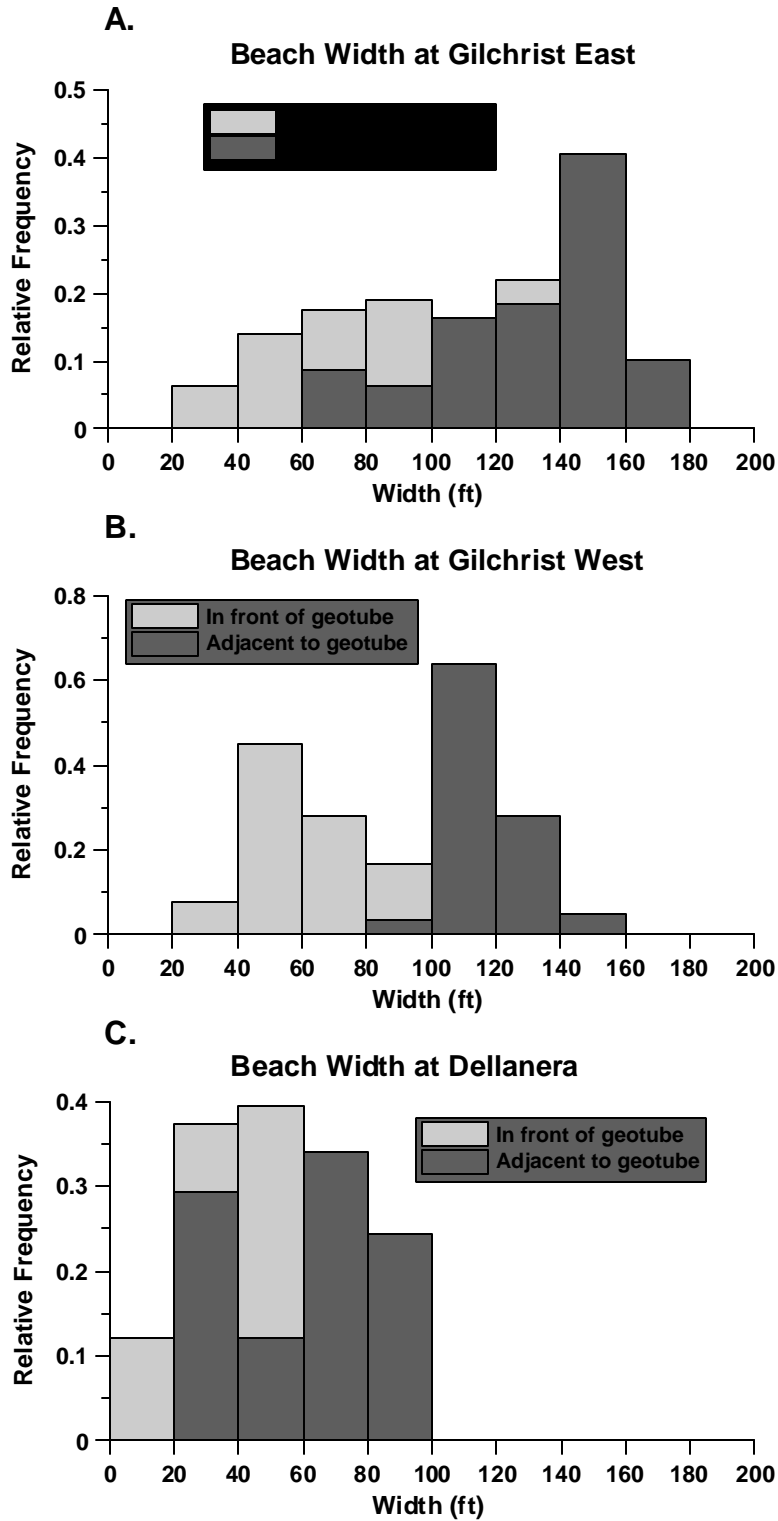
Figure 12. July 2001 beach width comparison shown as relative frequency of transects spaced every 16.4 ft (5 m) alongshore in front of and adjacent to the designated geotubes: (A) Gilchrist east; (B) Gilchrist west; (C) Dellanera.

Figures 12 and 13 are histograms that compare beach widths adjacent to and in front of each project except the Treasure Island projects. The histograms are shown in relative frequency of locations spaced 16.40 ft (5 m) alongshore. For example, figure 12A shows that approximately 40 % (0.4 relative frequency) of the length of the beach is 140 to 160 ft (42.7 to 48.8 m) wide adjacent to the geotubes. The histograms show that beaches in front of geotubes are generally narrower than beaches adjacent to them. There are, however, portions of the beaches in front of the geotubes that are as wide as the narrower portions of the adjacent beaches. Table 3 gives the minimum and average beach widths. Average beach widths are narrower in front of the geotubes than adjacent to them by 21 to 83 ft (6.4 to 25.3 m) with the Pirates Beach project showing the greatest difference. Except for the Riviera and Pocket Park II projects, the beaches in front of the geotubes have minimum beach widths narrow enough to prevent passage during water levels of 1 to 2 ft (0.30 to 0.61 m) above MHHW.

Visual inspection of the 1.97 ft (0.6 m) MSL contour line and back beach elevation on the topographic lidar images (Plates 1 and 2) show that the geotubes have not affected the erosion rates of adjacent beaches. If adjacent beaches were being affected, we would expect to see a decrease in the effect with distance from the geotubes. The morphologies and elevations of the back beach and fore beach portions of the beach profile, however, are similar for sections immediately adjacent to the geotubes and for beaches more distal to the geotubes.
