Geotextile Tubes along the Upper Texas Gulf Coast

May 2000 to March 2003

November 2003

A Report of the
Texas Coastal
Coordination
Council pursuant
to National
Oceanic and
Atmospheric
Administration
Award No.
NA07OZ0134,
GLO Contract
No. 02-493 R

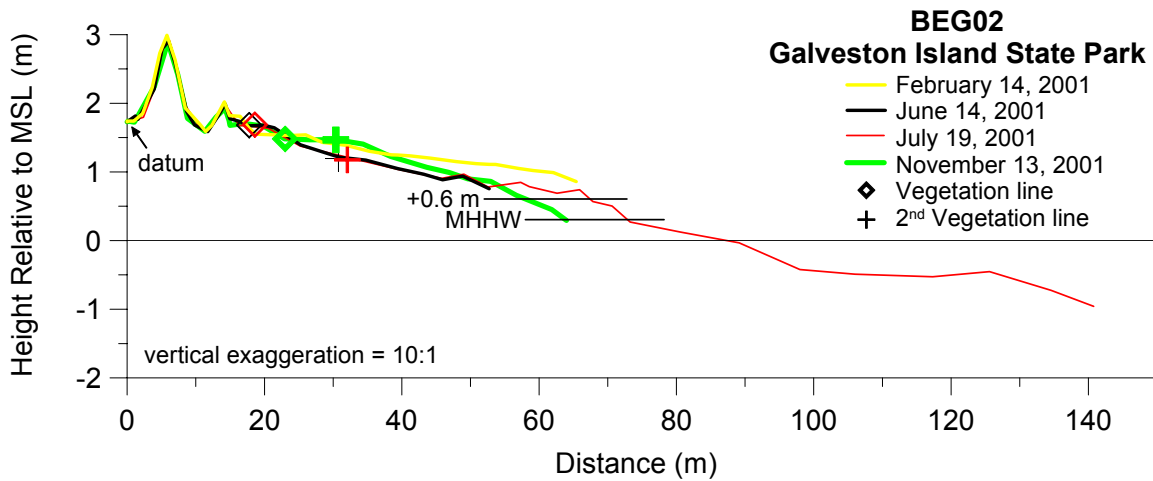
Figure 11. Beach profiles at Galveston Island State Park, location BEG02 (see Fig. 6 for location). The foredune and incipient dune seaward of the foredune survived Tropical Storm Allison in early June, 2001.

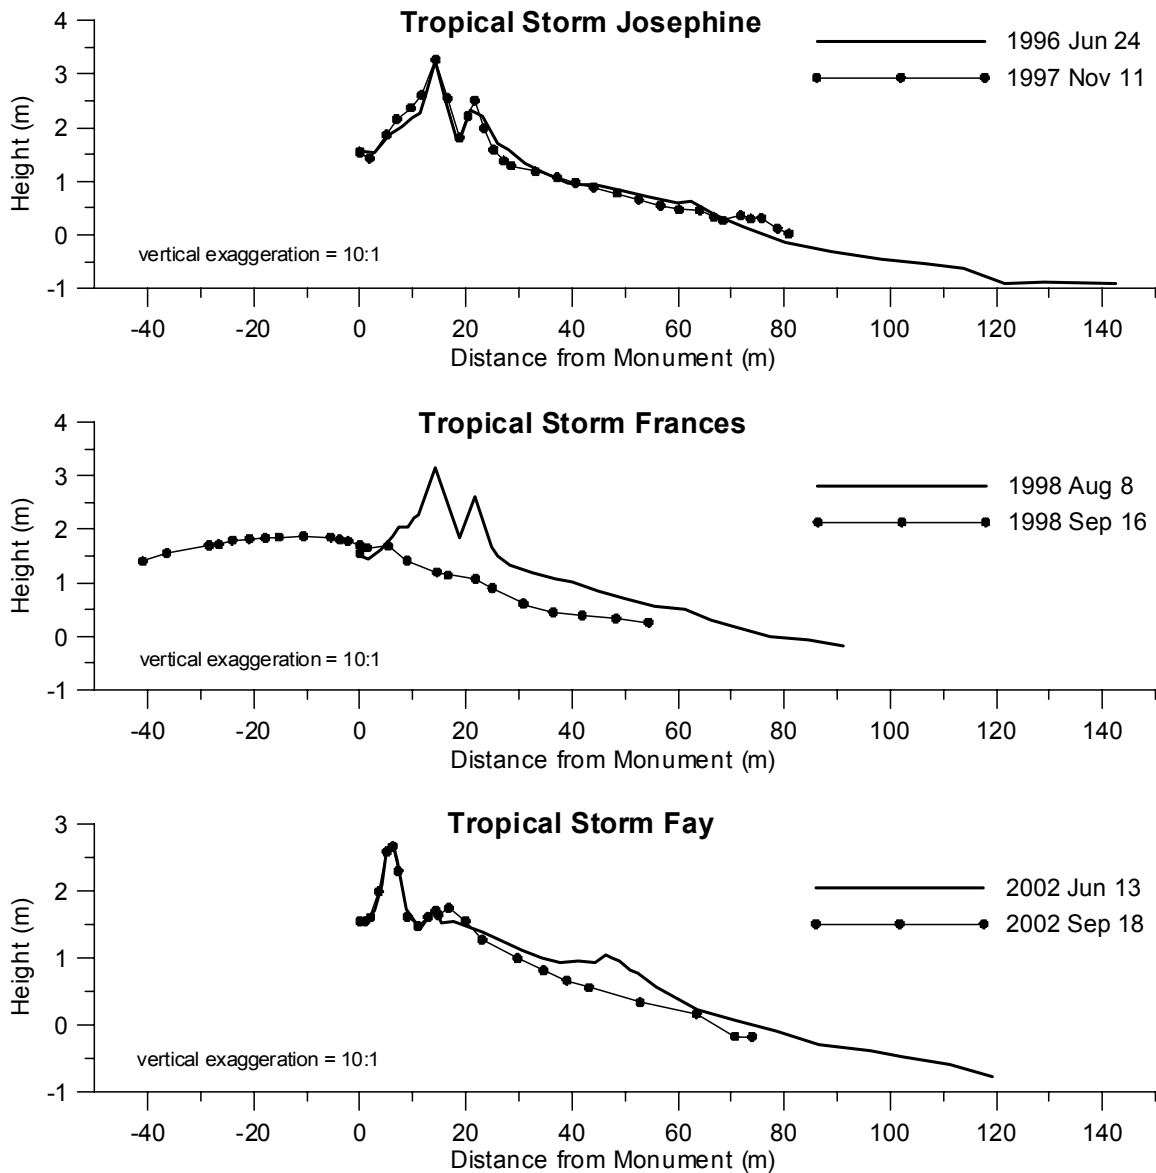
Beach profiles from the relatively natural BEG-02 beach profile site, gives an indication of the relative severity of erosion caused by Tropical Storms Josephine, Frances, and Fay (Fig. 13). Josephine caused the seaward-most vegetation line to retreat 9 m, but an incipient foredune survived and the primary foredune was untouched. Frances, on the other hand, flattened the incipient dune and foredune and washed over and deposited sand on the back barrier. Frances caused the vegetation line to retreat 20 m. Changes caused by Fay were very similar to those caused by Josephine. A foredune and incipient dune that reformed following Frances in 1998 survived Fay in 2002. Fay partially eroded coppice mounds seaward of a sand fence, but the seaward-most vegetation line did not change position and the vegetation line defining where the vegetation becomes essentially continuous landward retreated only about 8 m (Fig. 13 and BEG02 profiles and photos in Appendix B).

Figure 13. BEG-02 beach profiles from Galveston Island State Park where no geotextile tubes are present (see Fig. 6 for location). Profiles show changes before and after major storms. Tropical Storm Fay caused the same degree of change as Josephine, but Frances completely eroded the foredunes.

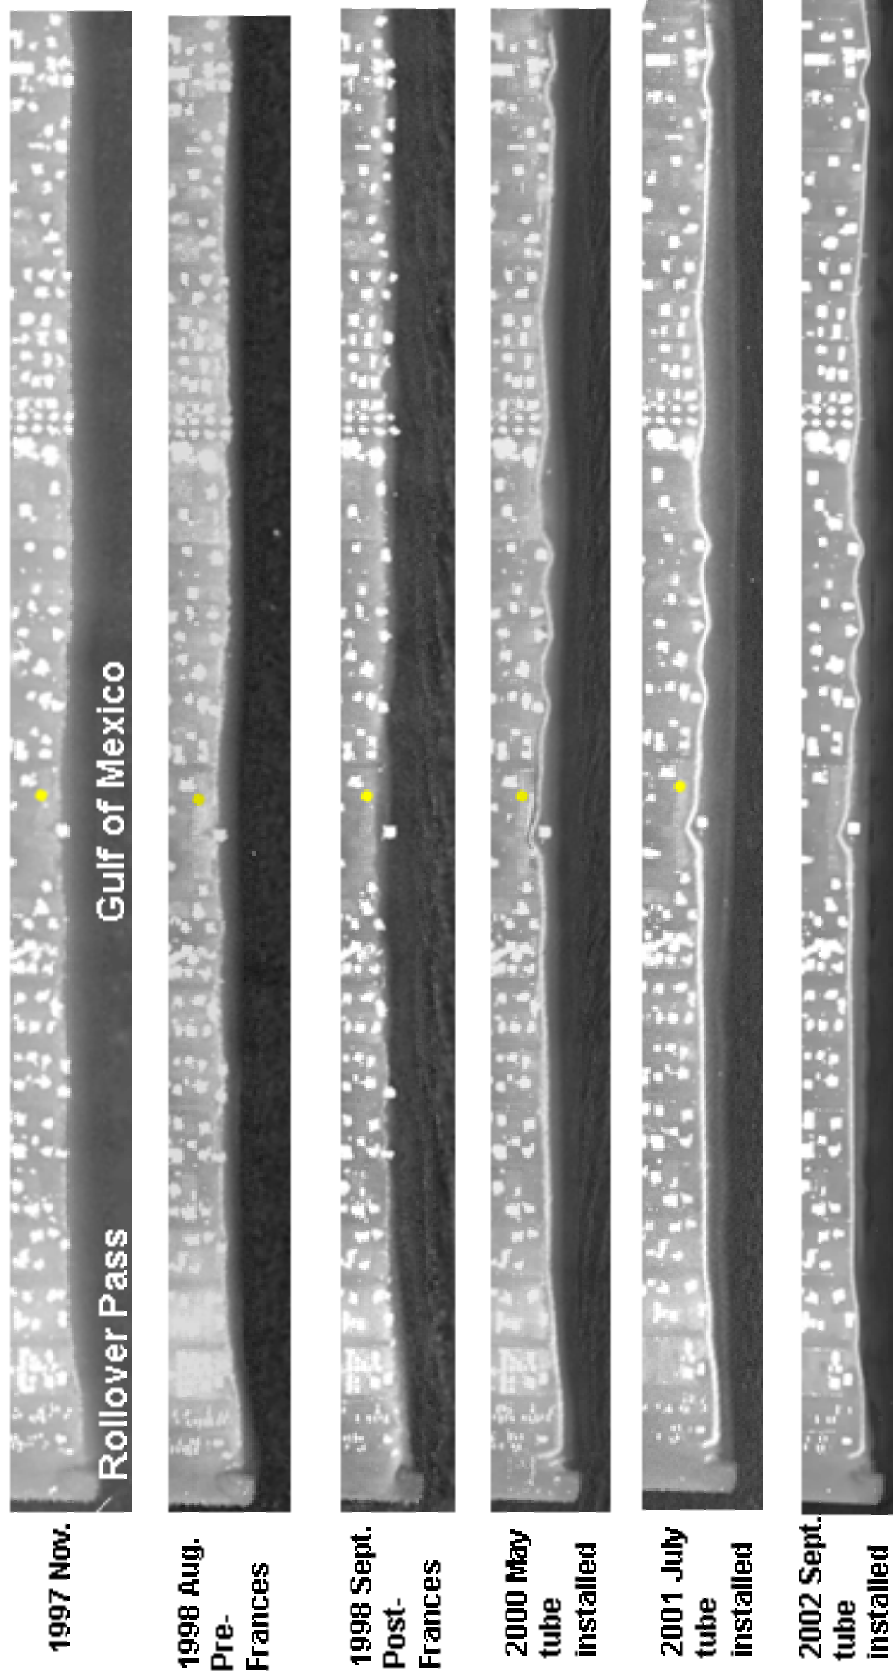
Figure 29. Lidar topographic images of a portion of the Gilchrist East project. Dark areas are low elevation, lighter higher elevation. Geotextile tubes were present during the 2000, 2001, and 2002 surveys. Note how the tubes were routed seaward of some houses and the overall geomorphic impact of the project.

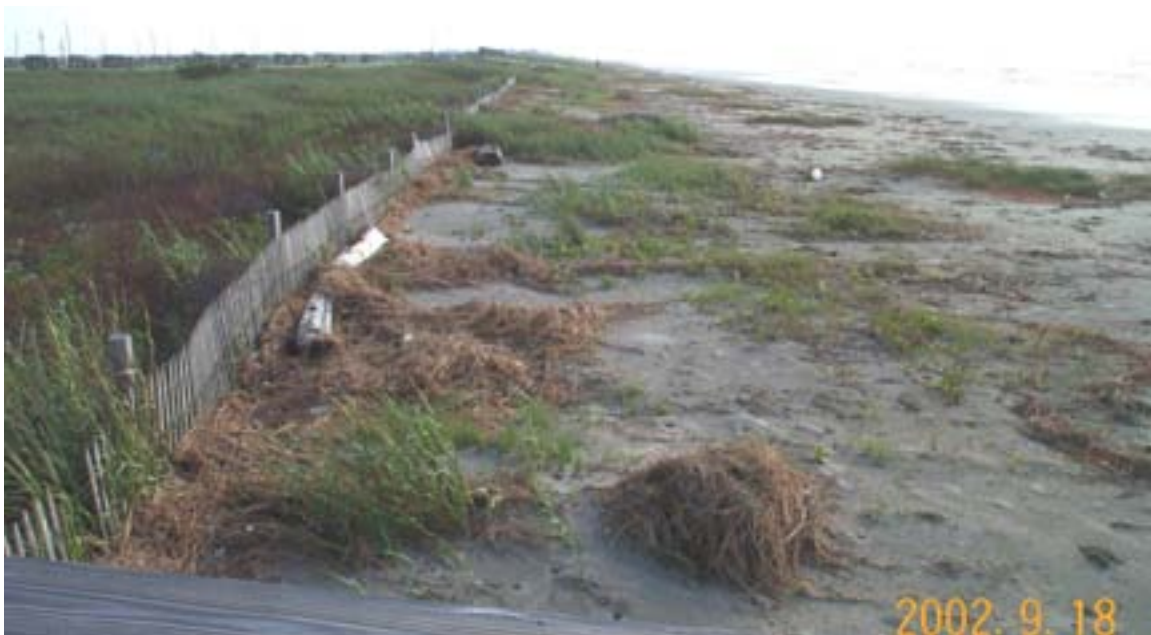
Figure 31. Coppice mounds at GLO06 profile location in Galveston Island State Park on September 18, 2002 (see figure 6 for location). There is no geotextile tube at this location. This subenvironment of wind-blown sand and sparse vegetation was eroded but survived Tropical Storm Fay in September 2002. Coppice mounds do not exist or are poorly developed along beaches with geotextile tubes or where structures are on the back beach.

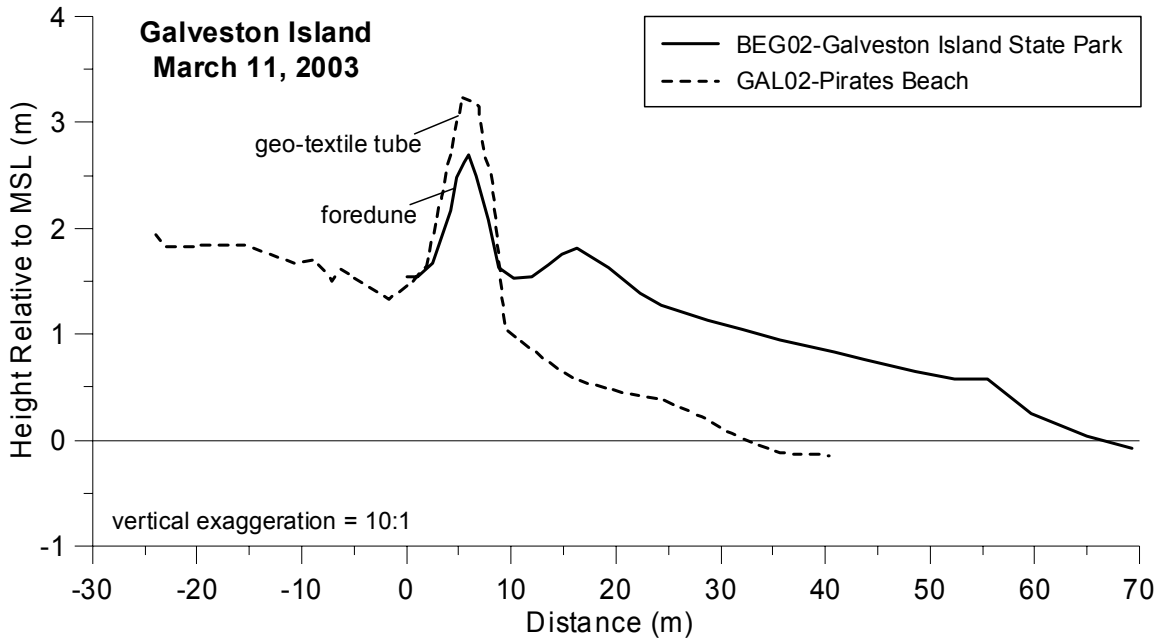
level. Figure 32 compares beach profiles from a Pirates Beach geotextile tube location and a relatively natural site at Galveston Island State Park in the early spring of 2003. The tube beach is about 3 ft (1 m) lower than the State Park beach. It is unlikely that the tube beach will naturally recover enough to allow coppice mounds to develop or to provide a recreational area equivalent to the State Park.

The profiles in figure 32 are lined up by shifting them horizontally so the foredune and geotextile tube coincide. This was done to emphasize the difference in the beach dimensions; however, it gives the impression that the shoreline is shifted landward at the tube location relative to the State Park. This is not the case. The shoreline along Pirates Beach is generally in a position congruent with the adjacent beaches. However, the geotextile tubes were installed seaward of the adjacent foredune positions which has caused a narrower beach at Pirates Beach. The same situation exists at the other projects; therefore, the primary reason for the geotextile tube beaches being narrower than adjacent beaches during the study period is the original placement of the tubes. This is apparent on the maps of plates 1 and 2 where one can see that the 2000, 2001, and 2002 shorelines are not offset alongshore but that the tubes are set seaward of the adjacent foredunes or bluffs.

Figure 32. Comparison of beach profiles BEG02 with no geotextile tube and GAL02 in the Pirates Beach geotextile tube project (see Fig. 6 for locations). Profiles are adjusted horizontally to line up the foredune and geotextile tube (see Figs. 33 and 34 for photos).

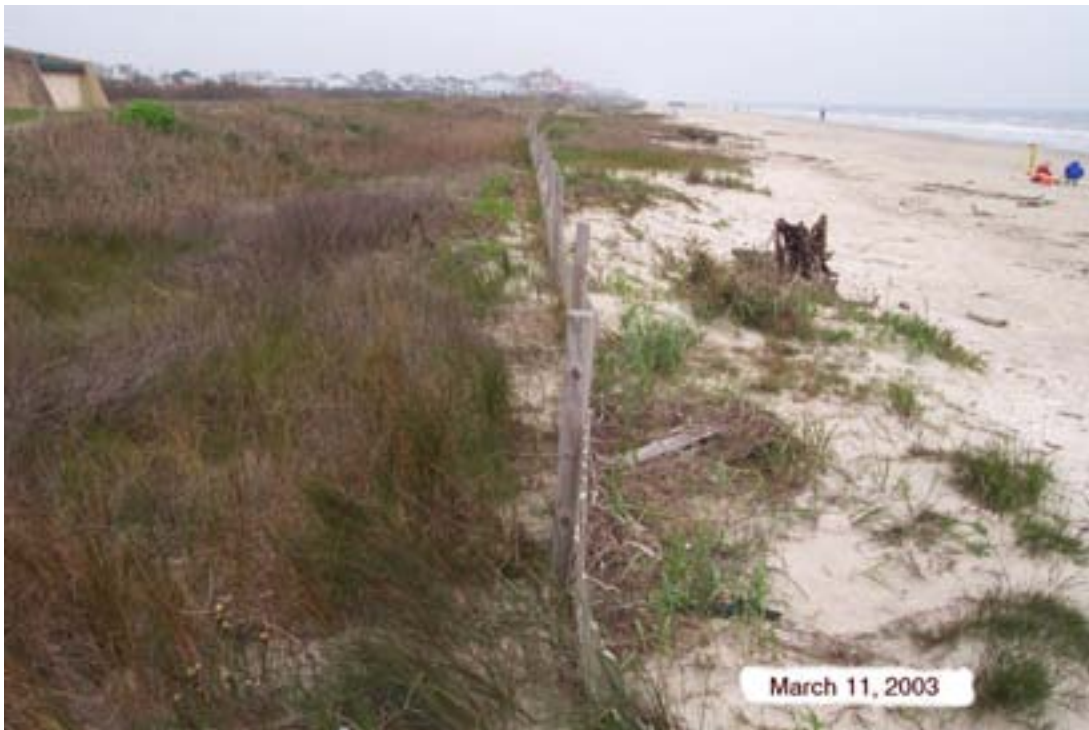
Figure 33. BEG02 beach profile location in Galveston Island State Park on March 11, 2003. No geotextile tube is at this location. Coppice mounds are present seaward of the sand fence and there is room on the back beach for further mound develop during the summer. This is in contrast to the setting in front of the Pirates Beach tube project shown in figure 34 (see Fig. 6 for location and Fig. 32 for beach profile).
