# Geotextile Tubes along the Upper Texas Gulf Coast

May 2000 to March 2003

## Bureau of Economic Geology

A Report of the  
Texas Coastal  
Coordination  
Council pursuant  
to National  
Oceanic and  
Atmospheric  
Administration  
Award No.  
NA07OZ0134,  
GLO Contract  
No. 02-493 R

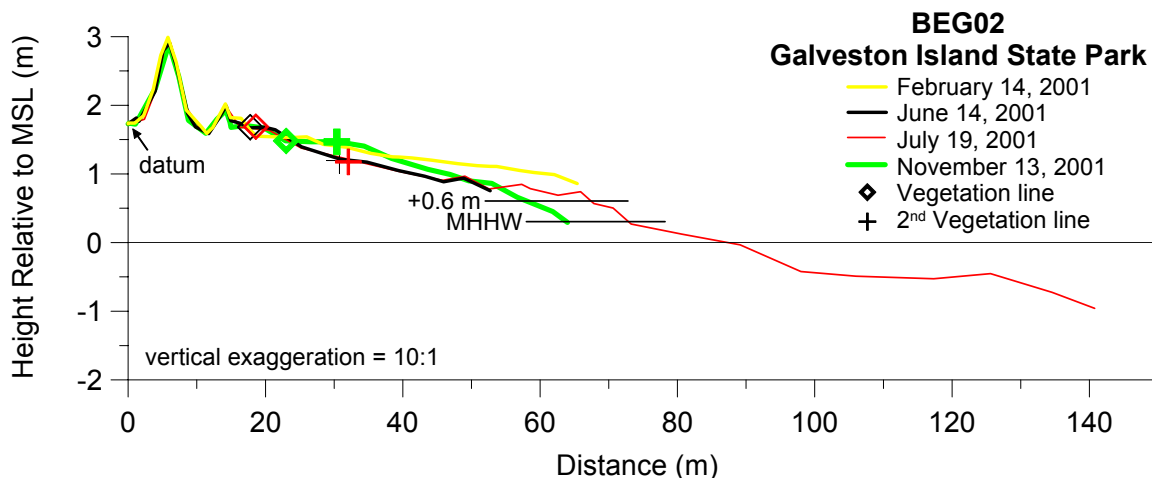
On June 5, 2001, TS Allison made landfall near Freeport, Texas. Figure 10 shows WL, WLS D, and  $WL \times WLS D$ . WL peaked at 3.12 ft (0.95 m) above MSL, and the highest waves were 13.94 ft (4.25 m), as measured by the NDBC buoy #42035 20 miles offshore of Bolivar Roads. The product of water level and WLS D peaked at only  $0.484 \text{ m}^2$  during Allison, considerably less than Tropical Storms Josephine and Frances in 1996 and 1998, respectively (Table 1). Furthermore, extreme conditions lasted only 5 hours to yield an EA of  $0.18 \text{ hrs-m}^2$ , much less than during Josephine. This analysis shows that TS Allison was not a “threshold” event expected to cause significant dune erosion and vegetation line retreat. Pre- and post-Allison beach profiles at the Galveston Island State Park (BEG02 location, Fig. 6) show that Allison did not cause significant erosion (Fig. 11). At this location, which has no geotextile tubes, the back beach was eroded but significant vegetation remained. A small, sparsely vegetated incipient foredune created with the aid of sand fencing seaward of the foredune ridge, survived.

**Figure 11. Beach profiles at Galveston Island State Park, location BEG02 (see Fig. 6 for location). The foredune and incipient dune seaward of the foredune survived Tropical Storm Allison in early June, 2001.**

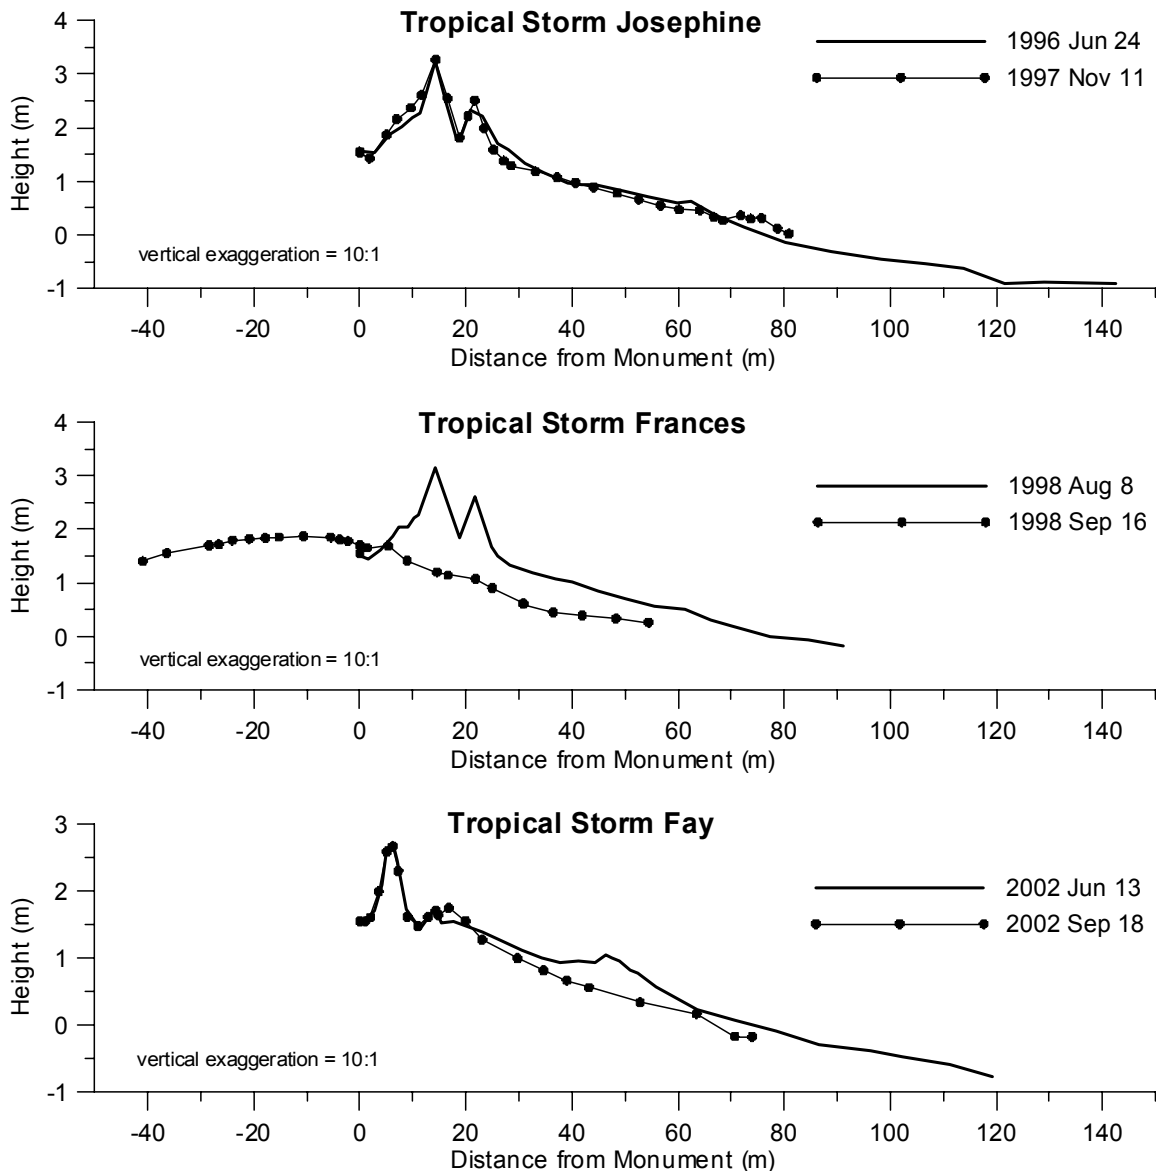
Beach profiles from the relatively natural BEG-02 beach profile site, gives an indication of the relative severity of erosion caused by Tropical Storms Josephine, Frances, and Fay (Fig. 13). Josephine caused the seaward-most vegetation line to retreat 9 m, but an incipient foredune survived and the primary foredune was untouched. Frances, on the other hand, flattened the incipient dune and foredune and washed over and deposited sand on the back barrier. Frances caused the vegetation line to retreat 20 m. Changes caused by Fay were very similar to those caused by Josephine. A foredune and incipient dune that reformed following Frances in 1998 survived Fay in 2002. Fay partially eroded coppice mounds seaward of a sand fence, but the seaward-most vegetation line did not change position and the vegetation line defining where the vegetation becomes essentially continuous landward retreated only about 8 m (Fig. 13 and BEG02 profiles and photos in Appendix B).

**Figure 13. BEG-02 beach profiles from Galveston Island State Park where no geotextile tubes are present (see Fig. 6 for location). Profiles show changes before and after major storms. Tropical Storm Fay caused the same degree of change as Josephine, but Frances completely eroded the foredunes.**

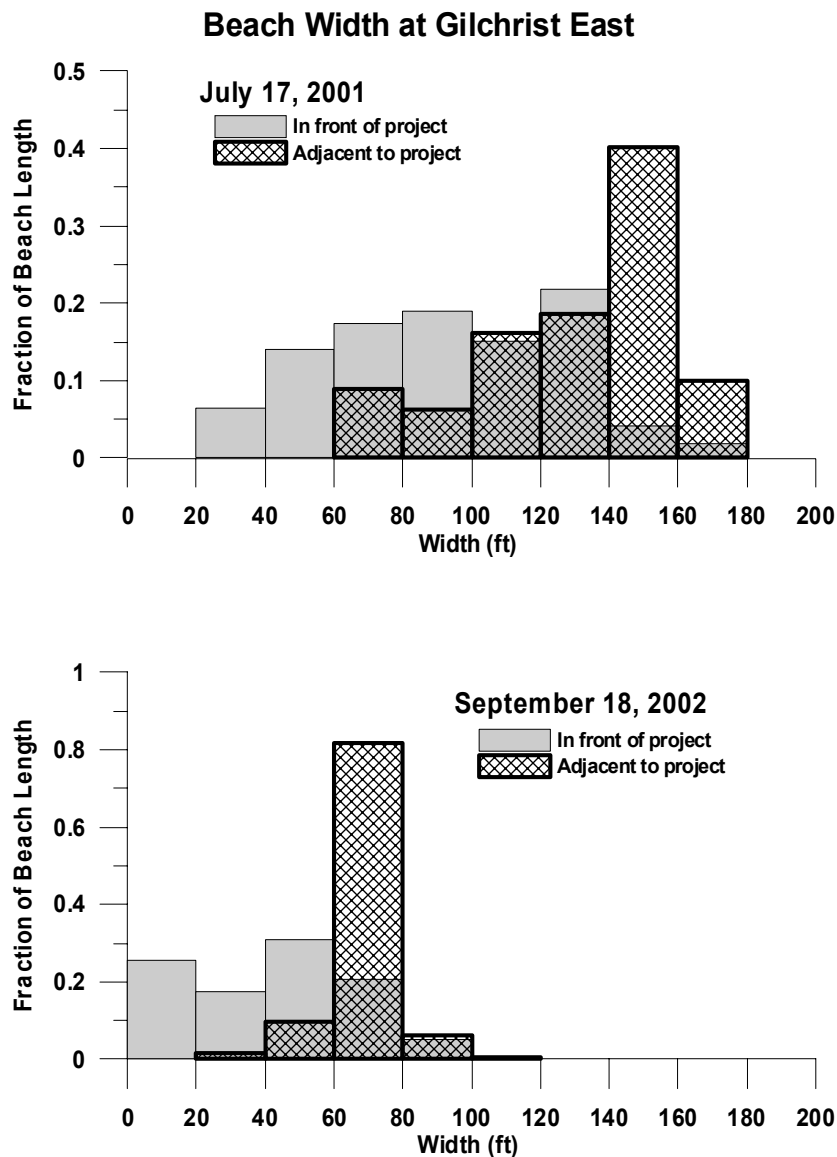
Figure 14. July 2001 and September 2002 beach width comparisons shown as fractions of beach length in front of and adjacent to the Gilchrist East (Gilchrist) geotextile tubes.

Along Galveston Island and Bolivar Peninsula, beaches in front of the geotextile tubes are narrower than adjacent beaches (Figs. 14 through 19, Tables 4 and 5). This is because of where the tubes were originally installed and because of shoreline retreat. Shoreline retreat will narrow the beaches in front of the tubes even more if there is not adequate beach nourishment. Tubes were installed farther seaward than the bluffs and foredune ridges on adjacent beaches (Fig. 8, Plates 1 and 2). The seaward edges of the foredune ridges and bluffs correspond with the continuous line of vegetation and are the natural geomorphic features that the geotextile tubes emulate. The continuous line of vegetation forms the landward boundary of the sparsely vegetated coppice mound environment where present and the landward boundary of the public beach easement. The placement of the tubes has created landward boundaries to the beaches that are more seaward than the relatively natural boundaries of adjacent beaches.

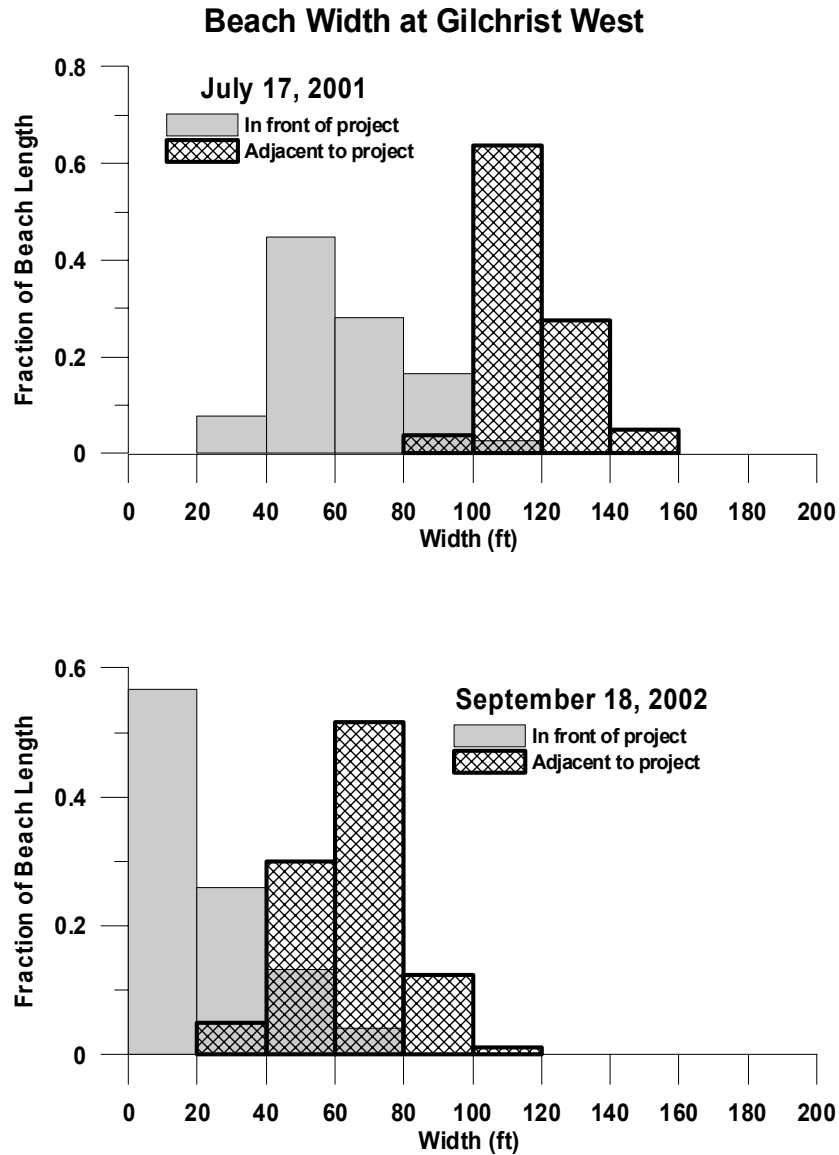
Figure 15. July 2001 and September 2002 beach width comparisons shown as fractions of beach length in front of and adjacent to the Gilchrist West (Caplen) geotextile tubes.

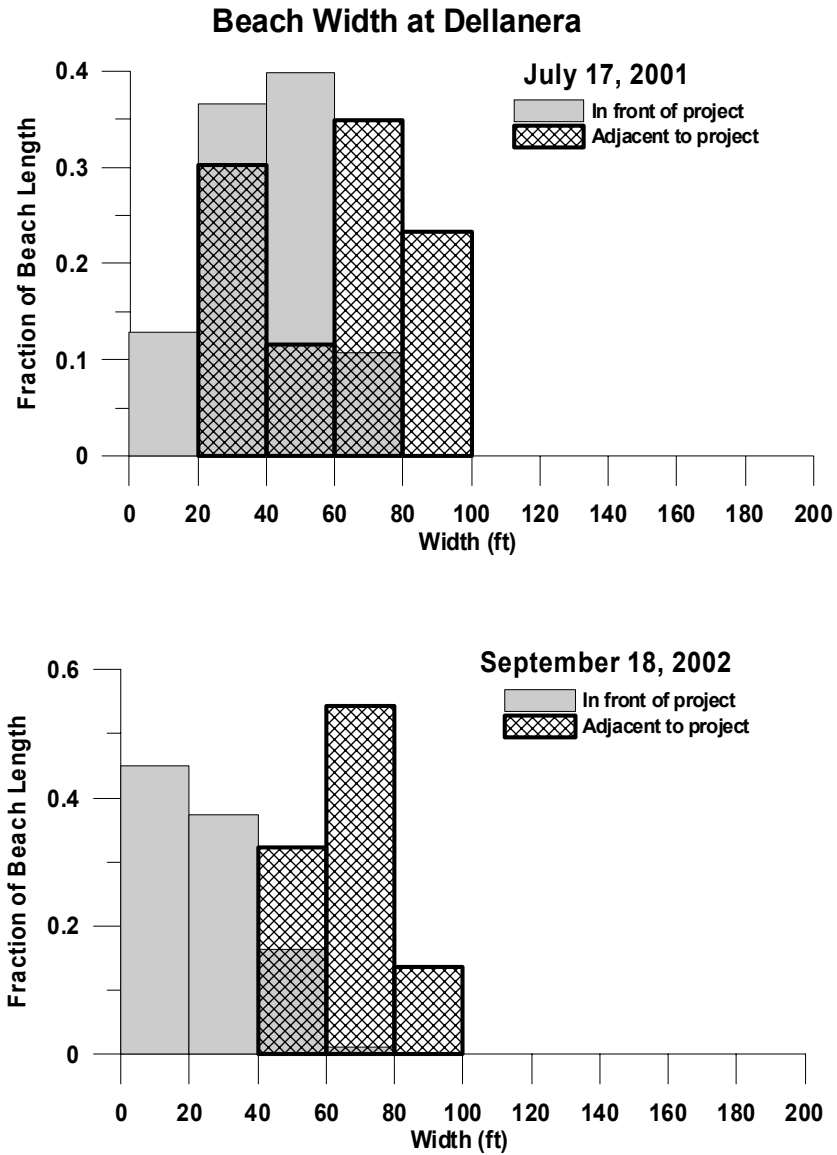
Figure 16. July 2001 and September 2002 beach width comparisons shown as fractions of beach length in front of and adjacent to the Dellanera geotextile tubes.

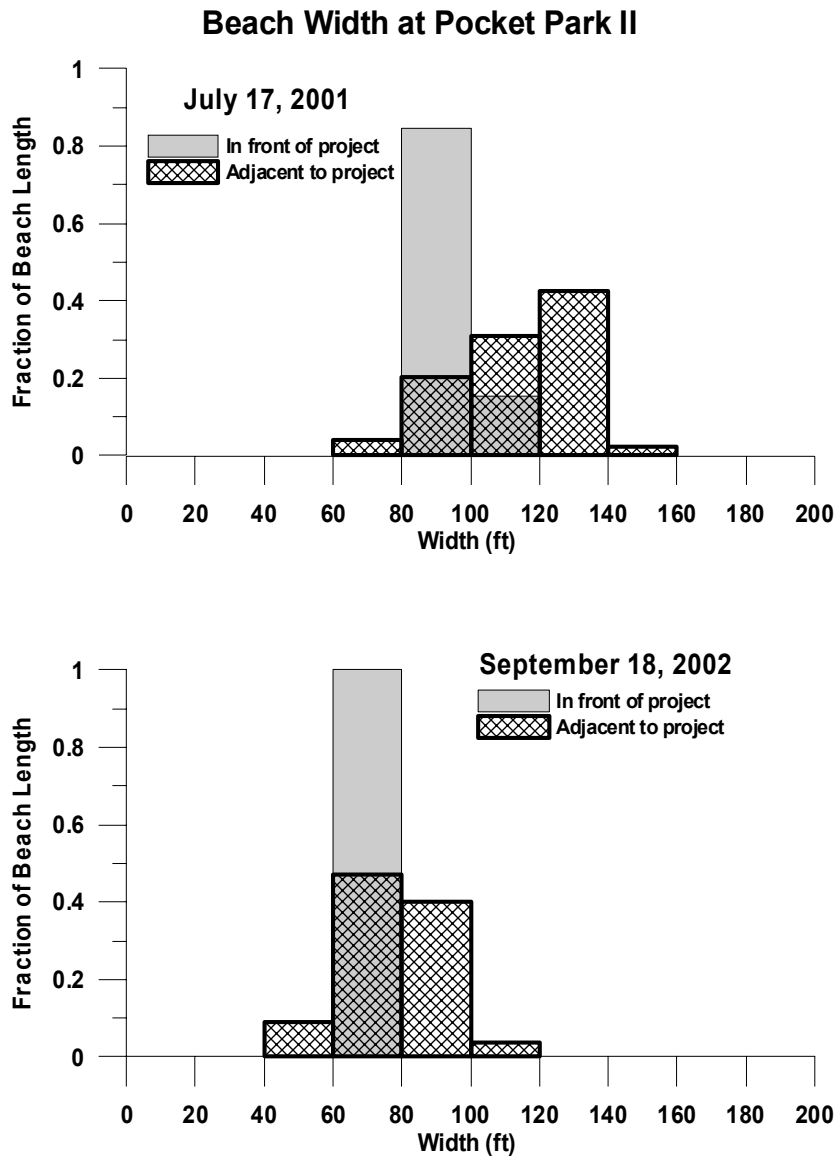
Figure 17. July 2001 and September 2002 beach width comparisons shown as fractions of beach length in front of and adjacent to the Pocket Park II geotextile tubes.

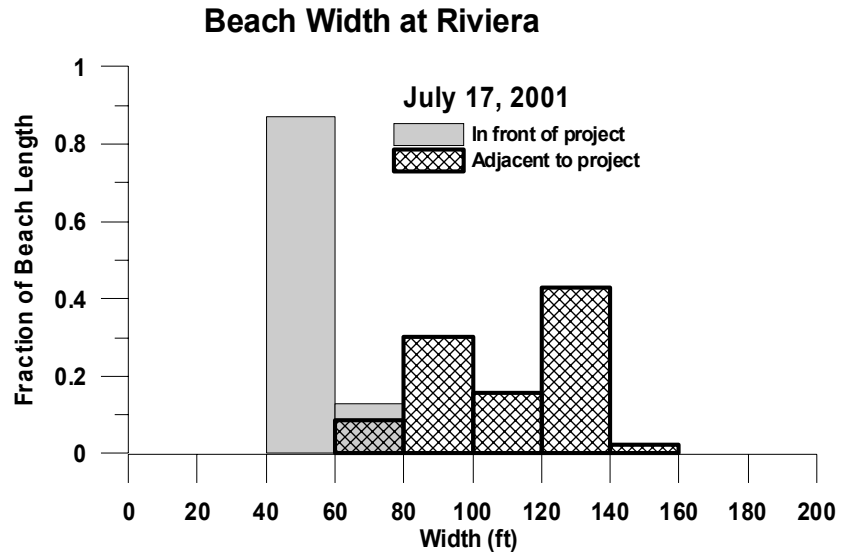
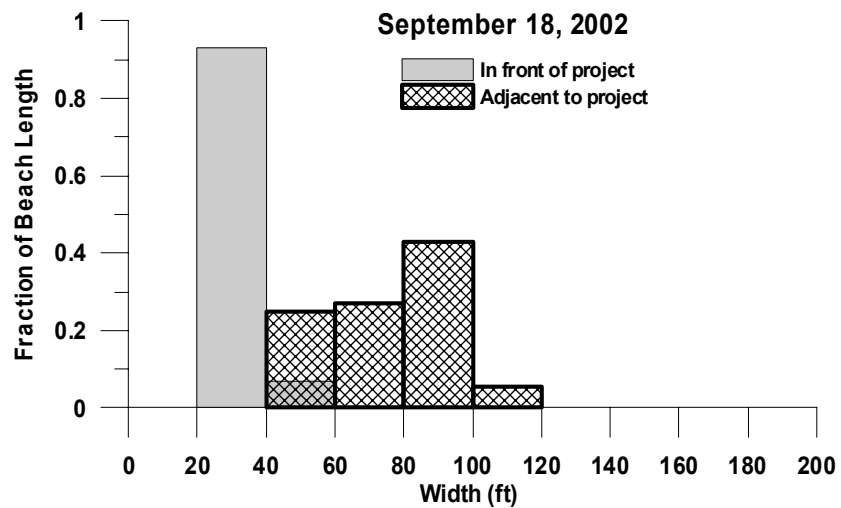
Figure 18. July 2001 and September 2002 beach width comparisons shown as fractions of beach length in front of and adjacent to the Riviera geotextile tubes.

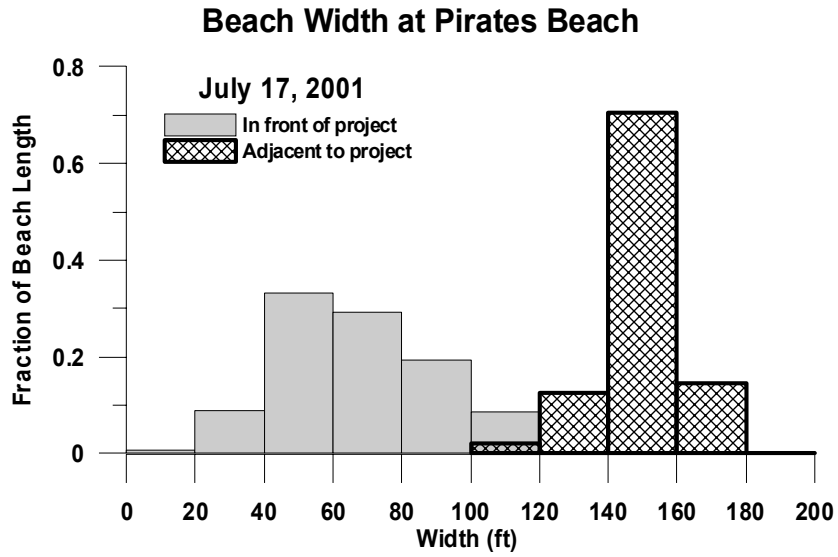
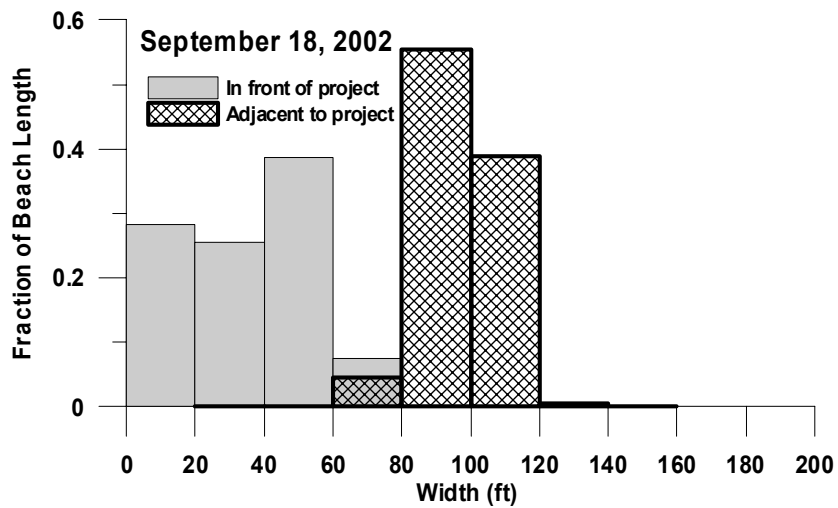
Figure 19. July 2001 and September 2002 beach width comparisons shown as fractions of beach length in front of and adjacent to the Pirates Beach geotextile tubes.

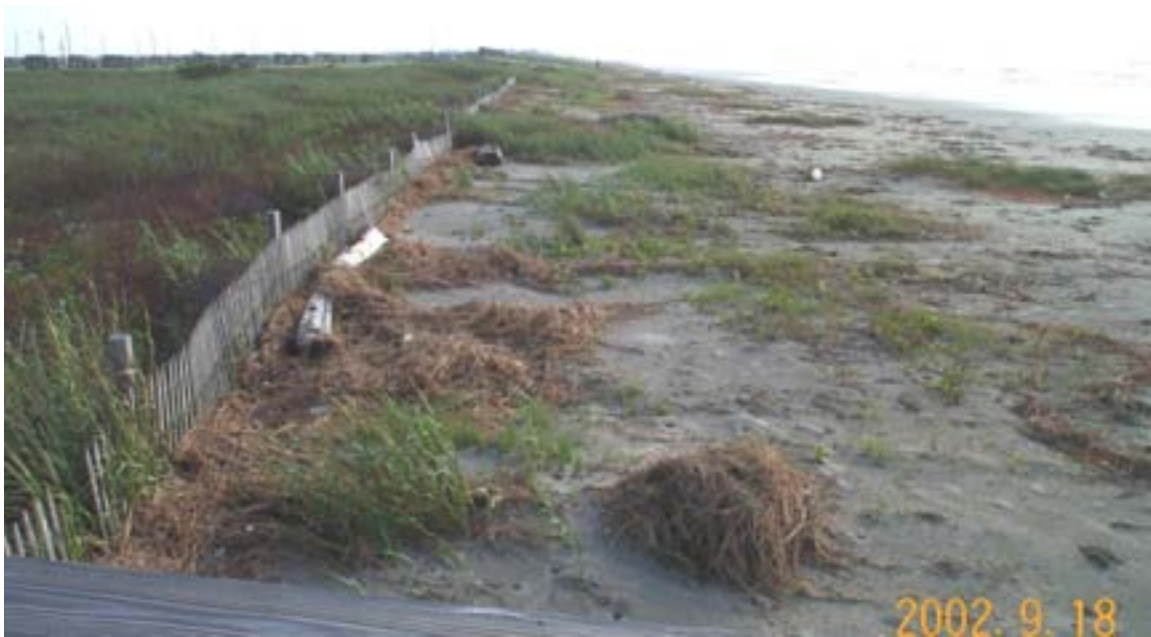
With regard to geomorphology, geotextile tubes are most congruent where they are placed in front of an eroding bluff such as along portions of the Gilchrist West project (see profile GLO20 in Appendix B). In most areas, however, the tubes have significantly altered the natural geomorphology and have prevented the formation of the coppice mound subenvironment (Fig. 31). This is the case even where the tubes are covered with vegetated sand (Fig. 27). The tubes rise abruptly from the back beach with relief of 1.6 to 6.6 ft (0.5 to 2 m) greater than the natural dune or bluff would (See GLO21 and GLO22 profiles in Appendix B). The covered tubes also lack the complex topography that natural dunes possess and in most places appear more like earthen dikes than wind-formed dunes (Figs. 28, 32 and Plates 1 and 2). If a beach is wide and high enough, vegetation will advance seaward from the dunes, trap wind-blown sand and form irregular and sparsely vegetated coppice mounds on the back beach (Fig. 31).

**Figure 31. Coppice mounds at GLO06 profile location in Galveston Island State Park on September 18, 2002 (see figure 6 for location). There is no geotextile tube at this location. This subenvironment of wind-blown sand and sparse vegetation was eroded but survived Tropical Storm Fay in September 2002. Coppice mounds do not exist or are poorly developed along beaches with geotextile tubes or where structures are on the back beach.**

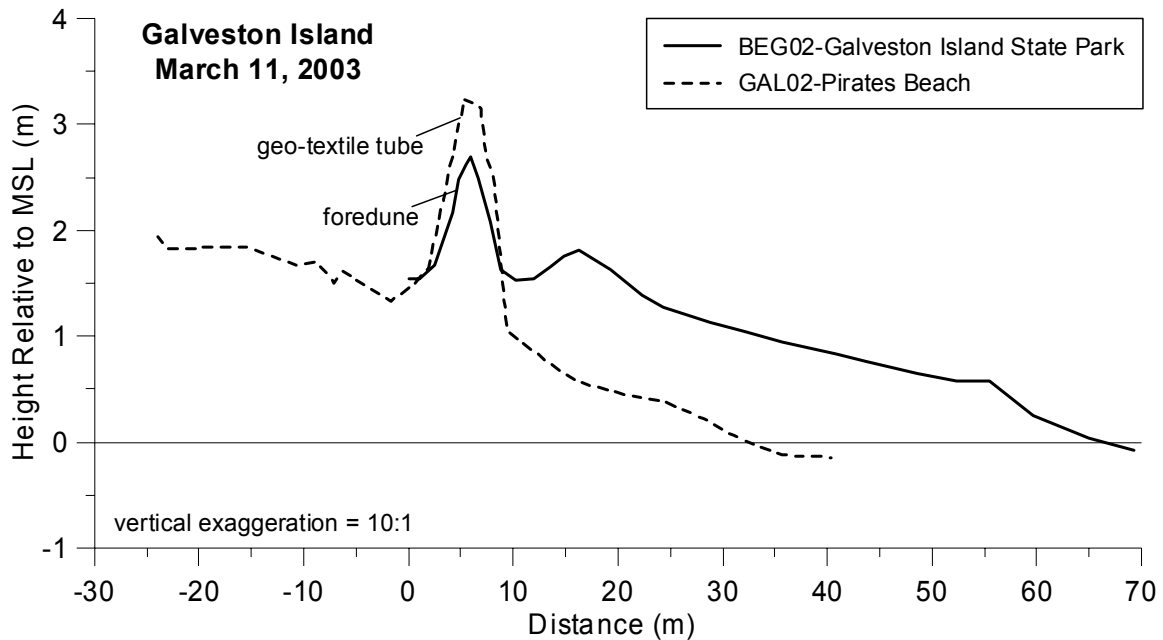
level. Figure 32 compares beach profiles from a Pirates Beach geotextile tube location and a relatively natural site at Galveston Island State Park in the early spring of 2003. The tube beach is about 3 ft (1 m) lower than the State Park beach. It is unlikely that the tube beach will naturally recover enough to allow coppice mounds to develop or to provide a recreational area equivalent to the State Park.

The profiles in figure 32 are lined up by shifting them horizontally so the foredune and geotextile tube coincide. This was done to emphasize the difference in the beach dimensions; however, it gives the impression that the shoreline is shifted landward at the tube location relative to the State Park. This is not the case. The shoreline along Pirates Beach is generally in a position congruent with the adjacent beaches. However, the geotextile tubes were installed seaward of the adjacent foredune positions which has caused a narrower beach at Pirates Beach. The same situation exists at the other projects; therefore, the primary reason for the geotextile tube beaches being narrower than adjacent beaches during the study period is the original placement of the tubes. This is apparent on the maps of plates 1 and 2 where one can see that the 2000, 2001, and 2002 shorelines are not offset alongshore but that the tubes are set seaward of the adjacent foredunes or bluffs.

**Figure 32. Comparison of beach profiles BEG02 with no geotextile tube and GAL02 in the Pirates Beach geotextile tube project (see Fig. 6 for locations). Profiles are adjusted horizontally to line up the foredune and geotextile tube (see Figs. 33 and 34 for photos).**

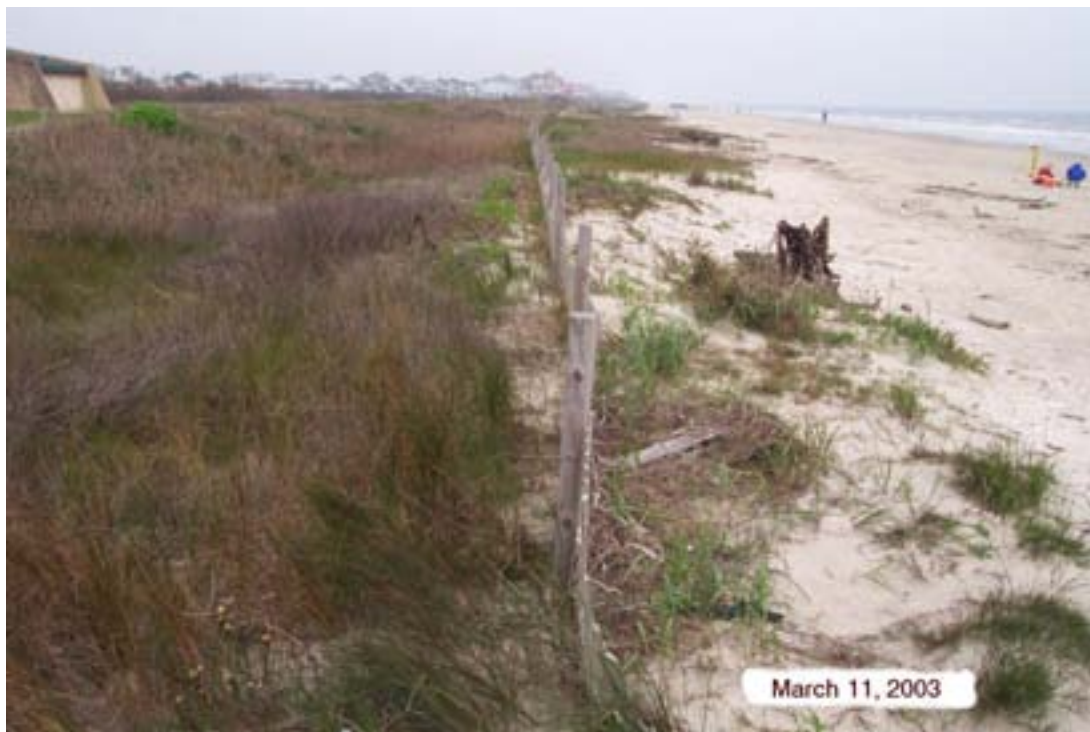
**Figure 33. BEG02 beach profile location in Galveston Island State Park on March 11, 2003. No geotextile tube is at this location. Coppice mounds are present seaward of the sand fence and there is room on the back beach for further mound develop during the summer. This is in contrast to the setting in front of the Pirates Beach tube project shown in figure 34 (see Fig. 6 for location and Fig. 32 for beach profile).**
