# GEOTUBES ALONG THE GULF SHORELINE OF THE UPPER TEXAS COAST: OBSERVATIONS DURING 2001

James C. Gibeaut, Tiffany L. Hepner, Rachel Waldinger, John R. Andrews,  
Rebecca C. Smyth, Roberto Gutierrez

A Report of the Texas Coastal Coordination Council pursuant to National Oceanic  
and Atmospheric Administration Award No. NA97OZ0179  
GLO Contract Number 01-597 R

March 2002

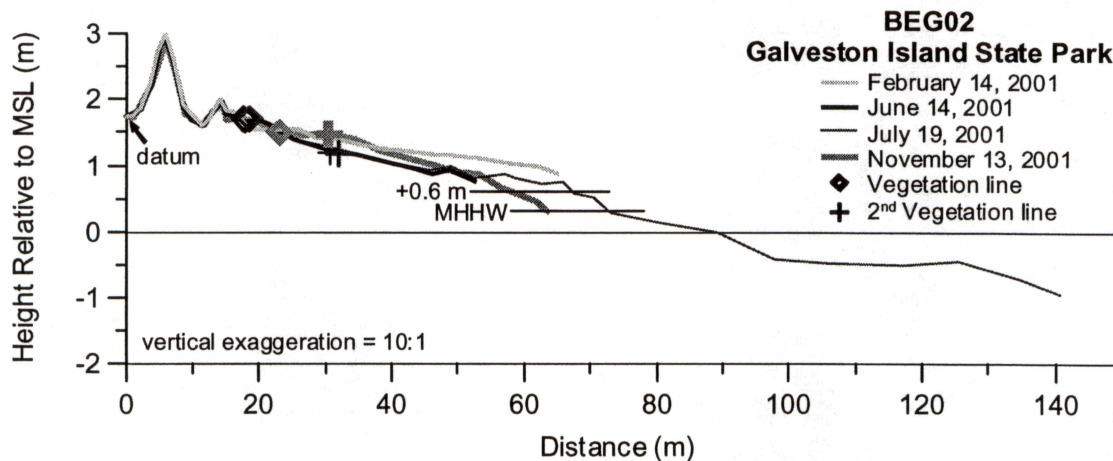
Figure 11. Beach profiles at Galveston Island State Park, location BEG02 (see Fig. 6 for location). The foredune and incipient dune seaward of the foredune survived Tropical Storm Allison in early June, 2001.

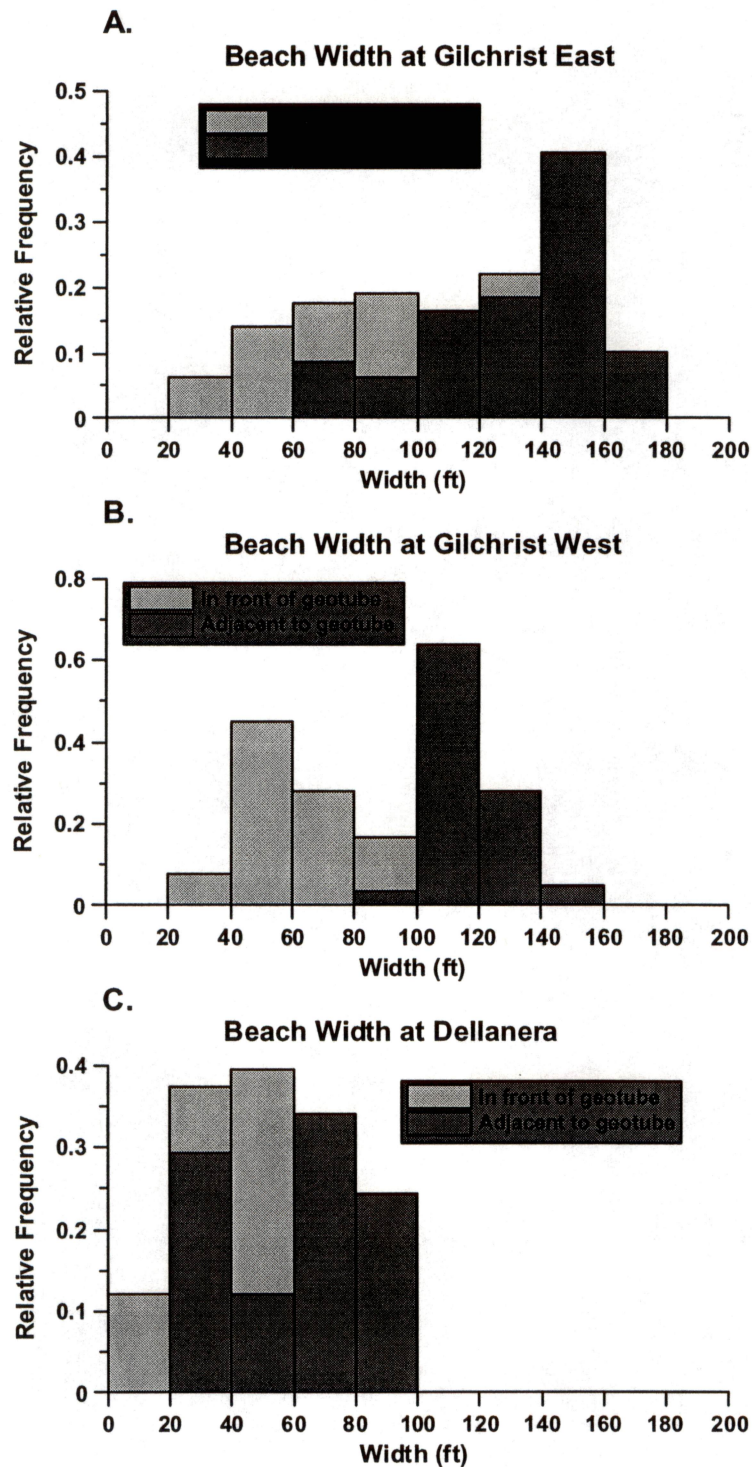
Visual inspection of the 1.97 ft (0.6 m) MSL contour line and back beach elevation on the topographic lidar images (Plates 1 and 2) show that the geotubes have not affected the erosion rates of adjacent beaches. If adjacent beaches were being affected, we would expect to see a decrease in the effect with distance from the geotubes. The morphologies and elevations of the back beach and fore beach portions of the beach profile, however, are similar for sections immediately adjacent to the geotubes and for beaches more distal to the geotubes.

Figure 12. July 2001 beach width comparison shown as relative frequency of transects spaced every 16.4 ft (5 m) alongshore in front of and adjacent to the designated geotubes: (A) Gilchrist east; (B) Gilchrist west; (C) Dellanera.

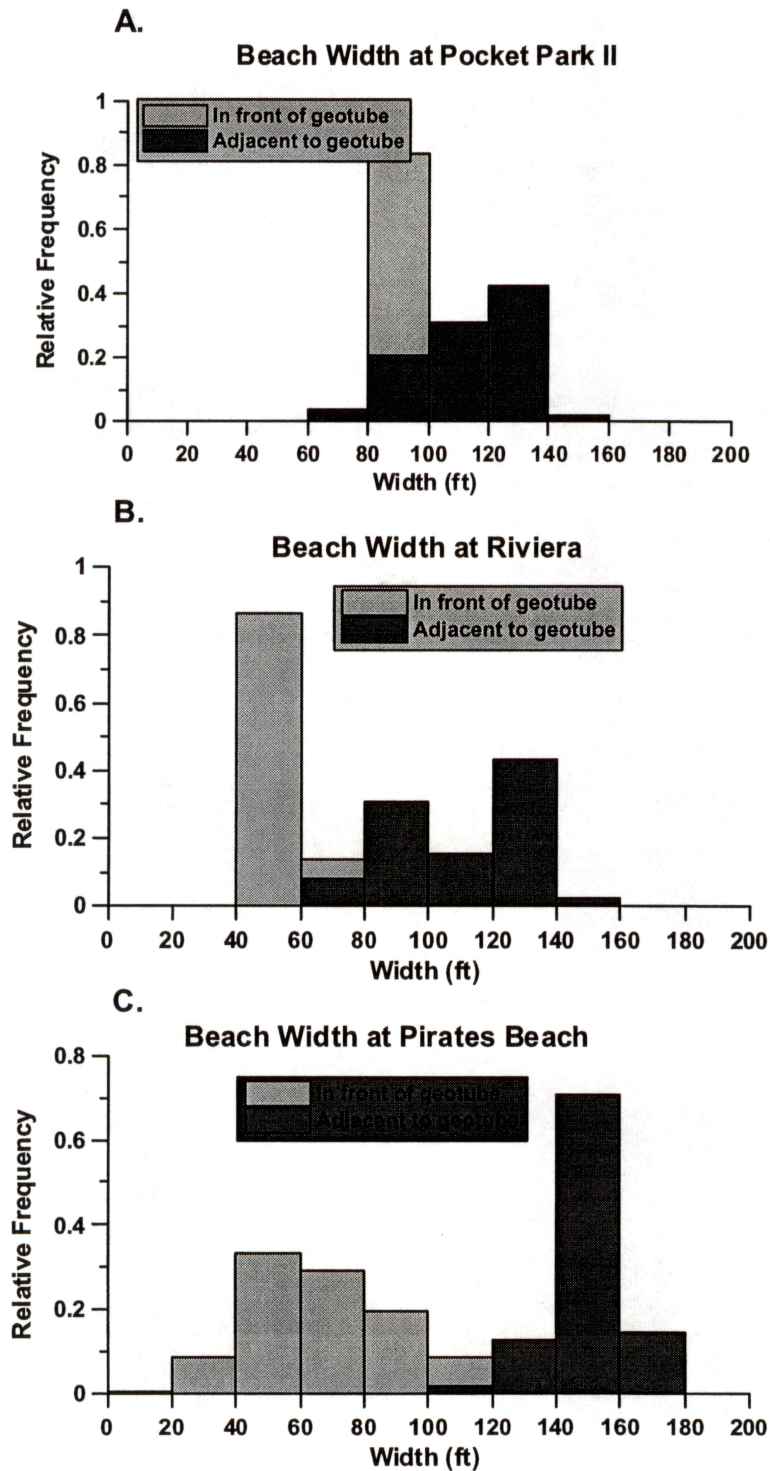
Figure 13. July 2001 beach width comparison shown as relative frequency of transects spaced every 16.4 ft (5 m) alongshore in front of and adjacent to the designated geotubes: (A) Pocket Park II; (B) Riviera; (C) Pirates Beach.

Along Galveston Island and Bolivar Peninsula, beaches in front of the geotubes are narrower than adjacent beaches (Figs. 12 and 13, Table 3). This is primarily because of where the geotubes were installed and not because of shoreline retreat, although shoreline retreat will narrow the geotube beaches even more if there is not adequate beach nourishment. Geotubes were placed farther seaward than the bluffs and foredune ridges on adjacent beaches (Fig. 8, Plates 1 and 2). The seaward edges of the foredune ridges and bluffs correspond with the line of vegetation and also are the natural geomorphic features that the geotubes emulate. The placement of the geotubes has created landward boundaries to the beaches that are more seaward than the relatively natural boundaries of adjacent beaches. Some geotube segments were routed seaward of

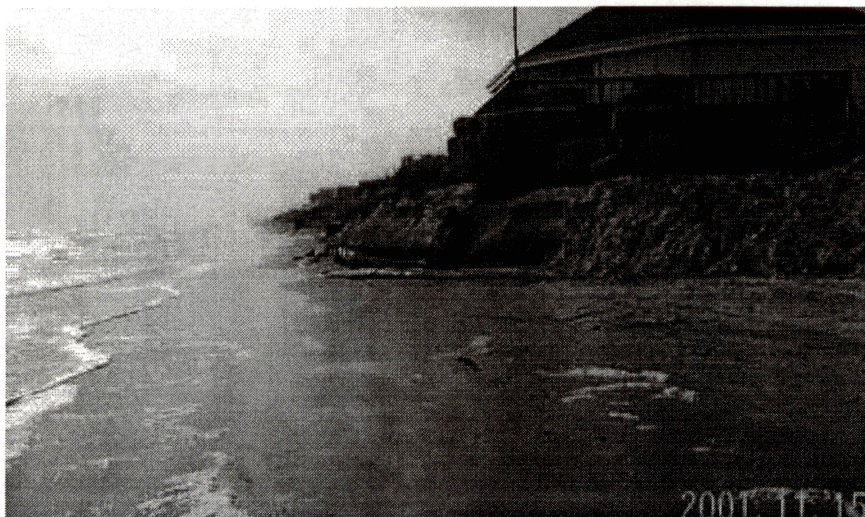
individual houses or groups of houses (Fig. 17, Plates 1 and 2). These areas create particularly narrow beaches that are not passable during times of moderately elevated water levels (1 to 2 ft above MHHW) (Fig. 18). Furthermore, outflow from the drainage pipes along the Pirates Beach project erode channels perpendicular to the shoreline that at times hinder passage (Fig. 19). These drainage pipes, which concentrate flow through the geotubes, are required to prevent flooding from rainfall landward of the geotube.

**Figure 18. Pirates Beach geotube on November 15, 2001. Geotube at this location was routed seaward of the house causing a particularly narrow beach and difficulty in maintaining a sand cover on the geotube. Water level was about 2.0 ft (0.61 m) above mean sea level.**
