FINAL REPORT

Geotextile Tubes along the Upper Texas Gulf Coast

May 2000 to March 2003

Bureau of Economic Geology

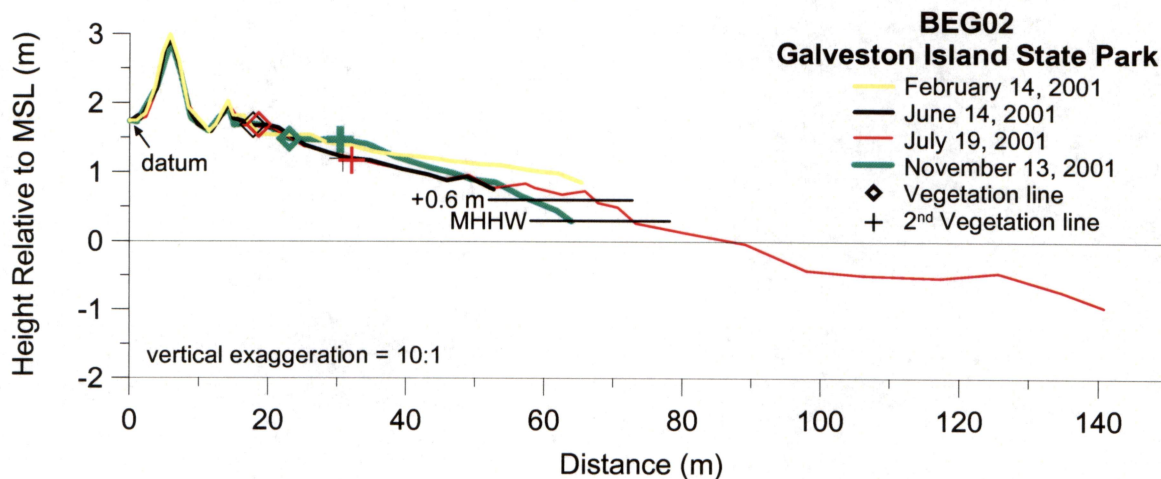
Figure 11. Beach profiles at Galveston Island State Park, location BEG02 (see Fig. 6 for location). The foredune and incipient dune seaward of the foredune survived Tropical Storm Allison in early June, 2001.

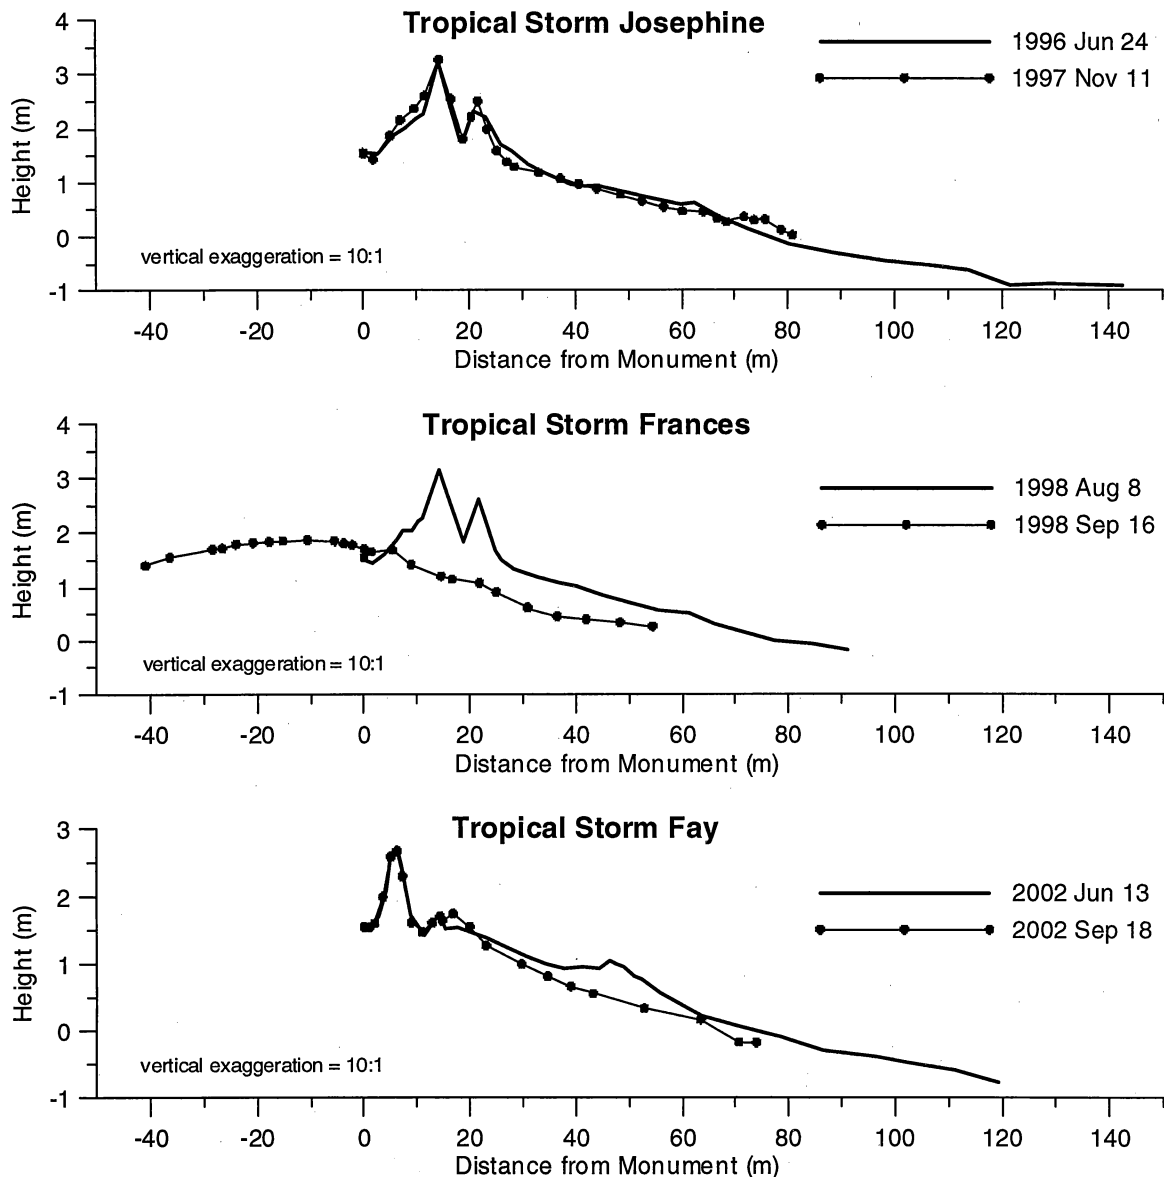
Beach profiles from the relatively natural BEG-02 beach profile site, gives an indication of the relative severity of erosion caused by Tropical Storms Josephine, Frances, and Fay (Fig. 13). Josephine caused the seaward-most vegetation line to retreat 9 m, but an incipient foredune survived and the primary foredune was untouched. Frances, on the other hand, flattened the incipient dune and foredune and washed over and deposited sand on the back barrier. Frances caused the vegetation line to retreat 20 m. Changes caused by Fay were very similar to those caused by Josephine. A foredune and incipient dune that reformed following Frances in 1998 survived Fay in 2002. Fay partially eroded coppice mounds seaward of a sand fence, but the seaward-most vegetation line did not change position and the vegetation line defining where the vegetation becomes essentially continuous landward retreated only about 8 m (Fig. 13 and BEG02 profiles and photos in Appendix B).

Figure 13. BEG-02 beach profiles from Galveston Island State Park where no geotextile tubes are present (see Fig. 6 for location). Profiles show changes before and after major storms. Tropical Storm Fay caused the same degree of change as Josephine, but Frances completely eroded the foredunes.

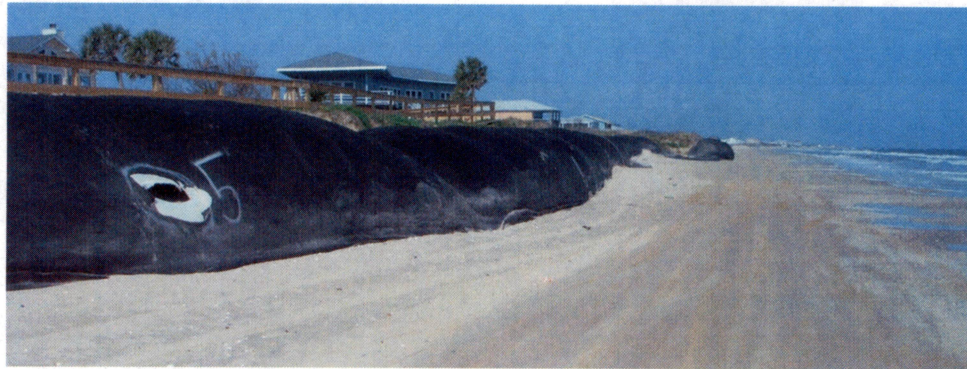
Figure 23. Slumped and collapsed geotextile tube with patched hole near east end of Gilchrist West project (in Caplen) on March 10, 2003. Note completely collapsed section in distance where tube turns seaward.

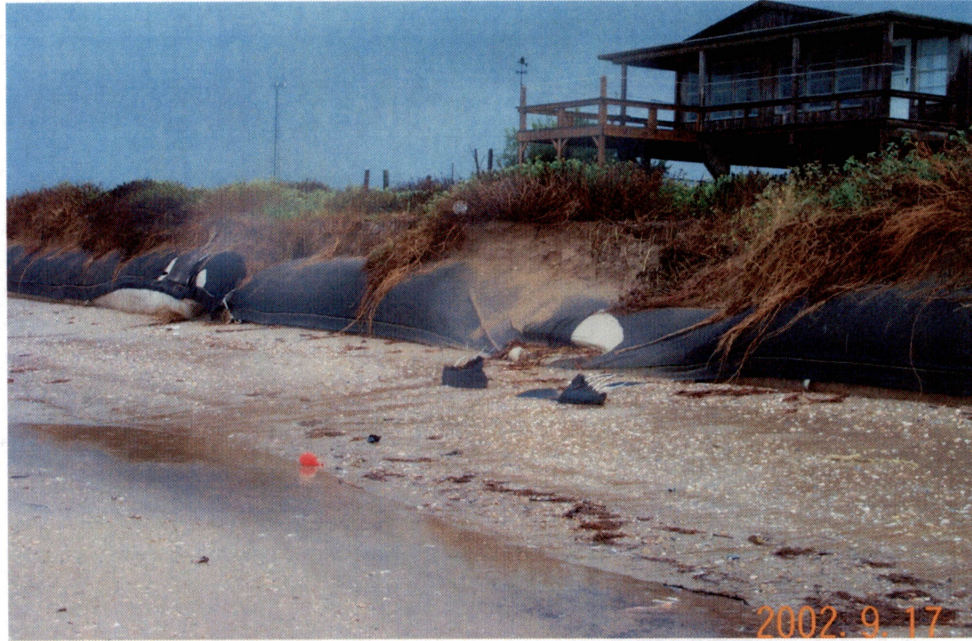
Figure 24. Collapsed geotextile tube section along west end of Gilchrist West project on September 17, 2002 after Tropical Storm Fay.

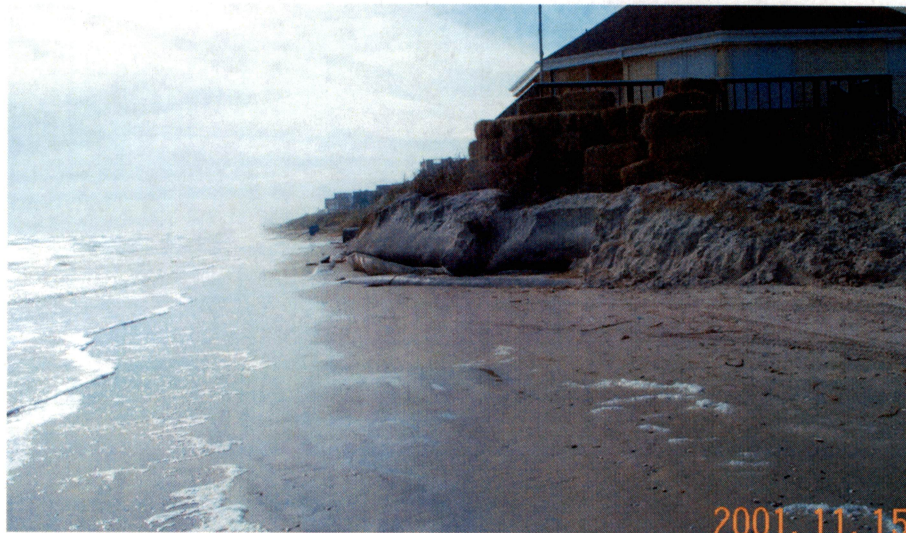
Some tube segments were routed seaward of individual houses or groups of houses (Figs. 28, 29, Plates 1 and 2). These areas create particularly narrow beaches that are not passable during times of moderately elevated water levels (1 to 2 ft above MHHW) (Fig. 28). Furthermore, outflow from the drainage pipes along the Pirates Beach project erode channels perpendicular to the shoreline that at times hinder passage (Fig. 30). These drainage pipes, which concentrate flow through the tubes, are required to prevent flooding from rainfall landward of the tubes.

Figure 28. Pirates Beach geotextile tube on November 15, 2001. The tube at this location was routed seaward of the house causing a particularly narrow beach and difficulty in maintaining a sand cover. Water level was about 1 ft (0.3 m) above mean higher high water.

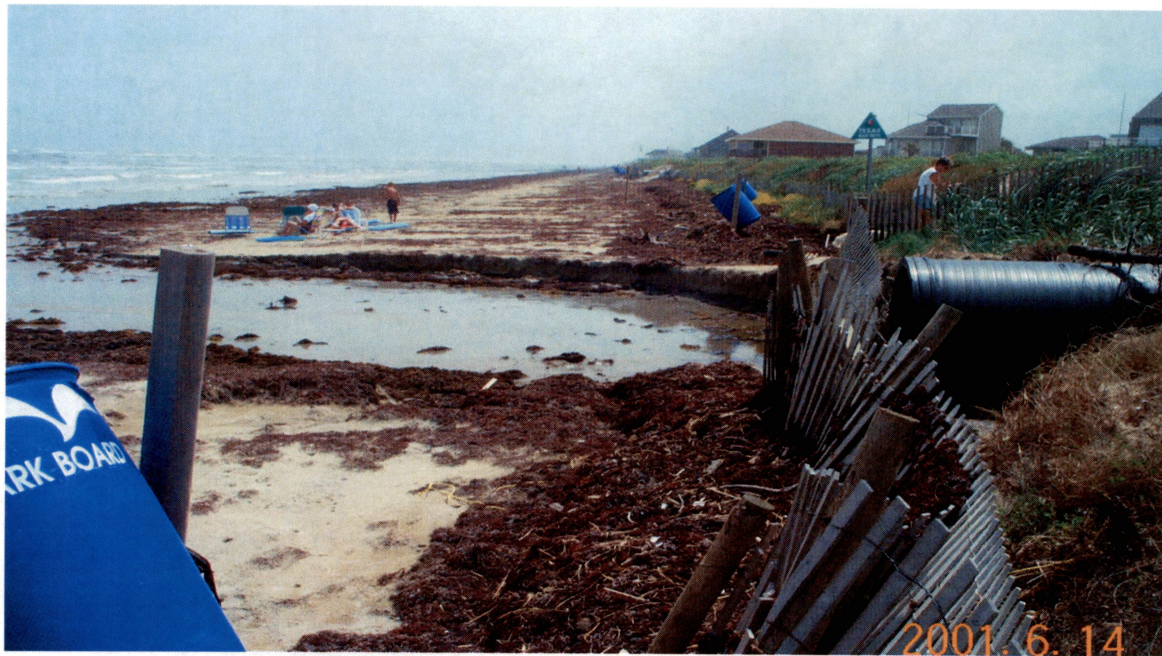
Figure 30. Pirates Beach geotextile tube project on June 14, 2001 after Tropical Storm Allison. Rainfall runoff from Allison flowed through the black street drainage pipe beneath the tube on the right and eroded this channel in the beach.

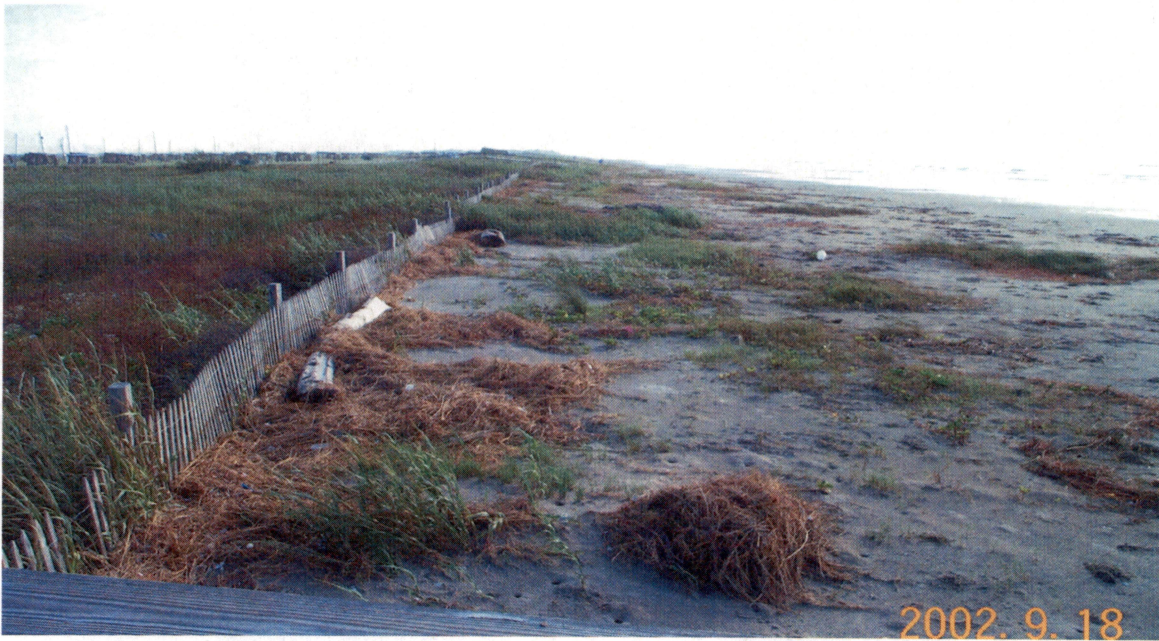
Figure 31. Coppice mounds at GLO06 profile location in Galveston Island State Park on September 18, 2002 (see figure 6 for location). There is no geotextile tube at this location. This subenvironment of wind-blown sand and sparse vegetation was eroded but survived Tropical Storm Fay in September 2002. Coppice mounds do not exist or are poorly developed along beaches with geotextile tubes or where structures are on the back beach.

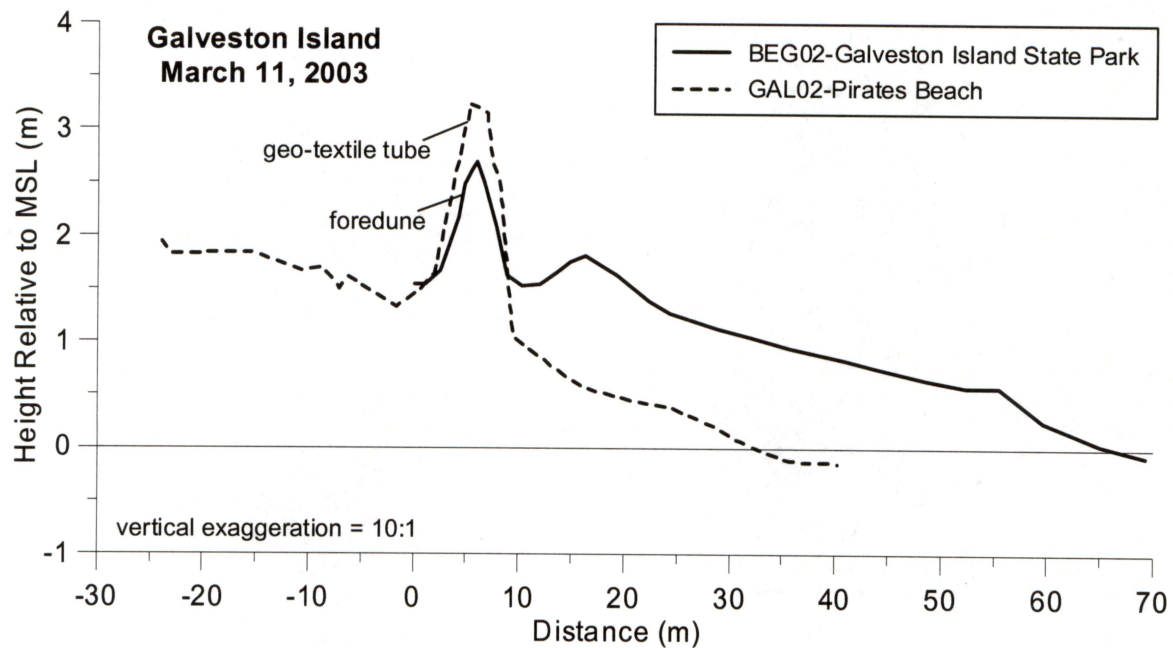
level. Figure 32 compares beach profiles from a Pirates Beach geotextile tube location and a relatively natural site at Galveston Island State Park in the early spring of 2003. The tube beach is about 3 ft (1 m) lower than the State Park beach. It is unlikely that the tube beach will naturally recover enough to allow coppice mounds to develop or to provide a recreational area equivalent to the State Park.

The profiles in figure 32 are lined up by shifting them horizontally so the foredune and geotextile tube coincide. This was done to emphasize the difference in the beach dimensions; however, it gives the impression that the shoreline is shifted landward at the tube location relative to the State Park. This is not the case. The shoreline along Pirates Beach is generally in a position congruent with the adjacent beaches. However, the geotextile tubes were installed seaward of the adjacent foredune positions which has caused a narrower beach at Pirates Beach. The same situation exists at the other projects; therefore, the primary reason for the geotextile tube beaches being narrower than adjacent beaches during the study period is the original placement of the tubes. This is apparent on the maps of plates 1 and 2 where one can see that the 2000, 2001, and 2002 shorelines are not offset alongshore but that the tubes are set seaward of the adjacent foredunes or bluffs.

Figure 32. Comparison of beach profiles BEG02 with no geotextile tube and GAL02 in the Pirates Beach geotextile tube project (see Fig. 6 for locations). Profiles are adjusted horizontally to line up the foredune and geotextile tube (see Figs. 33 and 34 for photos).

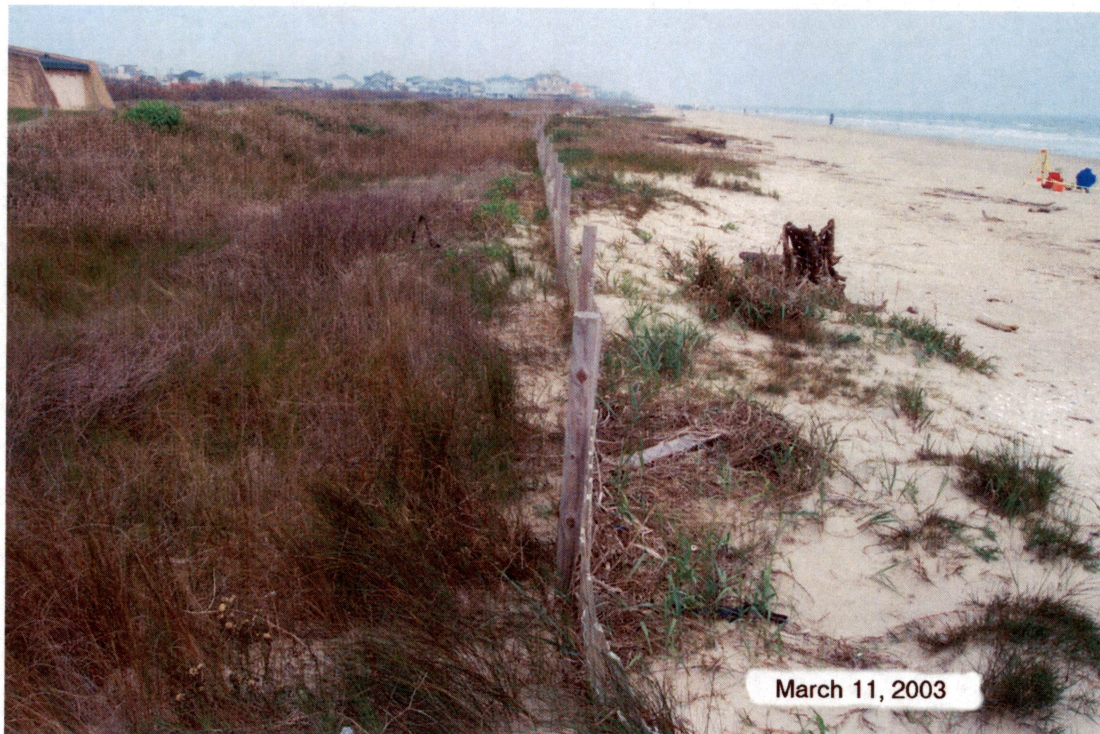
Figure 33. BEG02 beach profile location in Galveston Island State Park on March 11, 2003. No geotextile tube is at this location. Coppice mounds are present seaward of the sand fence and there is room on the back beach for further mound develop during the summer. This is in contrast to the setting in front of the Pirates Beach tube project shown in figure 34 (see Fig. 6 for location and Fig. 32 for beach profile).
