Ranking of TxDOT Maintenance Sections with Shallow Injection Wells
for Prioritizing Remedial Investigations

Final Topical Report

Texas Department of Transportation

February 1997
Revised July 1997

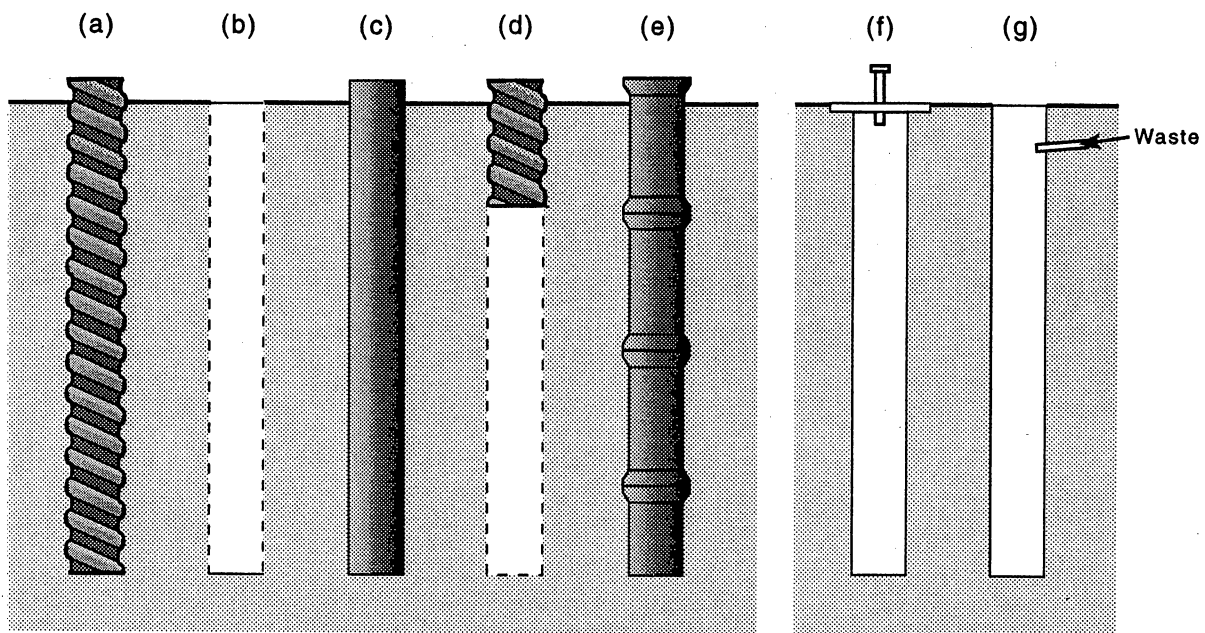
Figure 3. Construction materials and well completions used in TxDOT injection wells. Construction materials: (a) metal culvert pipe, (b) open hole (no casing), (c) steel casing, (d) metal culvert pipe from ground surface to some depth and open hole (no casing) at greater depth, and (e) cement culvert pipe. Well completions: (f) waste poured through a 3-inch-diameter above-ground pipe, and (g) waste piped underground through a 3-inch-diameter flow line from the maintenance building.

We found a variety of construction techniques for the injection wells at maintenance sections. Wells were completed with a variety of materials—metal or cement culvert pipe, and steel casing—or left open hole; some completions used a combination of materials (fig. 3). Well depth and diameter were estimated by 35 maintenance sections (Scott and Dutton, 1996). Reported well depth and diameter averaged 22 ft and 31 inches, respectively. Reported well depth ranged from 3 to 40 ft and well diameter ranged from 16 to 120 inches. Oil waste wells, wash rack waste wells, and asphalt waste wells were constructed using the same kinds of materials (fig. 3) and so do not differ in typical well depth and diameter. Waste fluid (asphalt, oil, or water) was found standing in some injection wells during site visits; maintenance sections at which standing waste fluid was found are identified in table 1 (column labeled well fluid). Additional findings from the questionnaires are summarized in Scott and Dutton (1996).

Only 7 maintenance sections (<12 percent of the ranked sections) received a higher score than the Brownfield maintenance section. The Brownfield maintenance section has 2 abandoned waste oil injection wells. Both are open-hole injection wells (fig. 3b), 36 inches in diameter and 30 ft in depth. Mainly waste oil was discharged into one injection well located at the southwest corner of the warehouse; fluids were pumped out and the well was backfilled with dirt in the mid-1980's and is now covered over. The second injection well, located at the southeast corner of the property, was used for disposal of asphalt, diesel fuel, and kerosene solvents used to clean asphalt from vehicles. This injection well may have

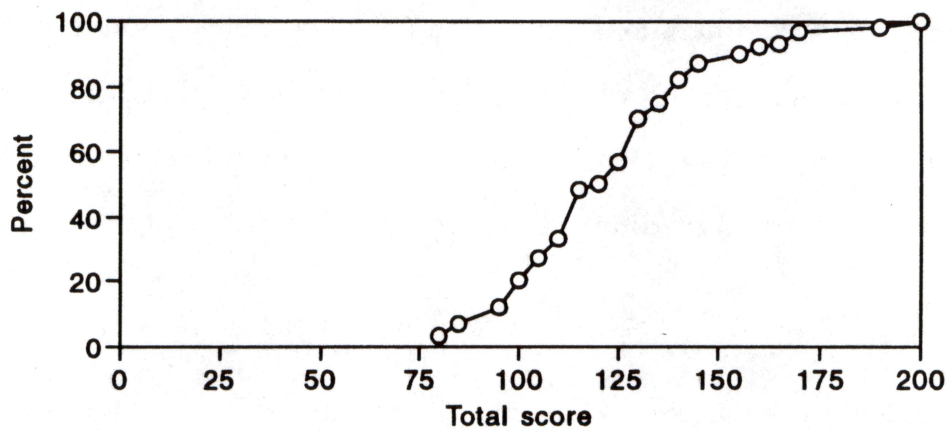
Figure 4. Cumulative distribution of total score for maintenance sections calculated from 13 environmental ranking criteria.

The 59 sections confirmed to have one or more injection well were selected for prioritization using the 13 environmental ranking criteria. The results of the prioritized ranking are given in table 2, which includes total scores and scores for each of the 13 environmental ranking criteria. Total score ranged from a high of 200 for the first-ranked Gruver maintenance section (section number 10) to a low of 80 for the Groom maintenance section (section number 18), both in the Amarillo District (table 2). The top-ranked 10 percent of the maintenance sections (total of 7 sections) have scores greater than 155 (fig. 4). The remaining 90 percent of the

ranked maintenance sections have scores between 80 and 155. The 59 maintenance sections were assigned a relative rank from 1 to 19 on the basis of total score. Several maintenance sections received the same total score and thus tied for a given rank.

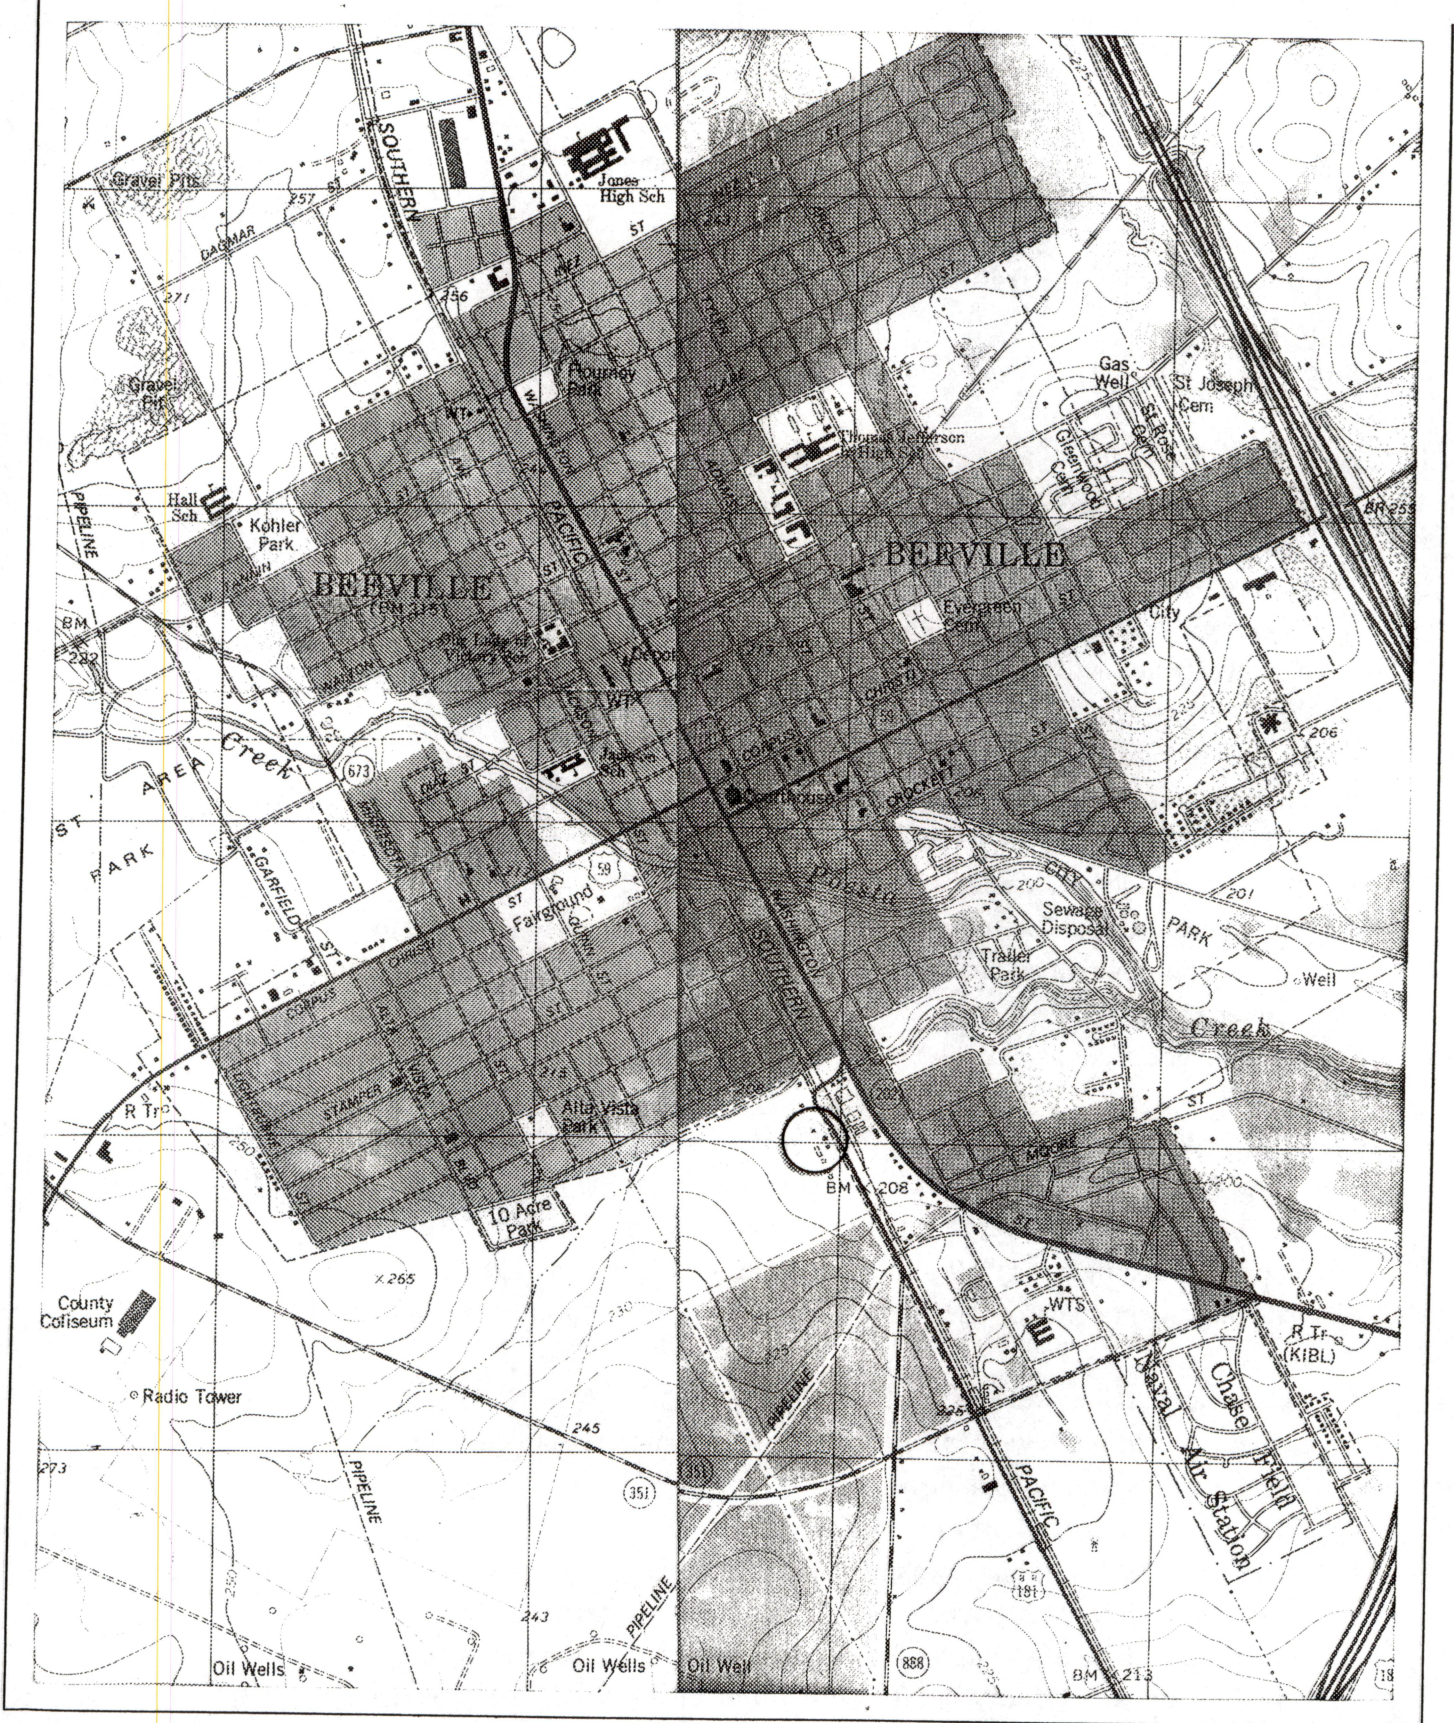
Figure 1. Location of the Beeville maintenance section (02), Bee County, Corpus Christi District.

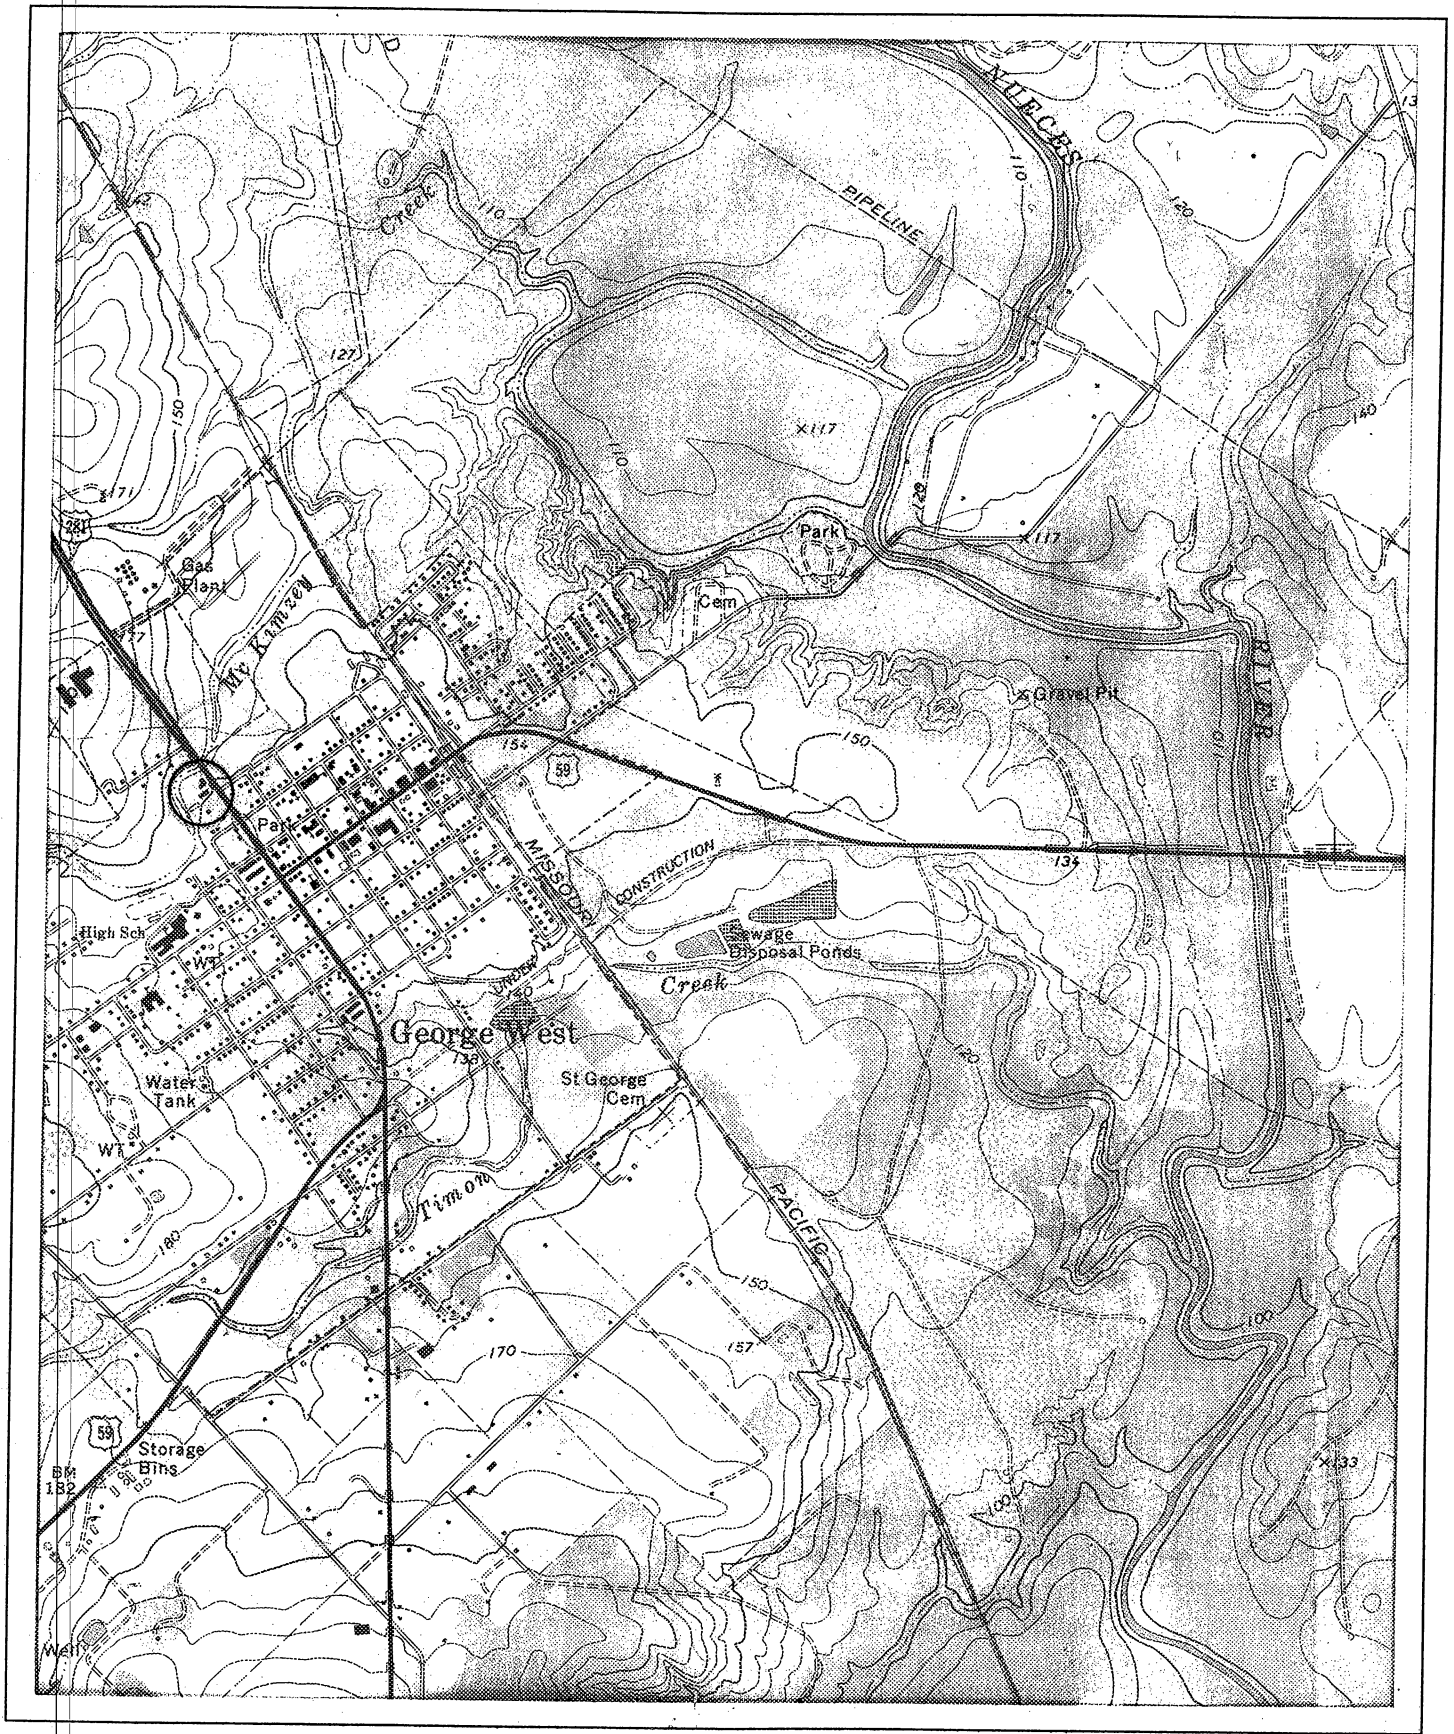
Figure 1. Location of the George West maintenance section (04), Live Oak County, Corpus Christi District.

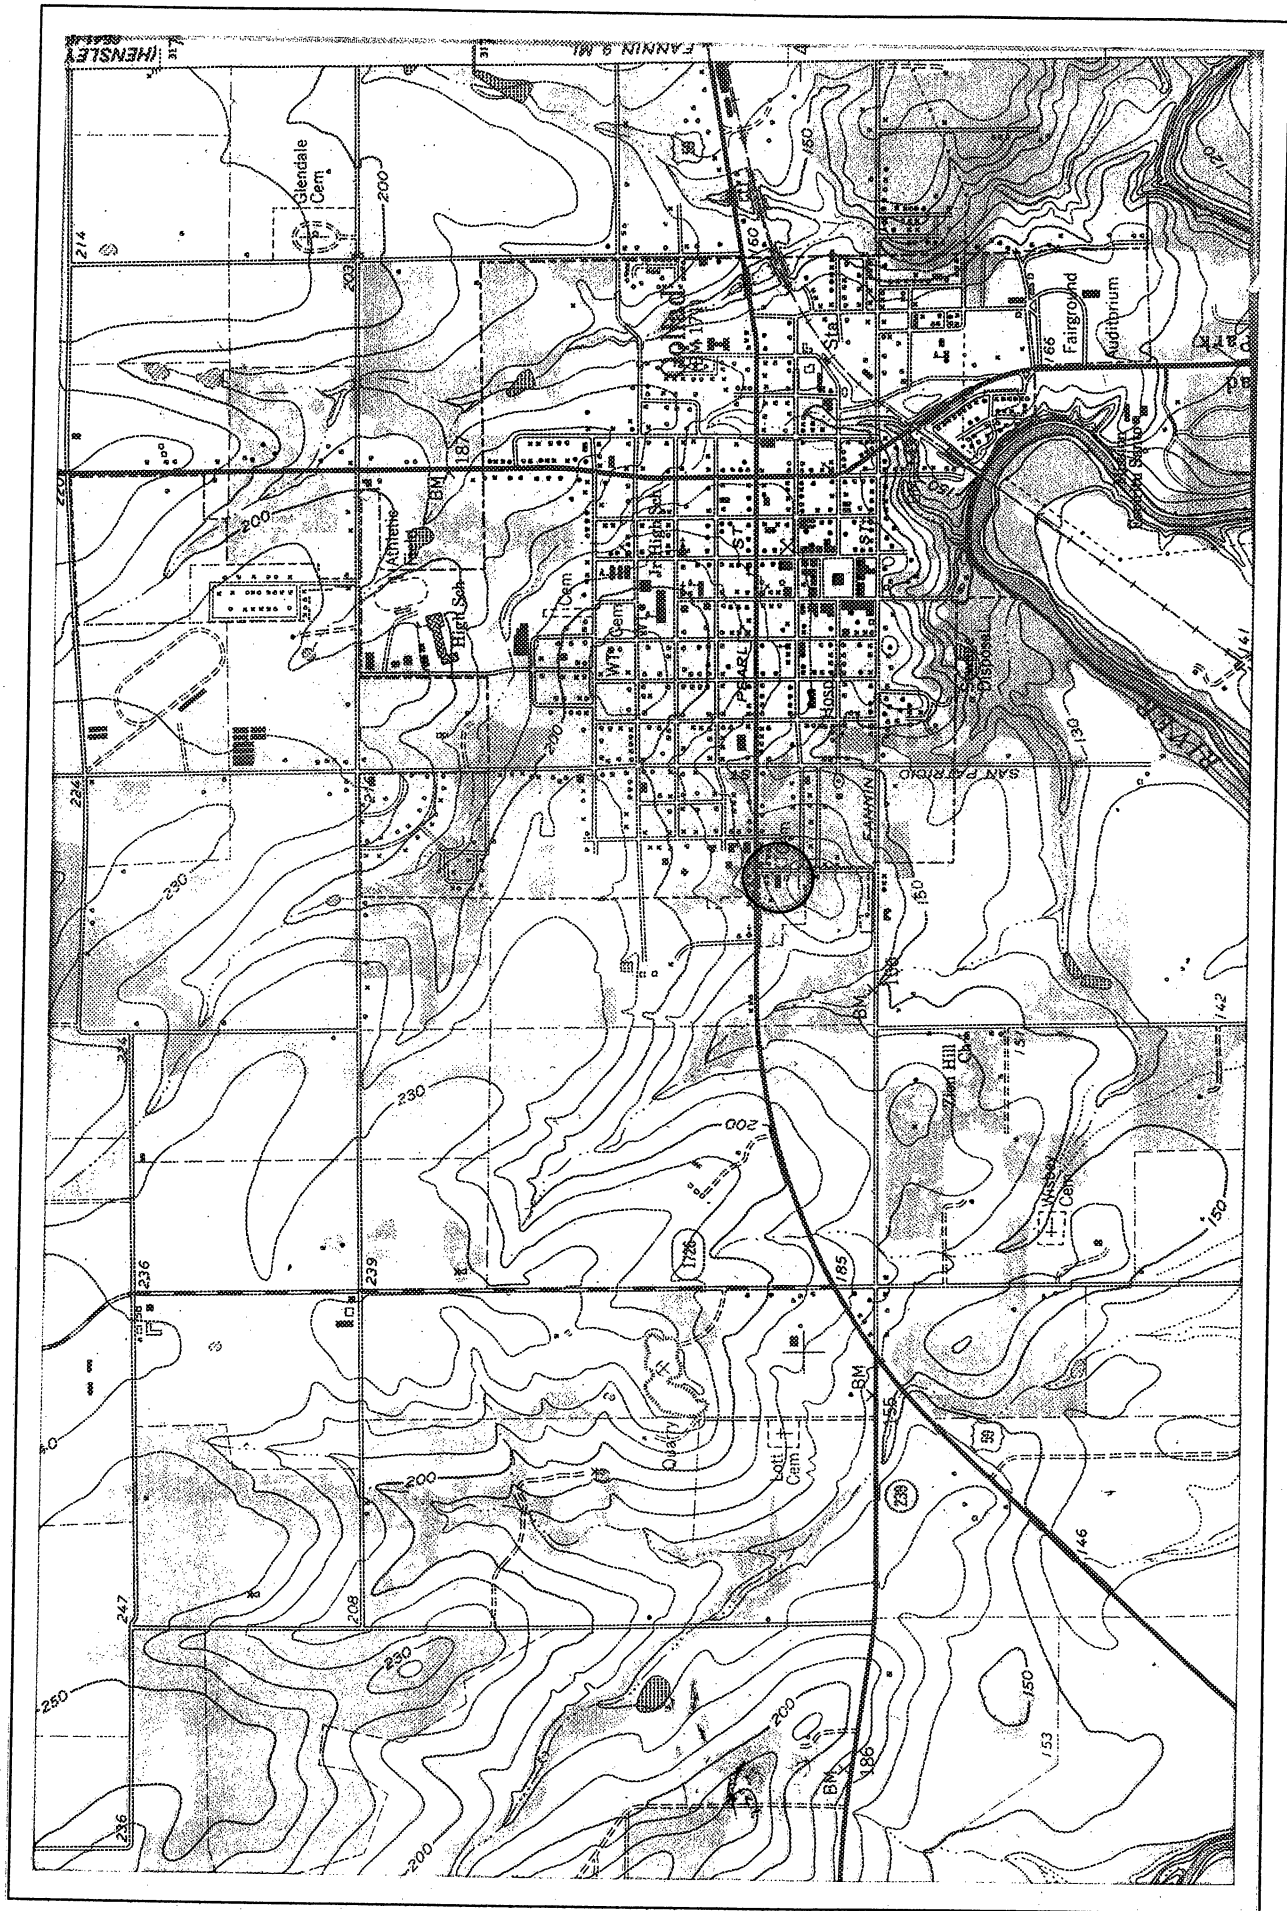
Figure 1. Location of the Goliad maintenance section (05), Goliad County, Corpus Christi District.

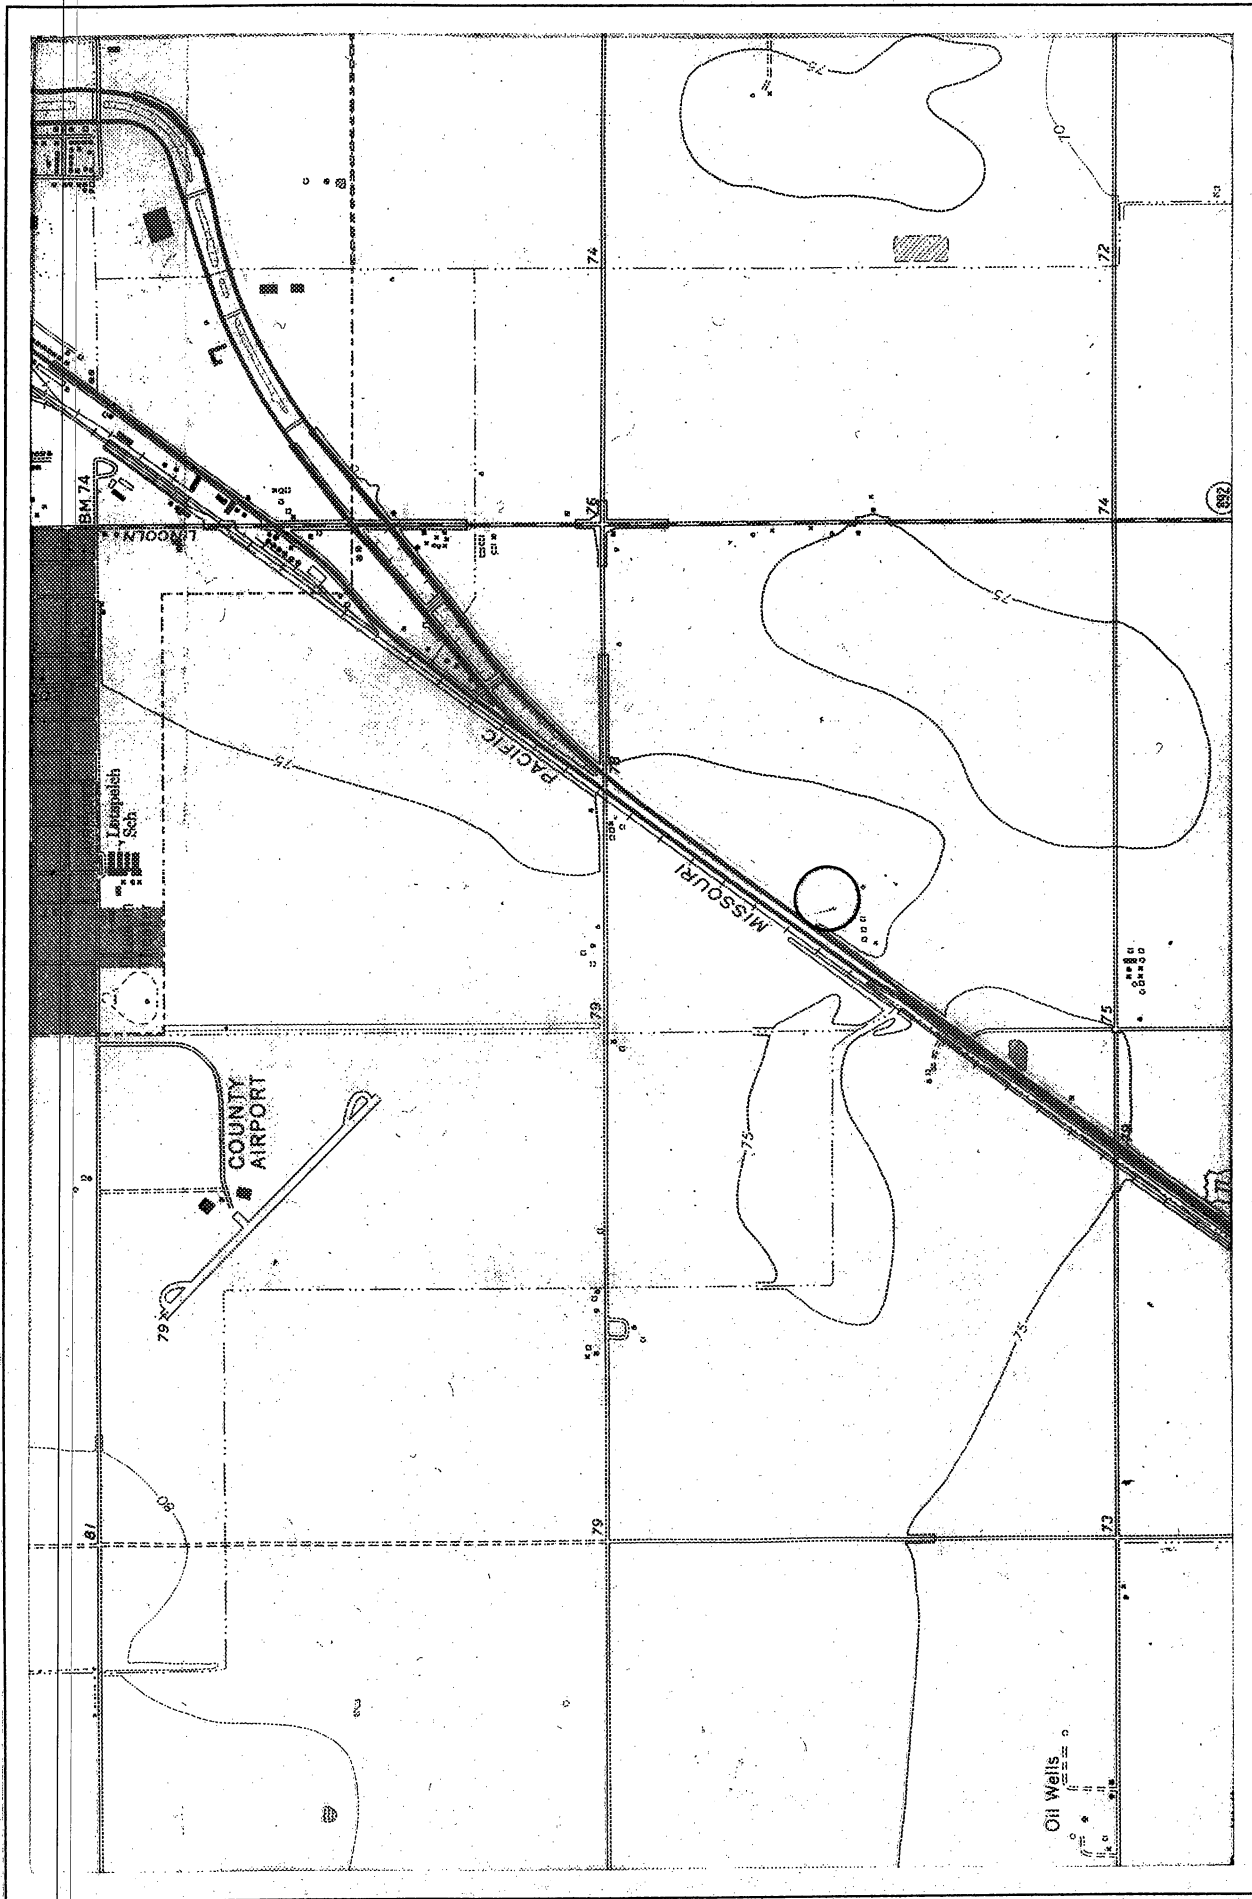
Figure 1. Location of the Robstown maintenance section (08), Nueces County, Corpus Christi District.

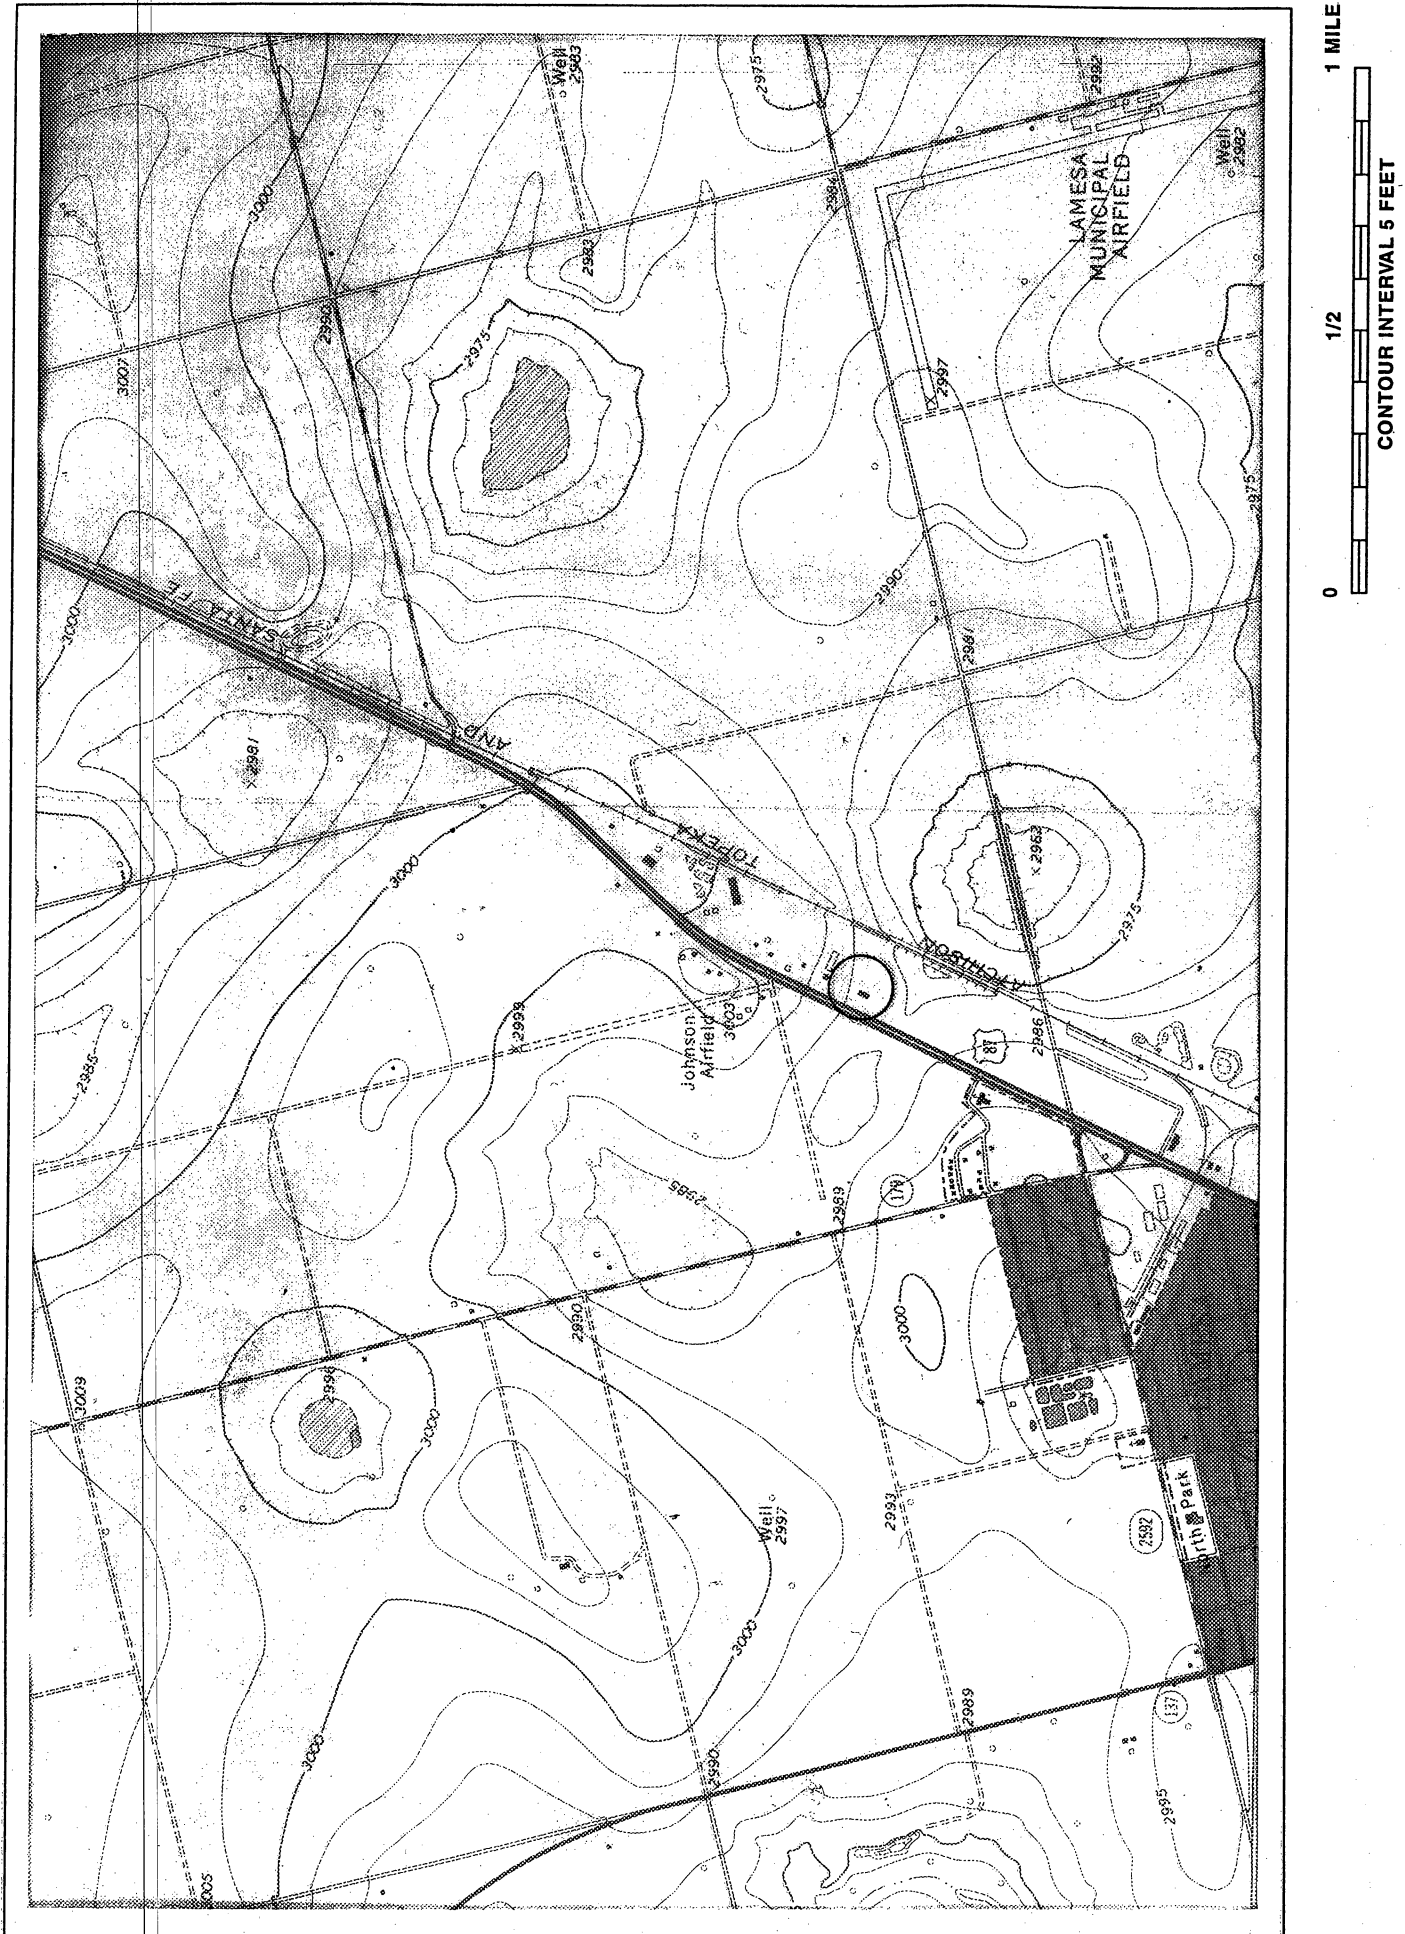
Figure 1. Location of the Lamesa maintenance section (05), Dawson County, Lubbock District.

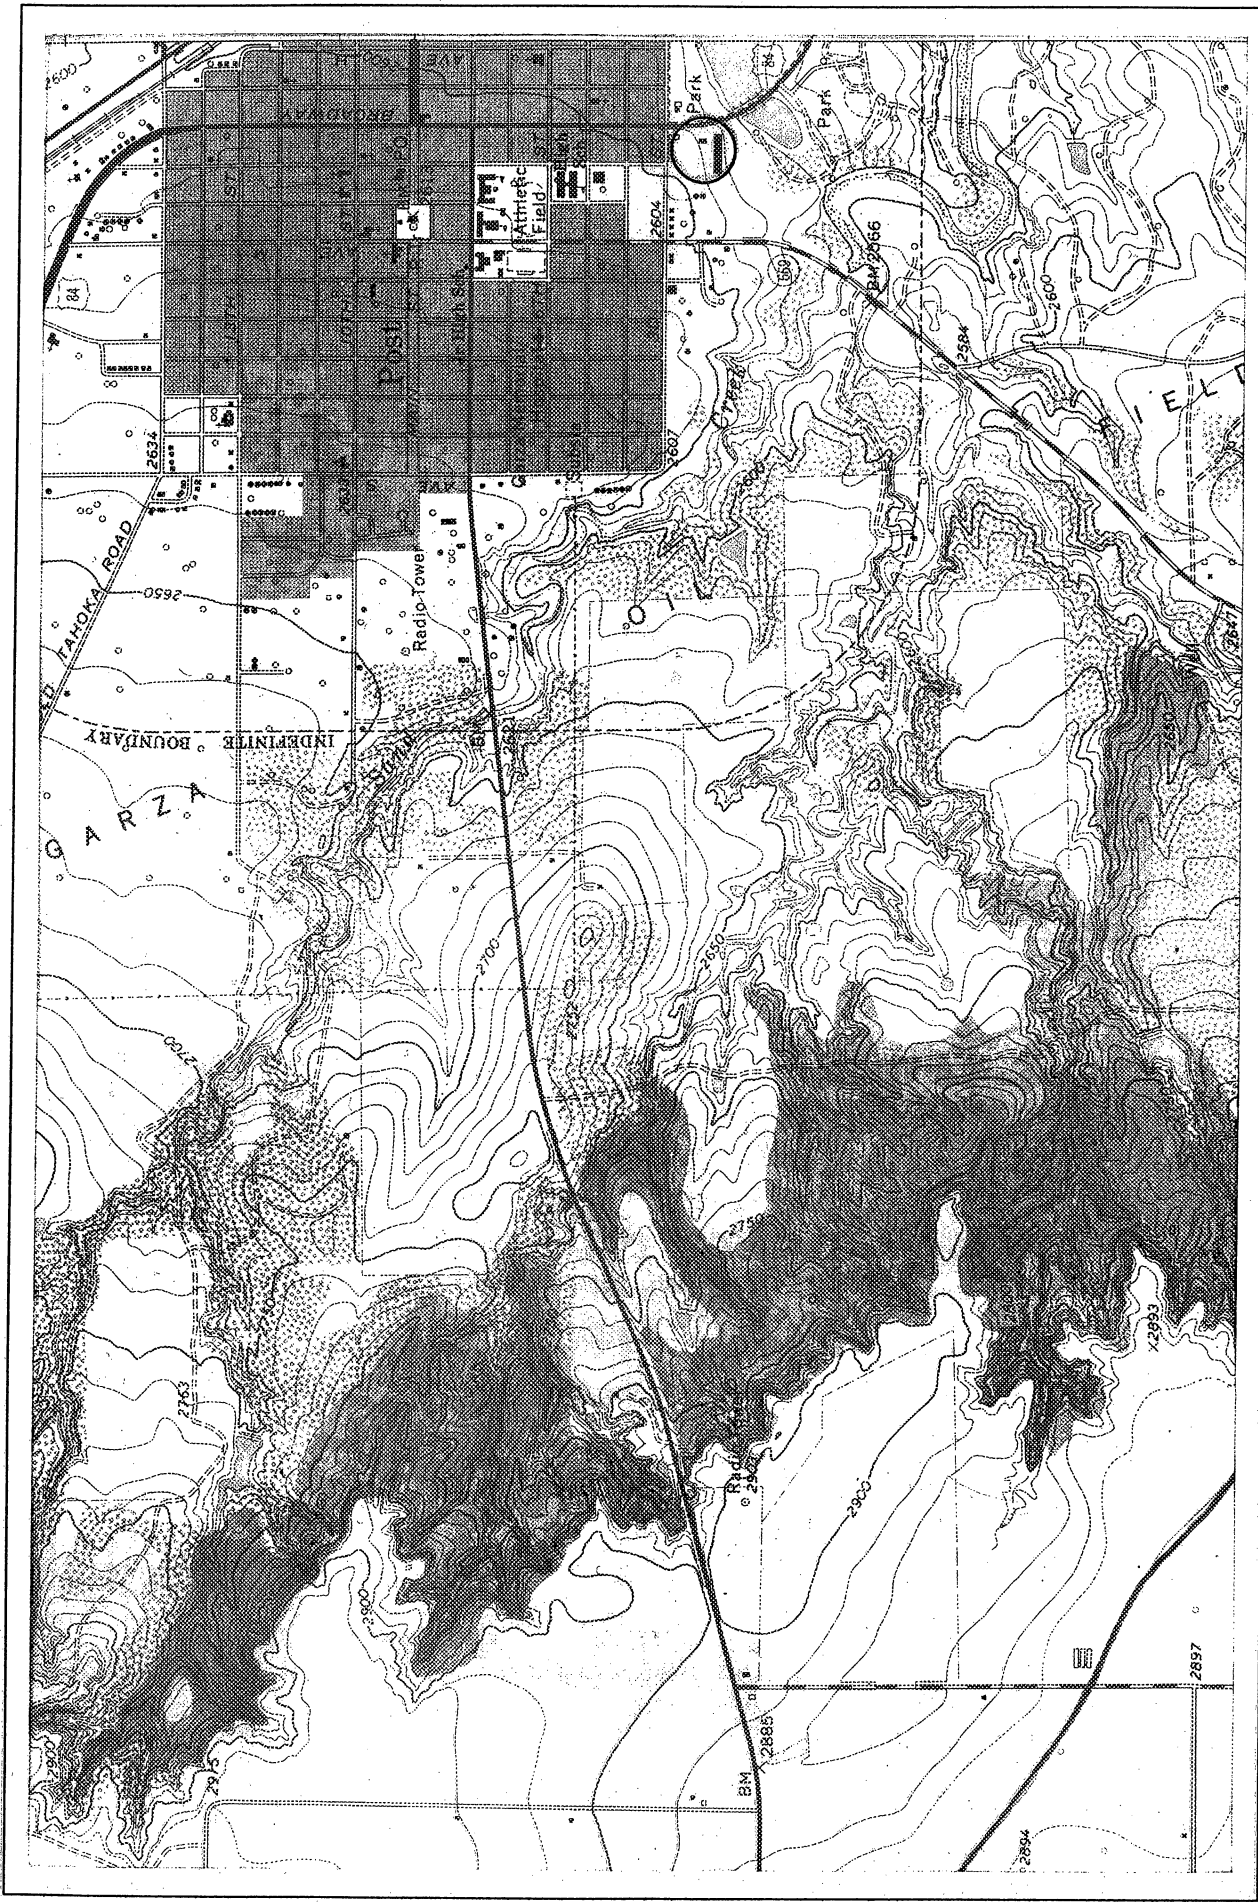
Figure 1. Location of the Post maintenance section (14), Garza County, Lubbock District.

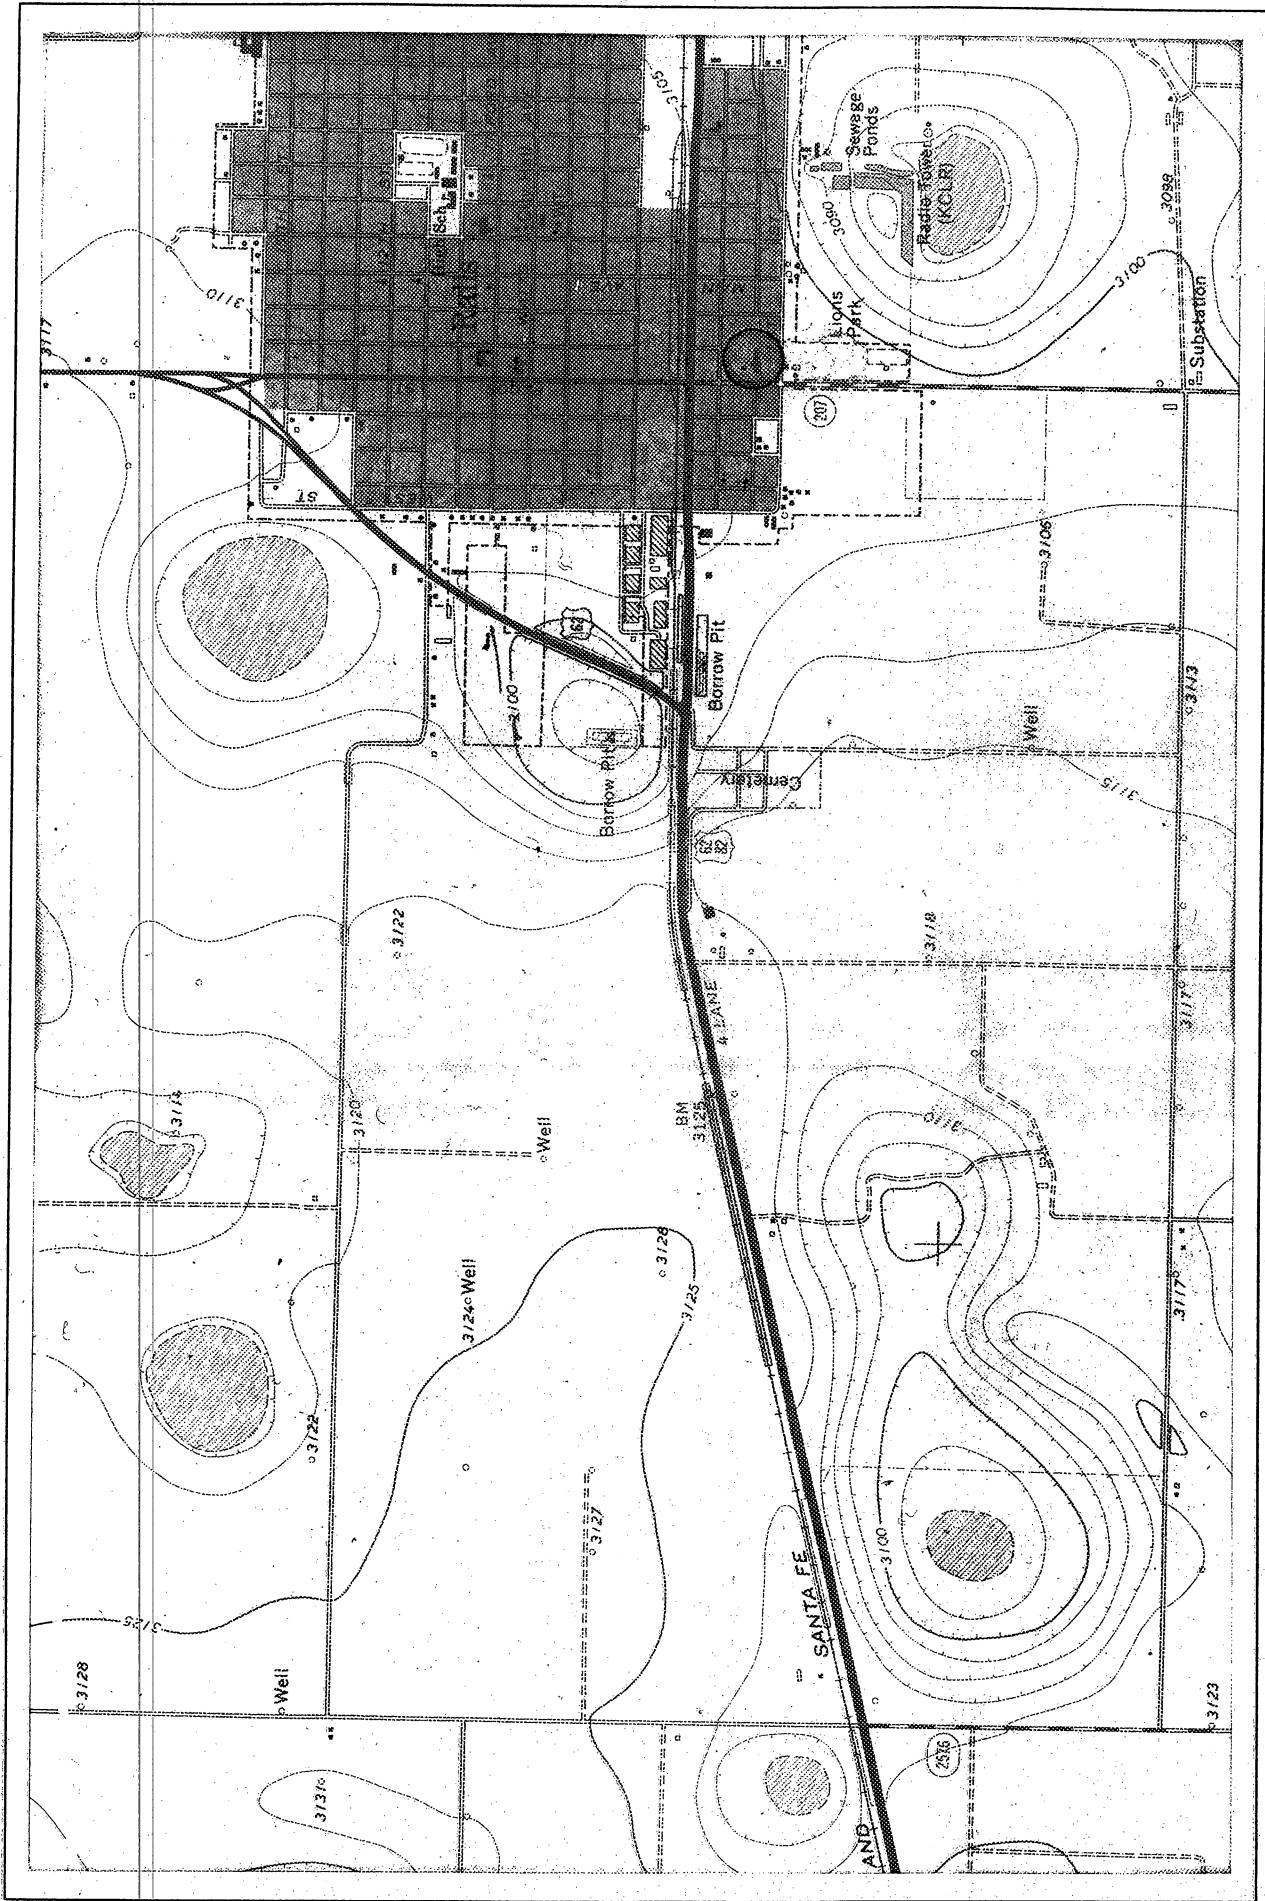
Figure 1. Location of the Ralls maintenance section (15), Crosby County, Lubbock District.

There is one abandoned waste oil injection well at the Ralls maintenance site which is located near the southern city limit on the east side of SH 207. This injection well was drilled in the early 1960's, remained active until 1985, and was remediated in 1987 or 1988. Waste products placed into the cement-lined injection well, which had a 24 to 36 in diameter and was approximately 25 ft deep, include motor oil, transmission and brake fluid, and hydraulic fluids. Data collected from observation wells drilled in the late 1980's after a gasoline leak indicated that the gasoline leaked 115 ft straight down to water table. The City of Ralls obtains most of their drinking water from White River Lake located 22 miles southeast of Ralls, but also has water wells within the city limit. Depth to top of fresh water in Ralls is estimated to be 220 to 240 ft and total depth is around 300 ft. There are some perched aquifers in area but these are relatively rare and very few people pump them.

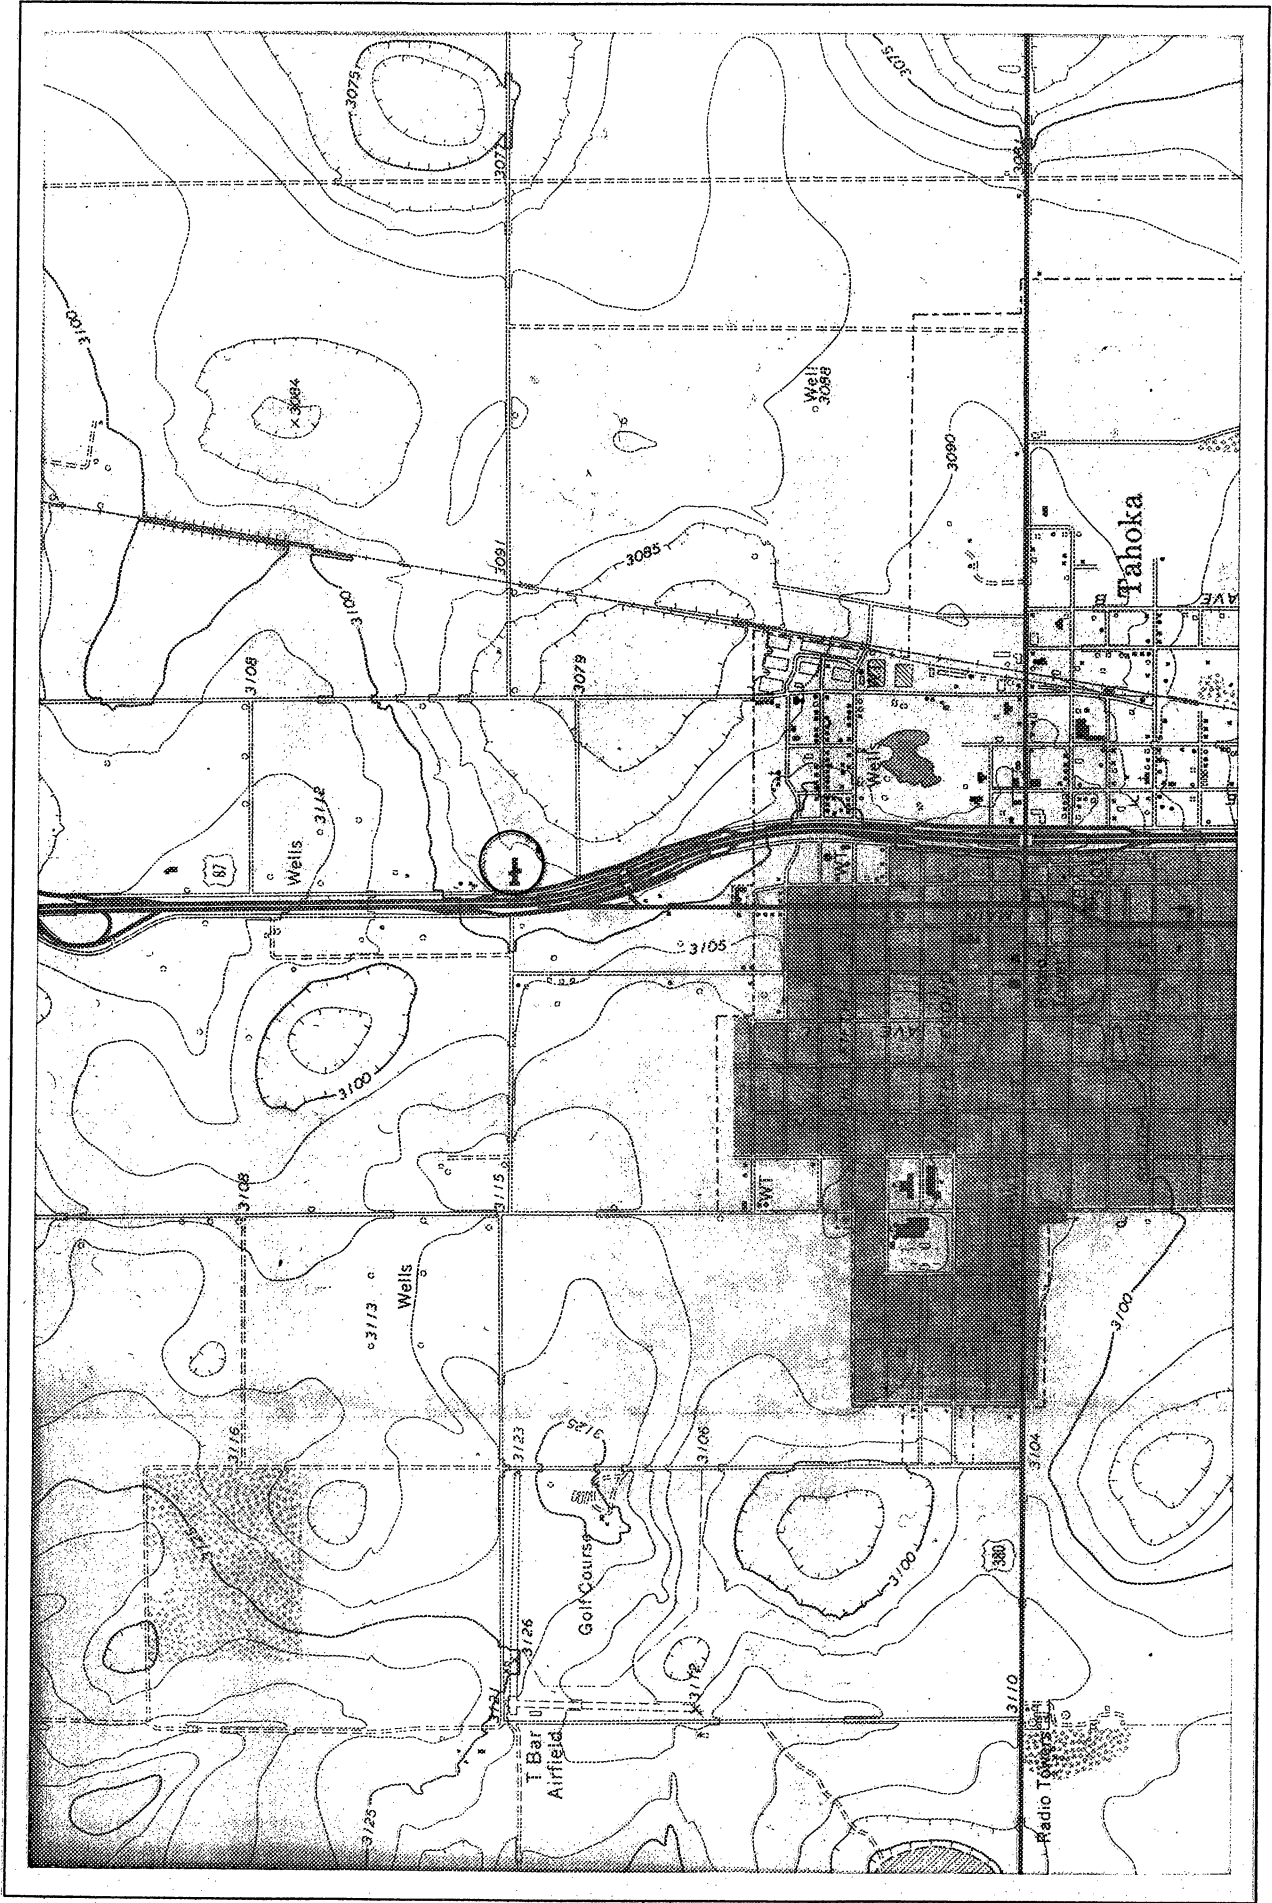
Figure 1. Location of the Tahoka maintenance section (17), Lynn County, Lubbock District.

There is one abandoned waste oil injection well at the Tahoka maintenance section north of the city on the east side of US 87. This injection well was 24 in diameter and approximately 30 ft deep and located midway down the north side of the main building adjacent to the shop. Motor oil, transmission and brake fluids and antifreeze were disposed of in the injection well while it was active between 1968 to 1986. Wash rack water was disposed of in a series of 3 ft diameter gravel pits behind the wash rack shed. These gravel pits were abandoned and the maintenance section now disposes wash rack water into the city sewer system. There are at least 30 water wells within a 1 mile radius of the maintenance site; 12 of them are within 0.5 mi. Houses on either side of the maintenance section have water wells. The depth to water at the house north of the maintenance site is 46 ft and other water wells in area encounter fresh water at 50 to 100 ft.
