**FINAL REPORT**

**Coastal Hazards Atlas of Texas: A Tool for Hurricane Preparedness  
and Coastal Management – Volume 1  
The Southeast Coast**

**James C. Gibeaut, William A. White, and Thomas A. Tremblay**

**A Report of the Texas Coastal Coordination Council pursuant to National Oceanic and Atmospheric  
Administration Award No. NA770Z0202**

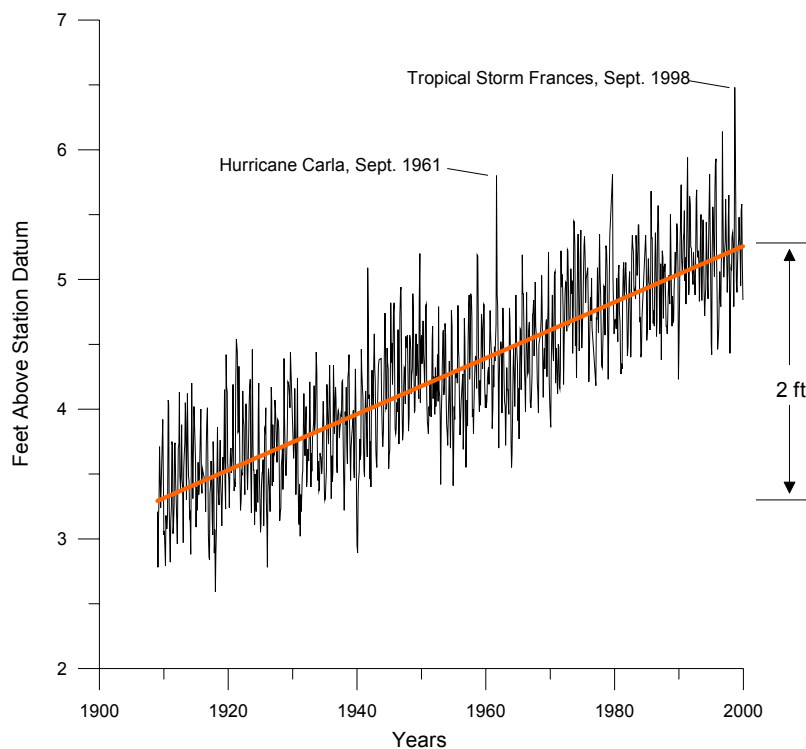
Figure 2. Monthly average sea level since 1909 as measured by the Pier 21 tide gauge in Galveston Bay. Straight line is a linear regression through all the data points.

During the 20<sup>th</sup> century along the upper Texas coast, the rate of relative sea-level rise has been 0.022 ft/yr (about 1 foot in 46 years) as measured by the Pier 21 tide gauge on Galveston Island (fig. 2). This rise is caused by compaction of sediments causing a lowering of the land surface (see the subsidence section) and by a raising in the global ocean surface caused by melting glaciers and thermal expansion of seawater. The upper Texas coast has a relatively high rate of relative sea-level rise compared to other Gulf of Mexico locations because of the high rate of land subsidence. Global warming scenarios predict an increase in the rate of global sea-level rise, but even if that does not happen and relative sea-level rise continues at its present rate there is reason for concern and special planning.

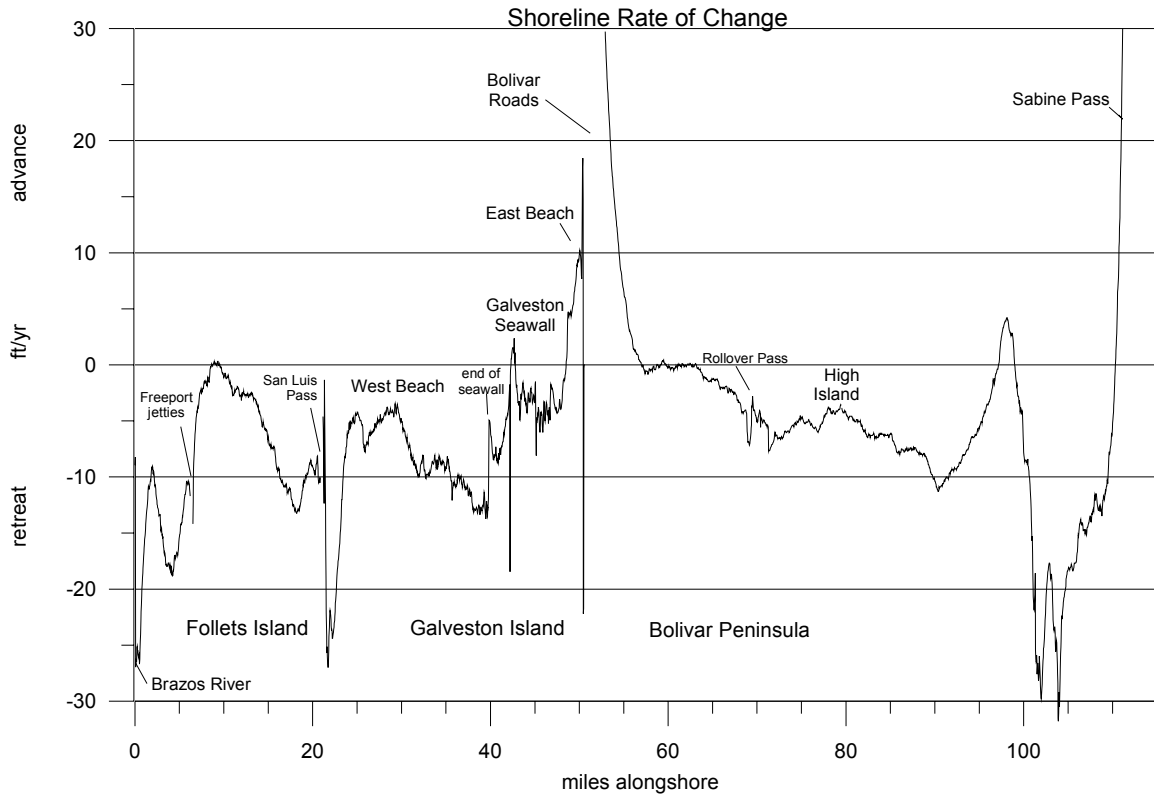
Figure 3. Rate of Gulf of Mexico shoreline change from the Brazos River to Sabine Pass

Overall, the shoreline from High Island to the Brazos River is retreating at a rate of 2 to 10 ft per year ([fig. 3](#), also see erosion layer in Geographic Information System files). From 1956 to 1996, approximately 6.9 mi<sup>2</sup> of land eroded; this erosion was partly offset by 0.42 mi<sup>2</sup> of accretion. Comparing the projected 2056 shoreline with the 1996

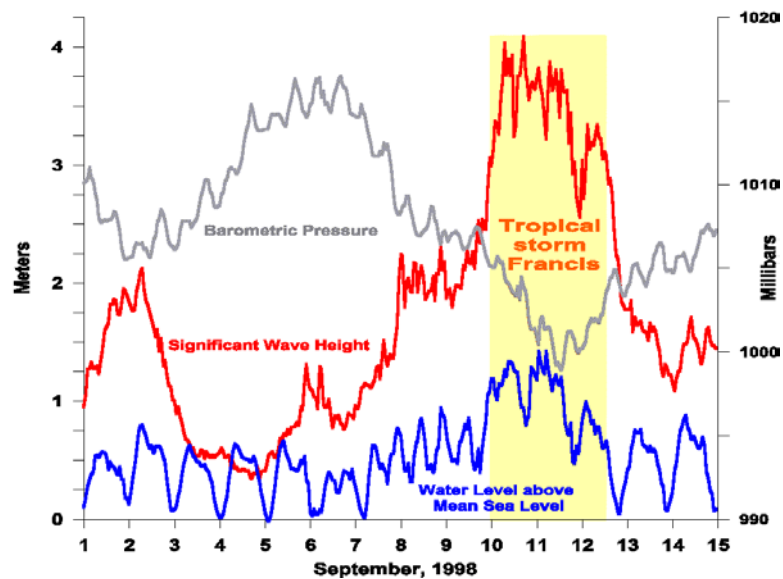
Figure 4. Plots of barometric pressure, wave height, and ocean level during Tropical Storm Frances.

1998 (fig. 4). Although winds only reached 50 mph, the ocean level was 3 to 5 ft above normal for 36 hours, and waves were 10- to 13-ft high for two and one half days. Because of the long period of time the storm affected the coast, beach erosion and flooding occurred that would normally be associated with at least a strong level 1 hurricane.

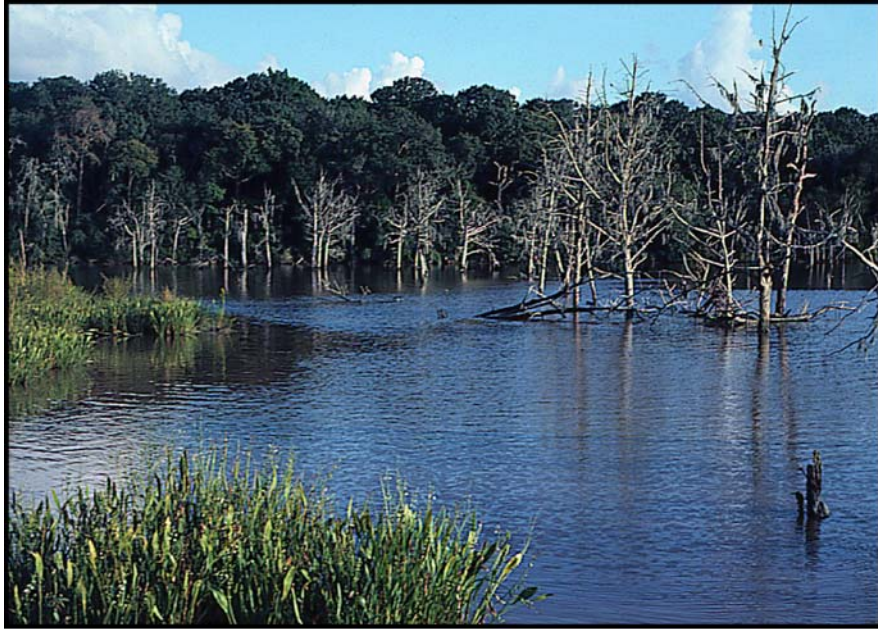
QAc2175c

Figure 5. Effects of subsidence on natural resources such as marshes and swamps in the Clear Lake area. Vegetation has been submerged and replaced by open water.

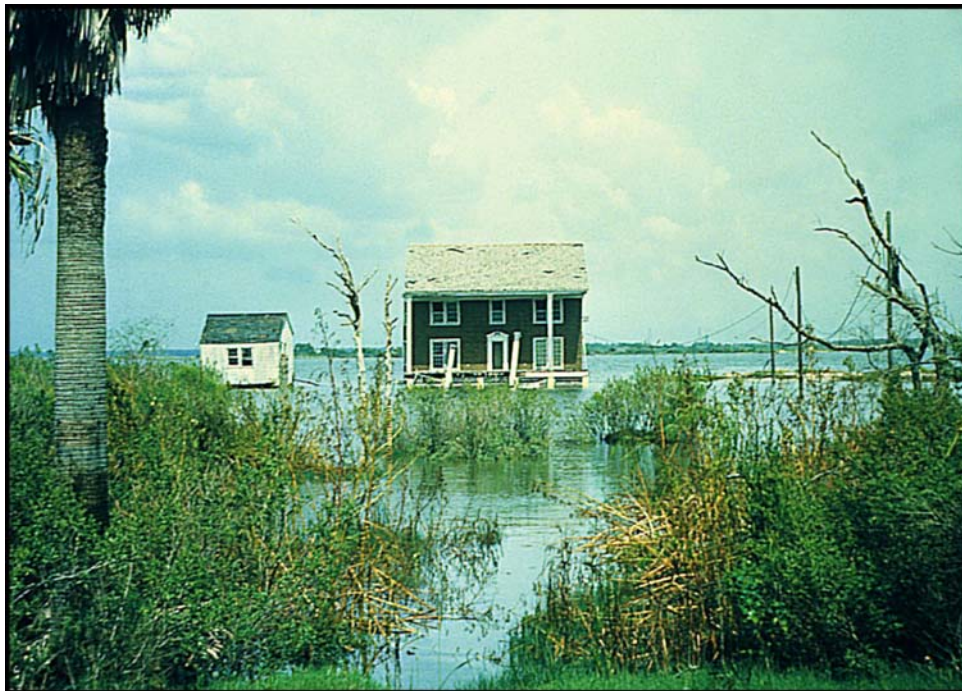
QAc2180c

Figure 6. Effects of subsidence on a residential area in Baytown at the head of Galveston Bay. The area was so impacted by subsidence and associated flooding during hurricanes that the houses were ultimately abandoned and the area converted into marshes and aquatic habitats.

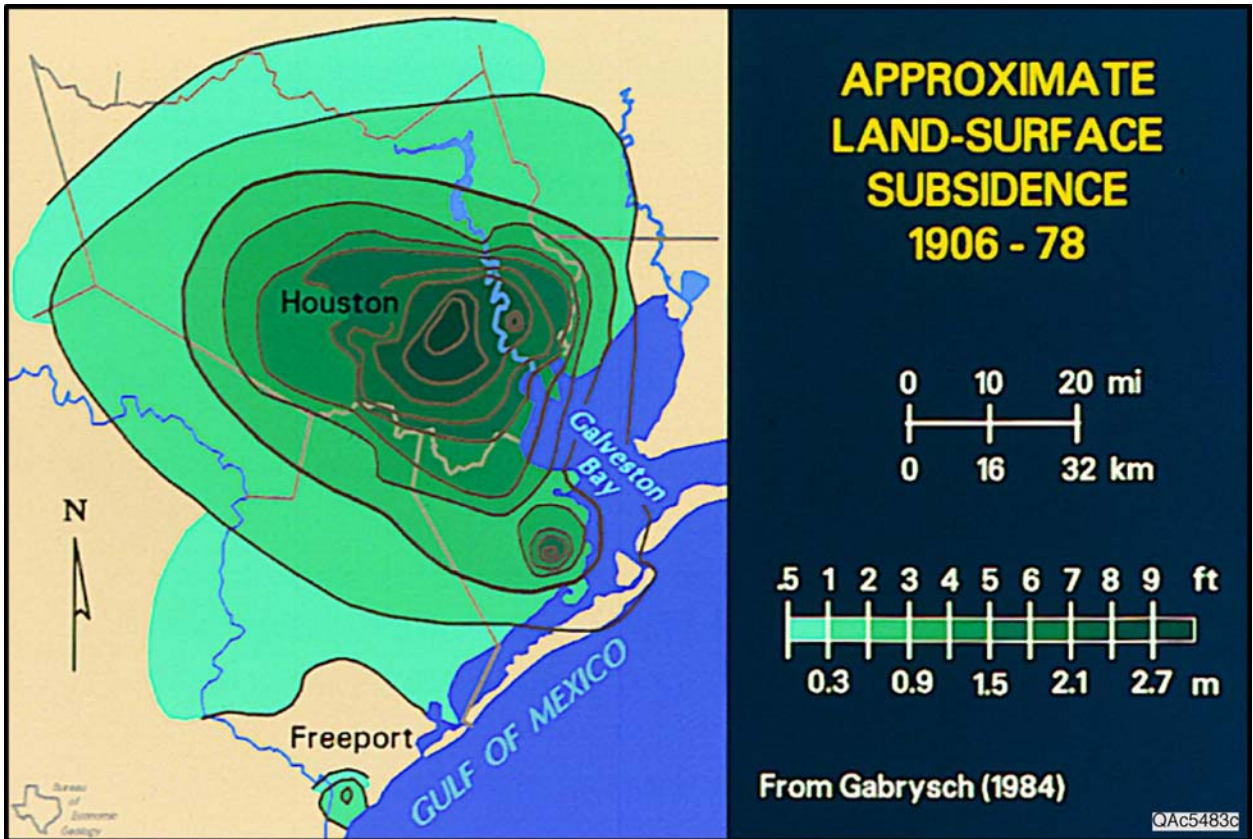
Figure 7. Land surface subsidence in the Houston-Galveston area from 1906-1978.<sup>(26)</sup>  
 This is a period during which much of the subsidence took place in the eastern part of the subsidence bowl. Since the late 1970's, reductions in rates of ground-water withdrawal in that area have greatly reduced rates of subsidence.<sup>(19)</sup>

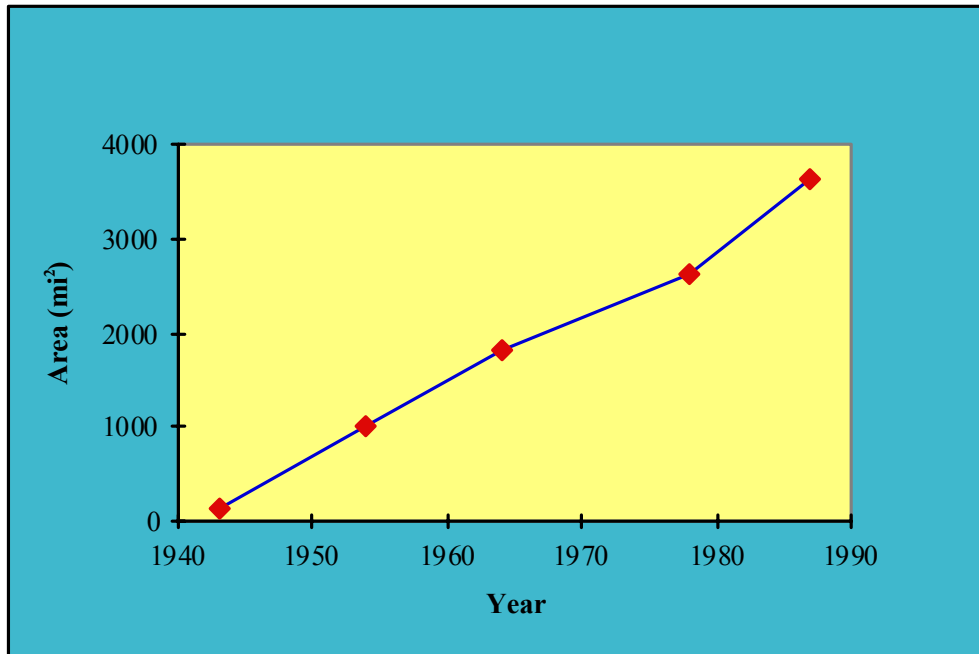
Figure 8. Growth of the Houston-Galveston area subsidence “bowl” from 1943 to 1987. Defined by cumulative area in which subsidence is more than one foot.<sup>(16,19)</sup>

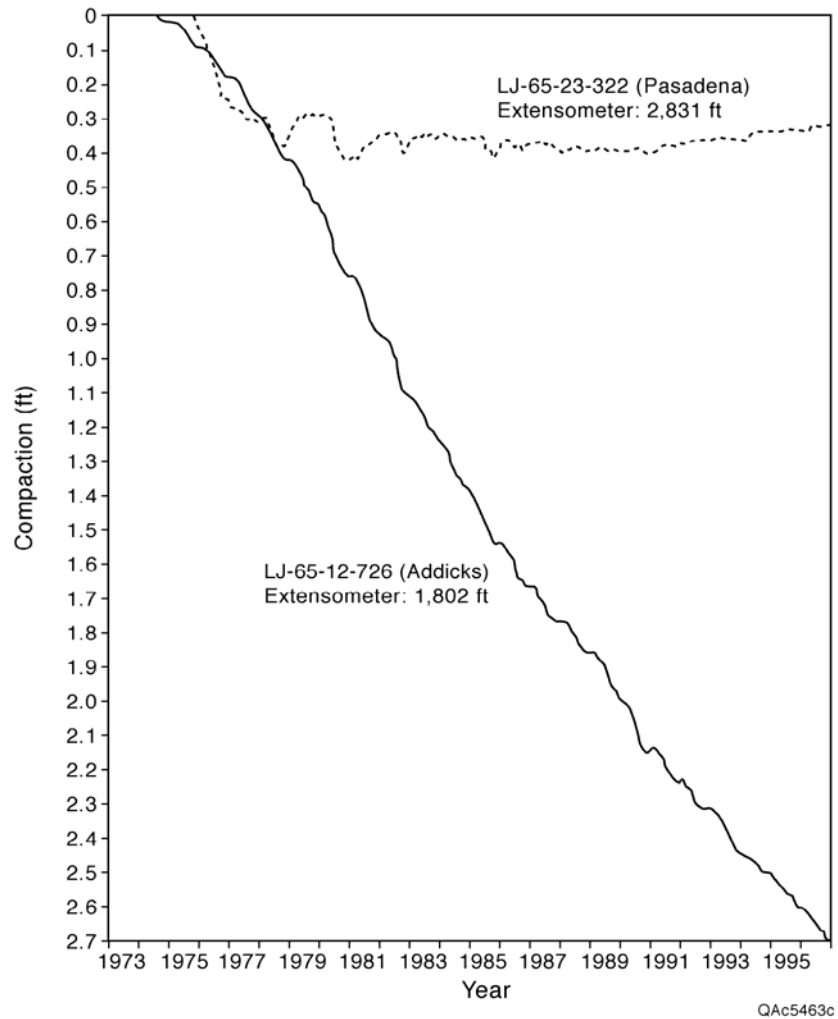
Figure 9. Cumulative compaction as measured by extensometers located at Pasadena and Addicks. <sup>(21)</sup> Pasadena is located on the eastern side of the subsidence bowl, and Addicks is on the western side. Note that cumulative compaction at Pasadena was high in the mid-1970's, but since that time has leveled off and even had some reversals, whereas at Addicks, rates of compaction remained high from the 1970's to the 1990's.

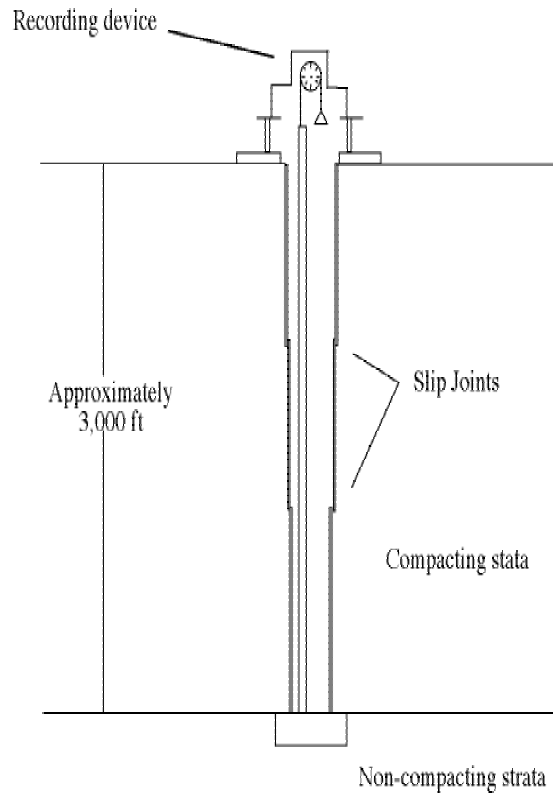
Figure 10. Illustration of a typical borehole extensometer. The inner rigid pipe maintains its position with respect to the outer segmented pipe and surface installation, which become lower as subsurface strata compact. The amount of compaction or shortening is measured by the wire tape rolling over the drum.<sup>(27)</sup>

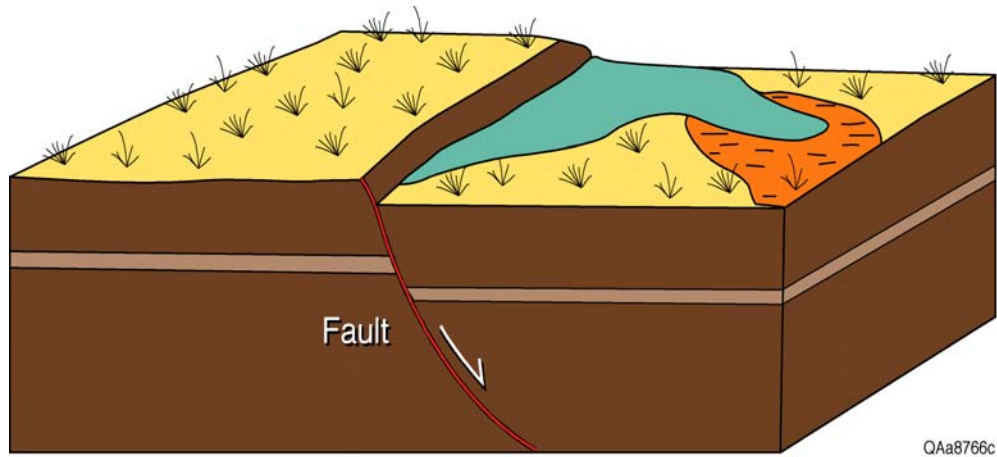
Figure 11. Diagram illustrating changes in wetlands along an active surface fault. There is generally an increase in low marshes and ponded water on the side of the fault that is moving downward.<sup>(17)</sup>

Geologically, active surface faults along the Texas coast are fractures in the earth's crust along which movement has occurred within the past few thousand years. Generally, the earth's surface moves downward or subsides at a faster rate on one side (downthrown side) of the fault than on the other side (Figs. 11 and 12). This produces a fault scarp or sharp change in elevation at the surface along the trace of the fault. Unlike faults along the West Coast where stress builds and then is released producing earthquakes, earthquakes are extremely rare on the Texas Gulf Coast. Nevertheless, active faults are significant geologic hazards because their movement at the surface breaks and bows structures such as highways, railroads, foundations of residential and commercial developments, pipelines, air field runways, football stadiums, and other features. Millions of dollars of damage are caused annually by faults.<sup>(28)</sup> Natural resources such as wetlands are also affected by faulting. As the land surface moves downward along a fault that intersects a wetland, more frequent and eventually permanent inundation can lead to replacement of marsh vegetation by open water (fig. 11).

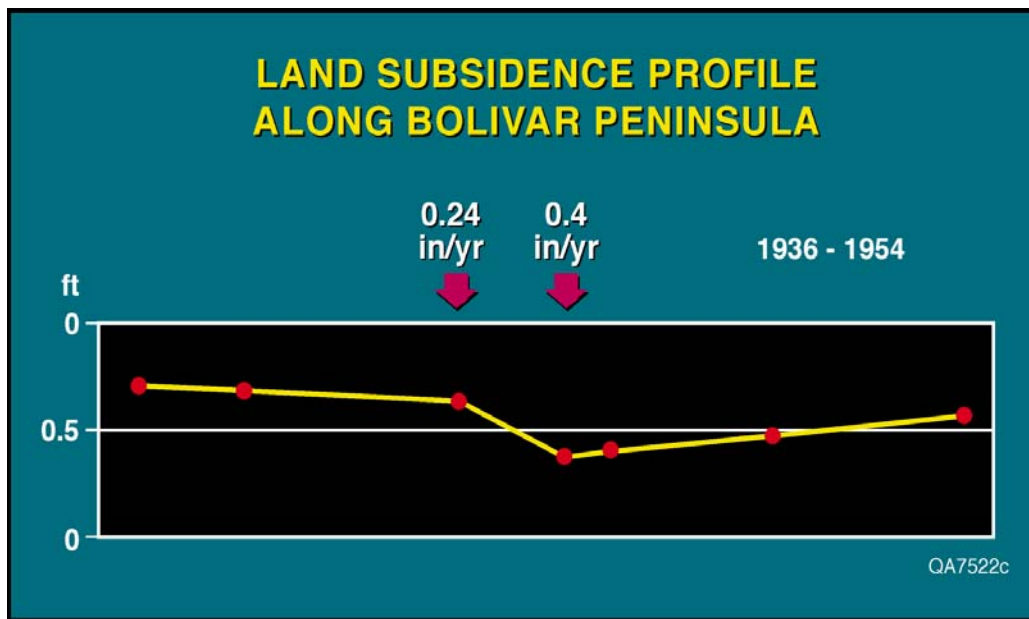
Figure 12. Profile constructed from benchmark releveling surveys that cross a fault along a highway on Bolivar Peninsula.<sup>(28)</sup> The increase in subsidence of 0.24 in/yr to 0.4 in/yr shows that the downthrown side of the fault is subsiding at a faster rate than the uplifted side for the period of the surveys, 1936-1954. Fault activation and subsidence at this site appear to be associated with hydrocarbon production.

Analysis of aerial photographs is a common method used to detect possibly active faults. Photographs showing linear and curvilinear features across which there are changes in colors and tones provide evidence that a fault may be present ([fig. 14](#)). These tonal variations across a fault may be caused by a combination of factors such as changes in vegetation, soil moisture, soil types, standing water, and elevation. Analysis of sequential photographs can provide evidence that a linear feature is an active fault. Many faults are not visible on historical photographs but are visible on more recent photographs, which indicates that they have become active recently. Other lines of evidence of fault activity are (1) reoccurring breaks and repairs in pavements, buildings, and other structures, (2) abrupt changes in elevations as shown on topographic maps, and (3) sharp changes in the rates of subsidence along benchmark releveling profiles ([fig. 12](#)).

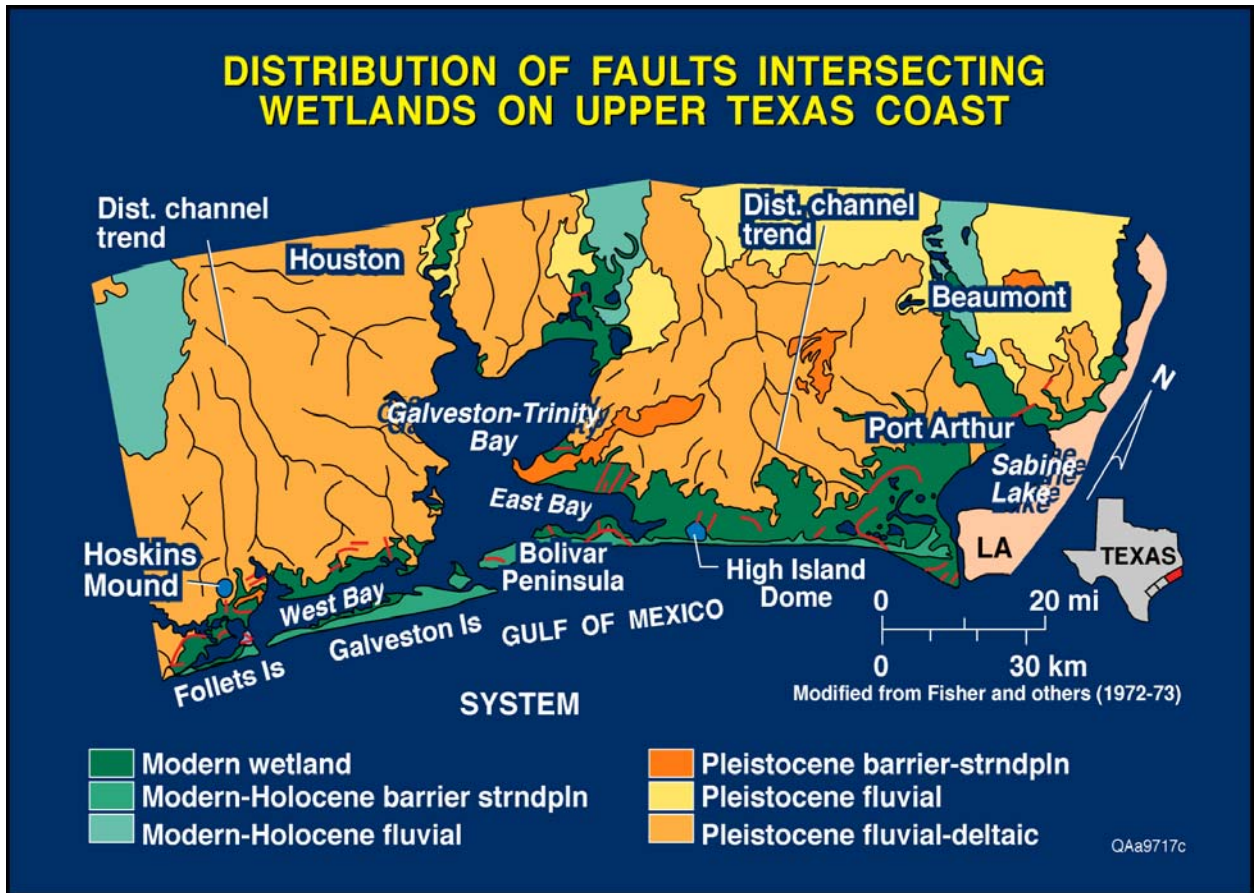
Figure 13. Surface faults, shown in red, that intersect marshes between Follets Island and the Louisiana border. The faults were mapped from sequential aerial photographs. Only about 25 percent of the faults were visible on photographs taken in the 1930's, but the remaining 75 percent could be seen on later photographs indicating that they have become active since the 1930's.<sup>(28)</sup>

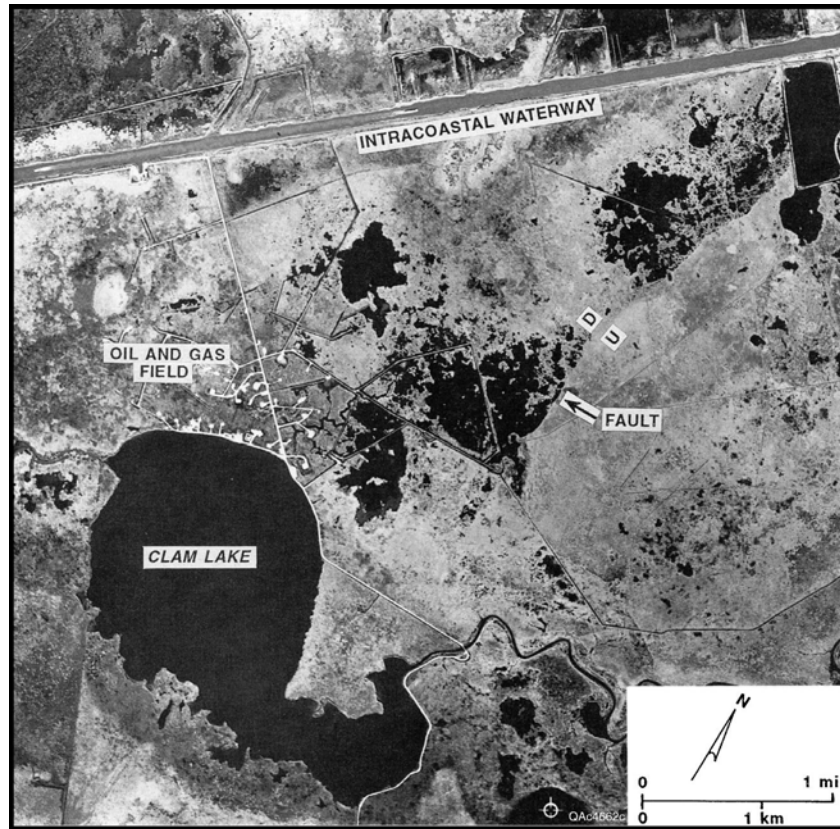
QAc5461c

Figure 14. Example of fault trace on a photograph taken in 1989 in the Clam Lake area between Sabine Lake and Galveston Bay. Topographically low marshes and open water (black areas) are more abundant on the side of the fault that is moving downward (labeled D). This fault is not visible on aerial photographs taken in the 1950's, but it is on photographs taken in the 1960's or later indicating that movement along the fault has occurred since the 1950's.<sup>(17)</sup>
