**PHYSICAL ENVIRONMENT OF FORT WOLTERS MILITARY RESERVATION,
PARKER AND PALO PINTO COUNTIES, TEXAS**

Texas Army National Guard

**Bureau of Economic Geology
W. L. Fisher, Director
The University of Texas at Austin
Austin, Texas 78713-7508**

April 1994

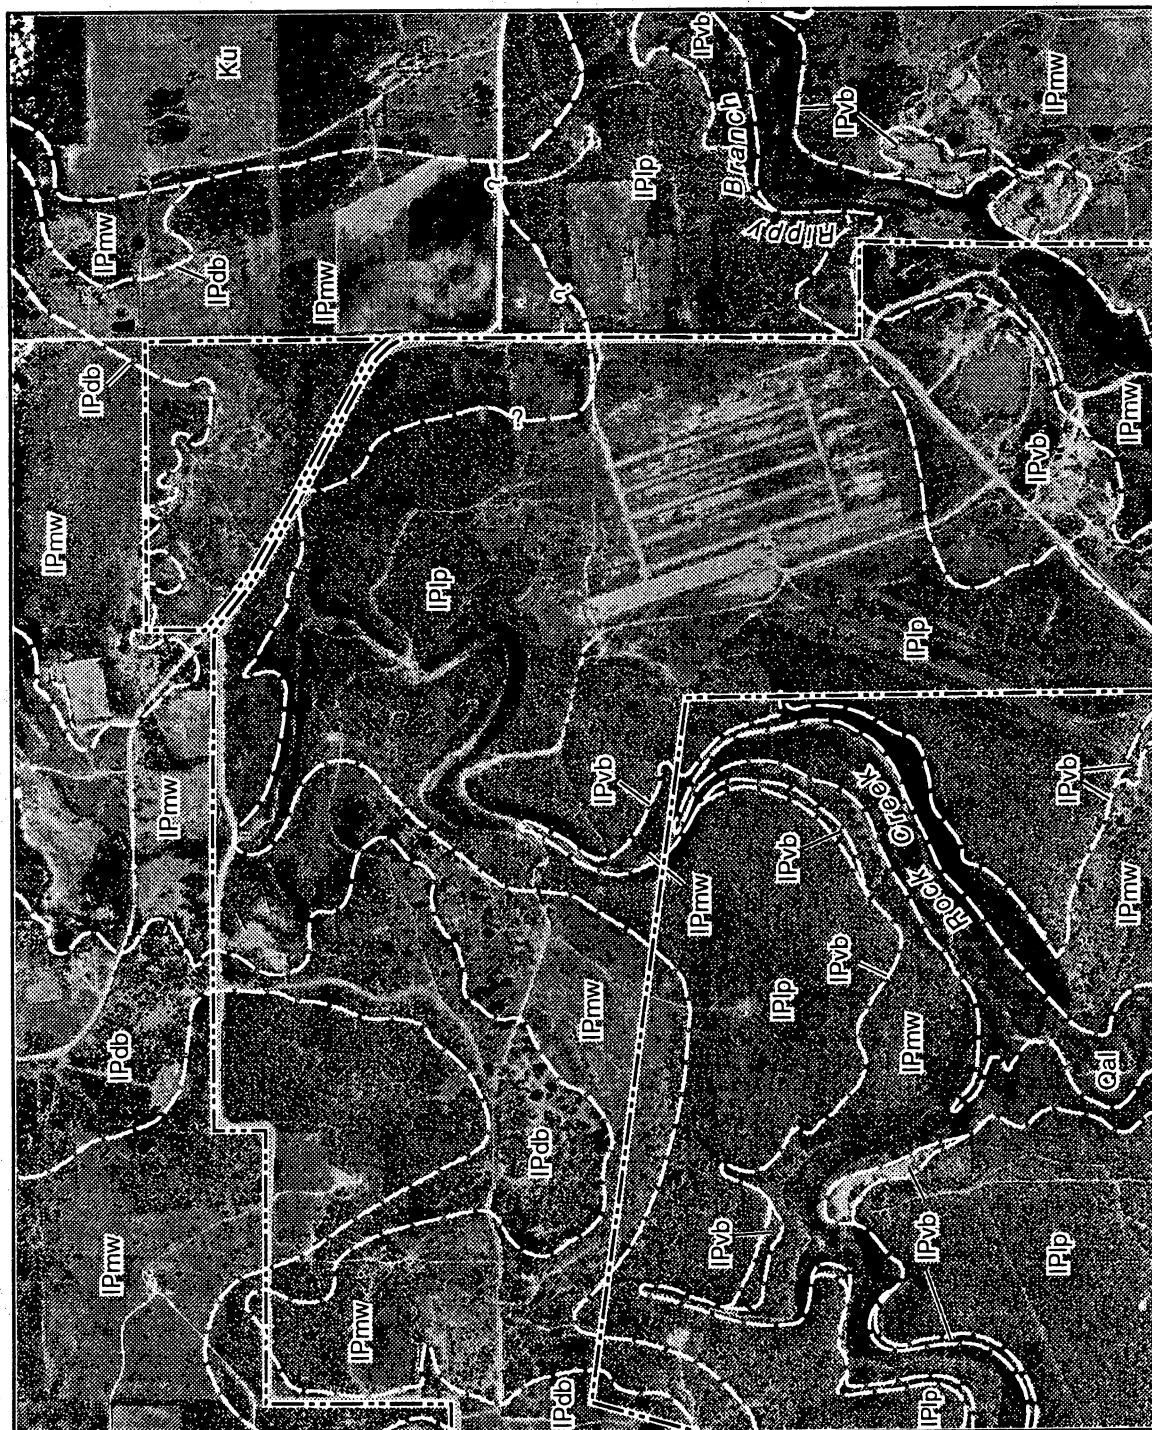
QAa6285c

Figure 8b. Geologic map of northeast portion of Fort Wolters on unrectified aerial photograph base (NAPP 2342-68; see table 1); see figure 8a for explanation of map symbols.

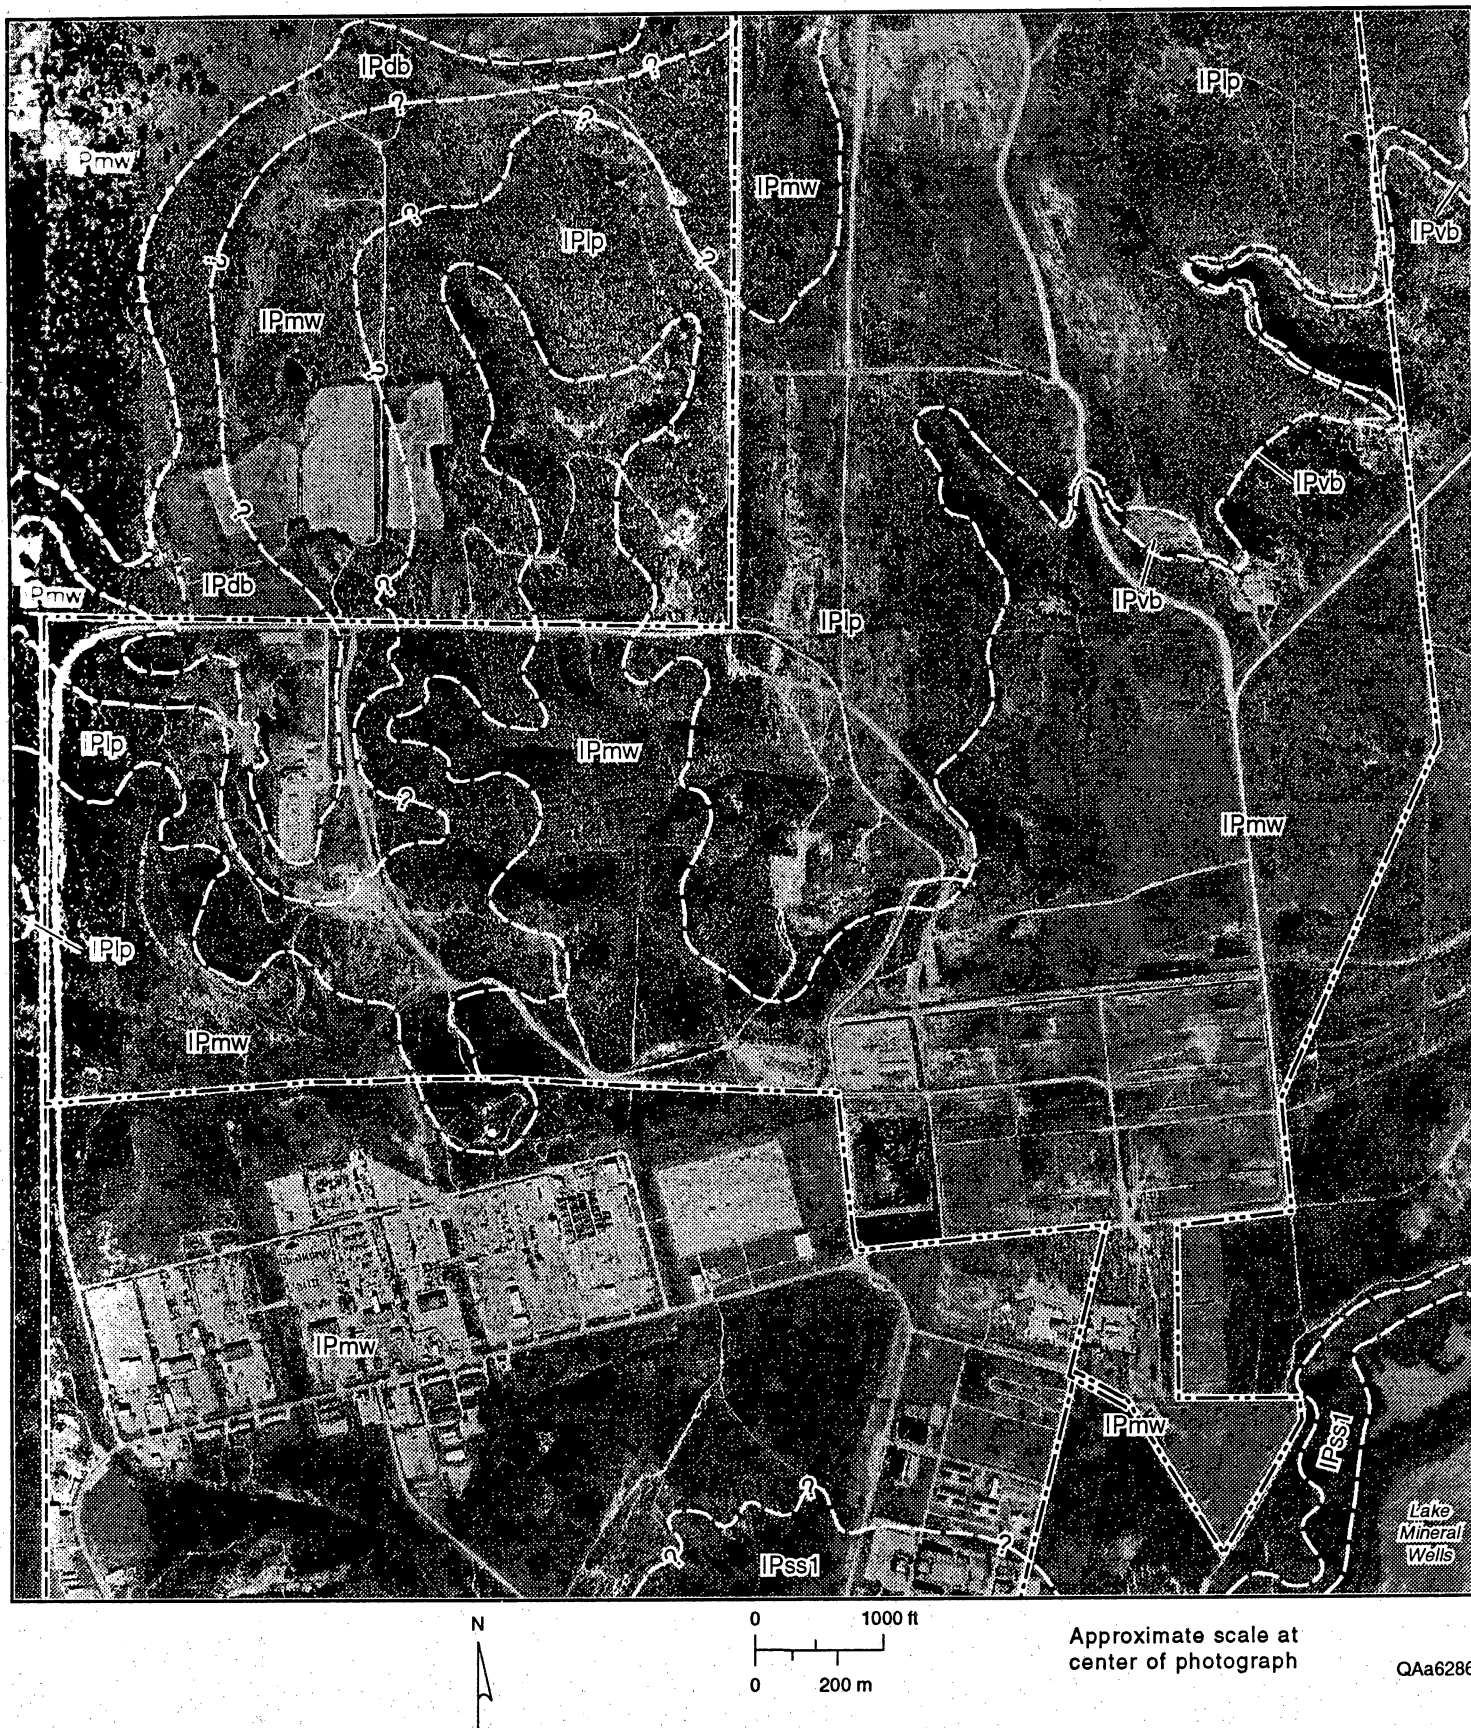
Figure 8c. Geologic map of southwest portion of Fort Wolters, on unrectified aerial photograph base (NAPP 2342-68; see table 1); see figure 8a for explanation of map symbols.

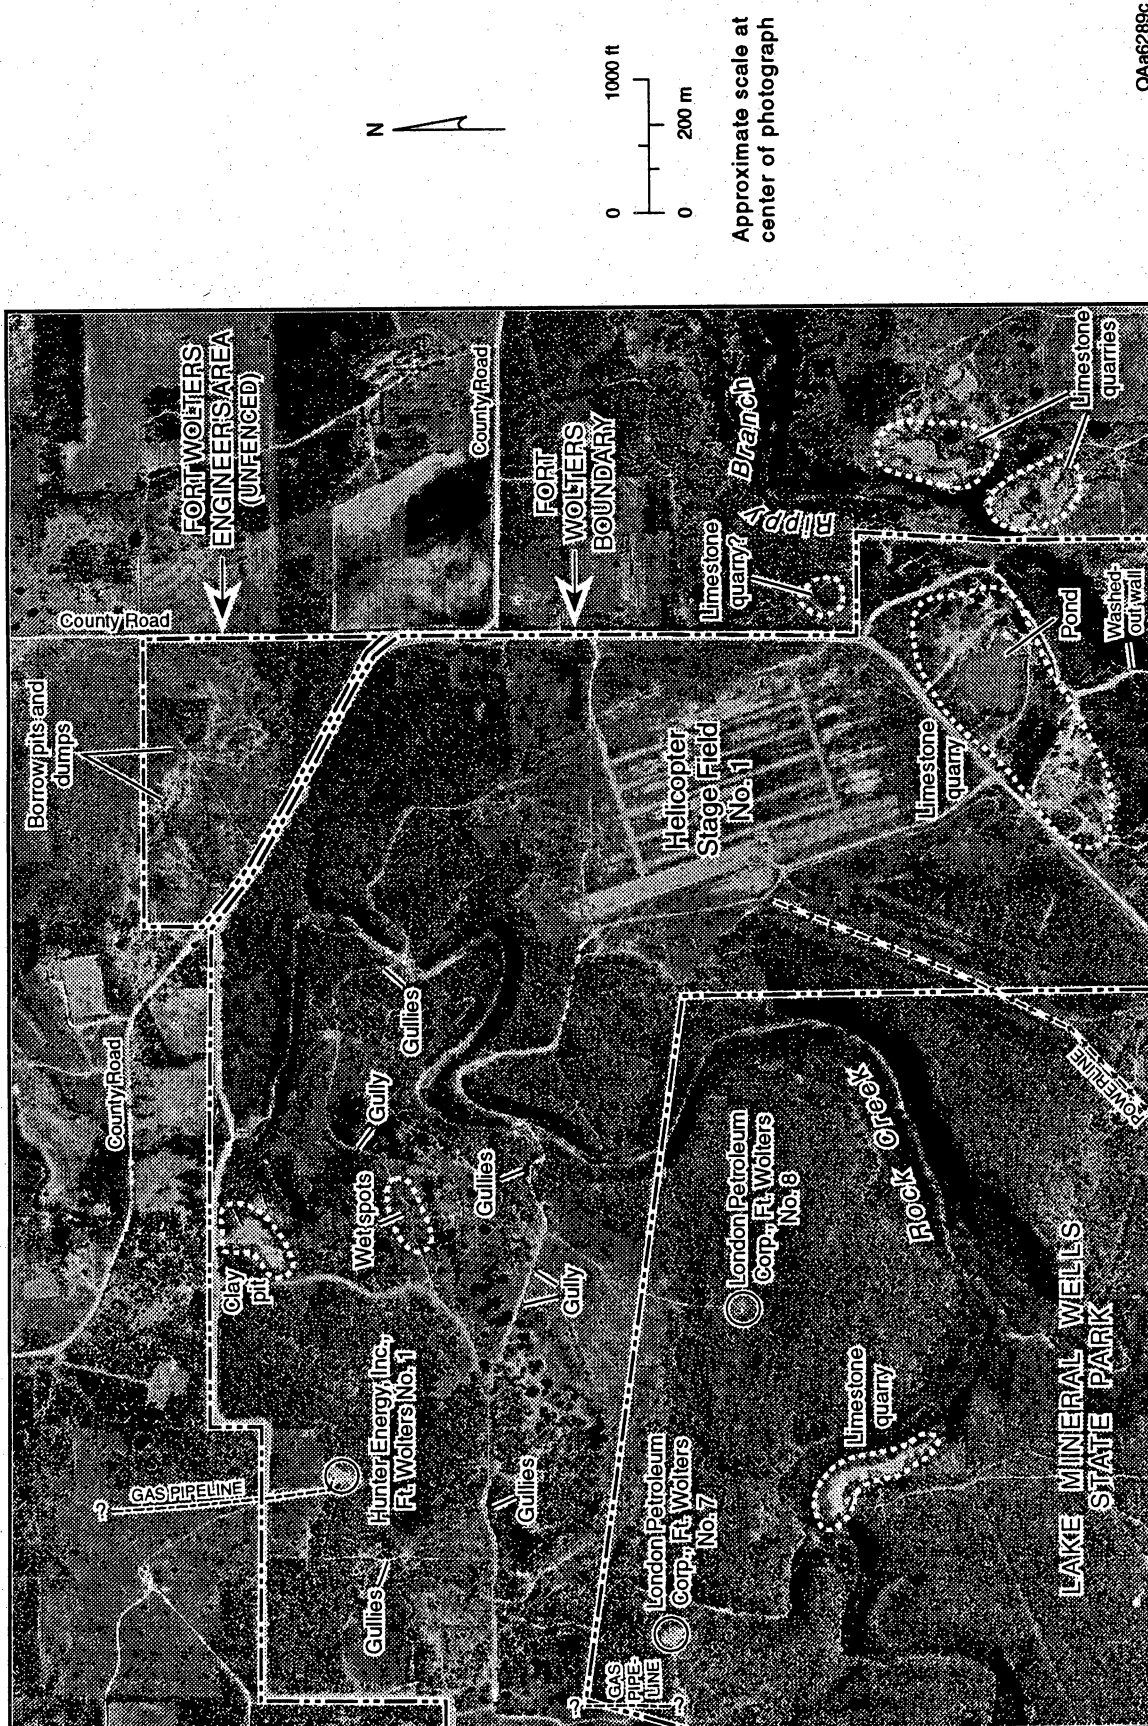
Figure 9b. Pits, quarries, gullies, and other surface disturbance features in northeast portion of Fort Wolters, on unrectified aerial photograph base (from NAPP 2342-68; see table 1).

Clay pits are present in a number of places on Fort Wolters (figs. 9a–d). One of special interest is located along the northern edge, near Rock Creek (fig. 9b). The pit is not present on 1953 aerial photographs but is present on the 1956 aerial photographs. Most of the clay was extracted in the mid-1950’s and used in roadbuilding on the base. The pit is especially interesting because it exposes fossil trees, present as fallen, detached, flattened trunks as much as 20 ft long, and as in-place stumps, some with radiating roots. The material is heavily carbonized (coalified) and fractured, black, and commonly contains gypsum and iron oxides that add yellow, red, and brown highlights. The trees are probably conifers (of the type *Cordaites*), or possibly a lepidodendron (club moss), although their poor preservation precludes positive identification (Theodore Delevoryas, The University of Texas at Austin, Botany Department, personal communication, March 1994). Crystalline masses of gypsum (variety selenite) of ≥ 5 cm in long dimension are scattered throughout this pit; some show well-developed crystal forms. A number of other clay and/or crushed stone pits are present on the western half of the base, particularly in the escarpment below the Lake Pinto Sandstone (fig. 9c).
