FINAL REPORT

Coastal Hazards Atlas of Texas: A Tool for Hurricane Preparedness and Coastal Management – Volume 1 The Southeast Coast

James C. Gibeaut, William A. White, and Thomas A. Tremblay

June 2000

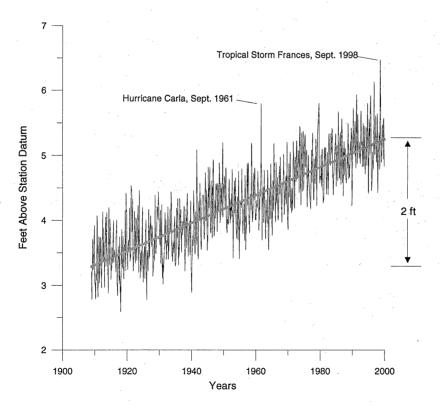
Figure 2. Monthly average sea level since 1909 as measured by the Pier 21 tide gauge in Galveston Bay. Straight line is a linear regression through all the data points.

During the 20th century along the upper Texas coast, the rate of relative sea-level rise has been 0.022 ft/yr (about 1 foot in 46 years) as measured by the Pier 21 tide gauge on Galveston Island (fig. 2). This rise is caused by compaction of sediments causing a lowering of the land surface (see the subsidence section) and by a raising in the global ocean surface caused by melting glaciers and thermal expansion of seawater. The upper Texas coast has a relatively high rate of relative sea-level rise compared to other Gulf of Mexico locations because of the high rate of land subsidence. Global warming scenarios predict an increase in the rate of global sea-level rise, but even if that does not happen and relative sea-level rise continues at its present rate there is reason for concern and special planning.

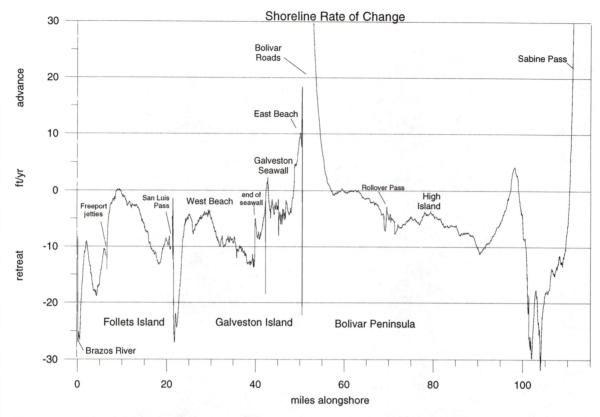
Figure 3. Rate of Gulf of Mexico shoreline change from the Brazos River to Sabine Pass

Overall, the shoreline from High Island to the Brazos River is retreating at a rate of 2 to 10 ft per year (fig. 3, also see erosion layer in Geographic Information System files). From 1956 to 1996, approximately 6.9 mi² of land eroded; this erosion was partly offset by 0.42 mi² of accretion. Comparing the projected 2056 shoreline with the 1996 shoreline reveals that an additional 8.2 mi² of land may be lost, which may be offset by 1.0 mi² gained.

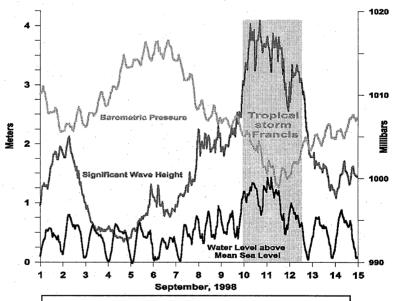
Figure 4. Plots of barometric pressure, wave height, and ocean level during Tropical Storm Frances.

1998 (fig. 4). Although winds only reached 50 mph, the ocean level was 3 to 5 ft above normal for 36 hours, and waves were 10- to 13-ft high for two and one half days. Because of the long period of time the storm affected the coast, beach erosion and flooding occurred that would normally be associated with at least a strong level 1 hurricane.

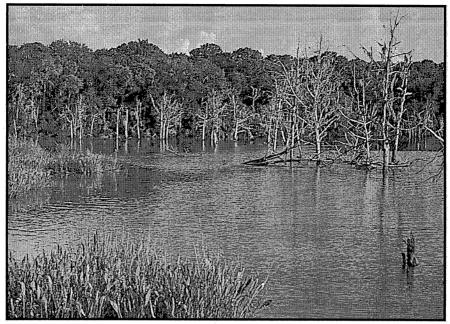
QAc2175c

Figure 5. Effects of subsidence on natural resources such as marshes and swamps in the Clear Lake area. Vegetation has been submerged and replaced by open water.

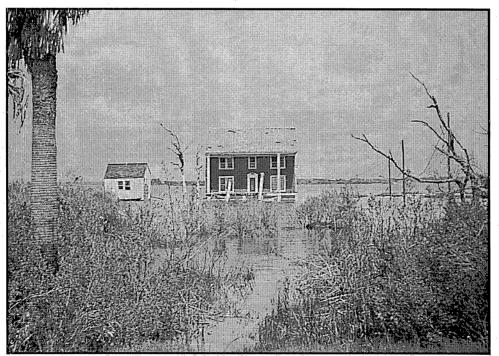
QAc2180c

Figure 6. Effects of subsidence on a residential area in Baytown at the head of Galveston Bay. The area was so impacted by subsidence and associated flooding during hurricanes that the houses were ultimately abandoned and the area converted into marshes and aquatic habitats.

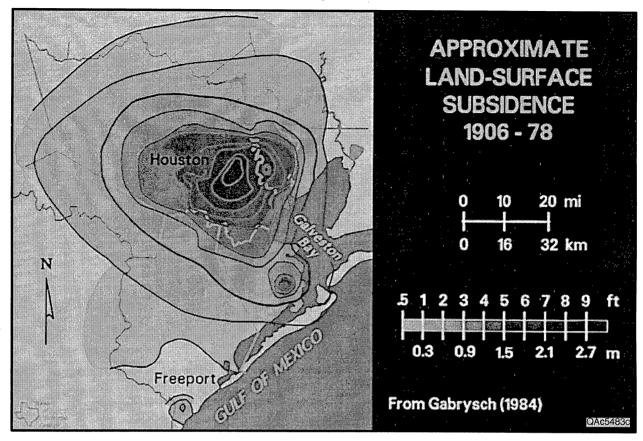
Figure 7. Land surface subsidence in the Houston-Galveston area from 1906-1978.⁽²⁶⁾ This is a period during which much of the subsidence took place in the eastern part of the subsidence bowl. Since the late 1970's, reductions in rates of ground-water withdrawal in that area have greatly reduced rates of subsidence.⁽¹⁹⁾

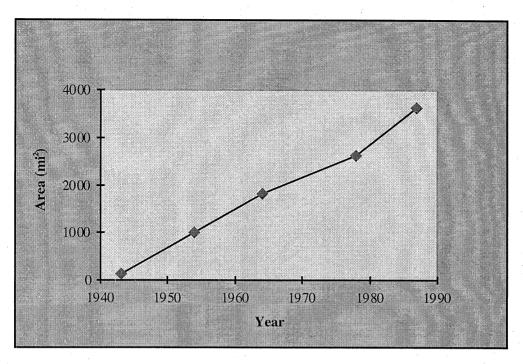
Figure 8. Growth of the Houston-Galveston area subsidence "bowl" from 1943 to 1987. Defined by cumulative area in which subsidence is more than one foot. (16,19)

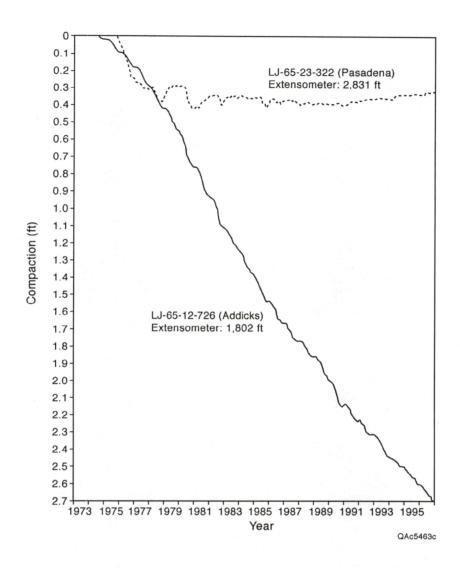
Figure 9. Cumulative compaction as measured by extensometers located at Pasadena and Addicks. ⁽²¹⁾ Pasadena is located on the eastern side of the subsidence bowl, and Addicks is on the western side. Note that cumulative compaction at Pasadena was high in the mid-1970's, but since that time has leveled off and even had some reversals, whereas at Addicks, rates of compaction remained high from the 1970's to the 1990's.

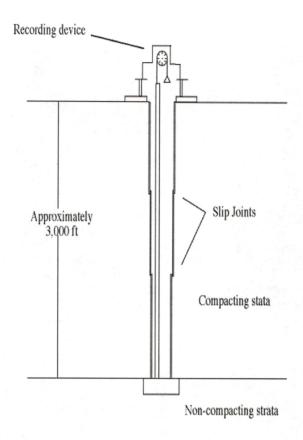
Figure 10. Illustration of a typical borehole extensometer. The inner rigid pipe maintains its position with respect to the outer segmented pipe and surface installation, which become lower as subsurface strata compact. The amount of compaction or shortening is measured by the wire tape rolling over the drum.⁽²⁷⁾

Methods of measuring subsidence include conventional leveling, extensometers, tide gauges, and more recently, Global Positioning Systems (GPS). Conventional leveling is the most frequently used method, and involves comparing the elevations of benchmarks through time using precise leveling techniques. Borehole extensometers (fig. 10) have been used at specific locations to determine small changes in elevations; extensometers can provide very precise, continuous records with information on the compacting interval, but they are costly to install and have small areal application (see extensometer layer in GIS data files). Subsidence can be determined by comparing tide gauge records from two different stations, but this method is less precise than leveling and extensometers. Today, many benchmarks are releveled using satellites or GPS, which provide very precise measurements.

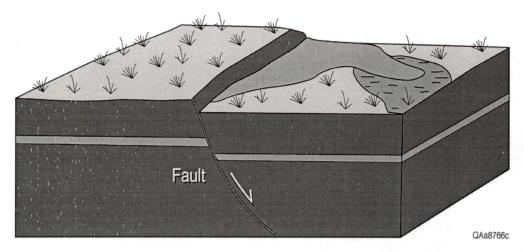
Figure 11. Diagram illustrating changes in wetlands along an active surface fault. There is generally an increase in low marshes and ponded water on the side of the fault that is moving downward.⁽¹⁷⁾

Geologically, active surface faults along the Texas coast are fractures in the earth's crust along which movement has occurred within the past few thousand years. Generally, the earth's surface moves downward or subsides at a faster rate on one side (downthrown side) of the fault than on the other side (Figs.s. 11 and 12). This produces a fault scarp or sharp change in elevation at the surface along the trace of the fault. Unlike faults along the West Coast where stress builds and then is released producing earthquakes, earthquakes are extremely rare on the Texas Gulf Coast. Nevertheless, active faults are significant geologic hazards because their movement at the surface breaks and bows structures such as highways, railroads, foundations of residential and commercial developments, pipelines, air field runways, football stadiums, and other features. Millions of dollars of damage are caused annually by faults. Natural resources such as wetlands are also affected by faulting. As the land surface moves downward along a fault that intersects a wetland, more frequent and eventually permanent inundation can lead to replacement of marsh vegetation by open water (fig. 11).

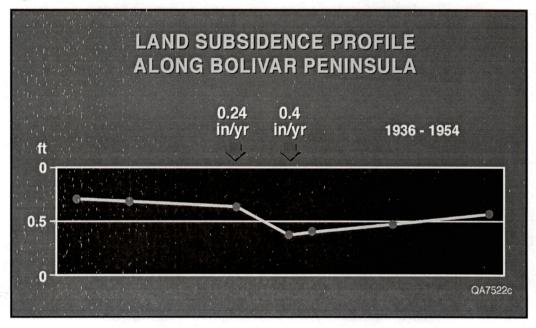
Figure 12. Profile constructed from benchmark releveling surveys that cross a fault along a highway on Bolivar Peninsula. The increase in subsidence of 0.24 in/yr to 0.4 in/yr shows that the downthrown side of the fault is subsiding at a faster rate than the upthrown side for the period of the surveys, 1936-1954. Fault activation and subsidence at this site appear to be associated with hydrocarbon production.

Analysis of aerial photographs is a common method used to detect possibly active faults. Photographs showing linear and curvilinear features across which there are changes in colors and tones provide evidence that a fault may be present (fig. 14). These tonal variations across a fault may be caused by a combination of factors such as changes in vegetation, soil moisture, soil types, standing water, and elevation. Analysis of sequential photographs can provide evidence that a linear feature is an active fault. Many faults are not visible on historical photographs but are visible on more recent photographs, which indicates that they have become active recently. Other lines of evidence of fault activity are (1) reoccurring breaks and repairs in pavements, buildings, and other structures, (2) abrupt changes in elevations as shown on topographic maps, and (3) sharp changes in the rates of subsidence along benchmark releveling profiles (fig. 12).

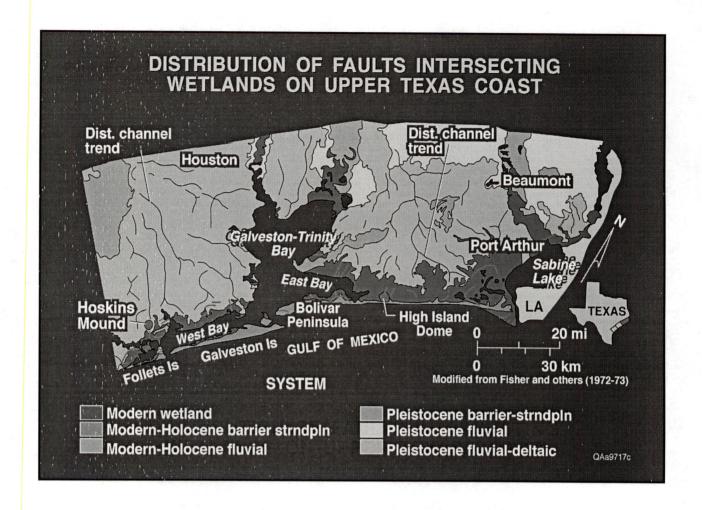
Figure 13. Surface faults, shown in red, that intersect marshes between Follets Island and the Louisiana border. The faults were mapped from sequential aerial photographs. Only about 25 percent of the faults were visible on photographs taken in the 1930's, but the remaining 75 percent could be seen on later photographs indicating that they have become active since the 1930's. (28)

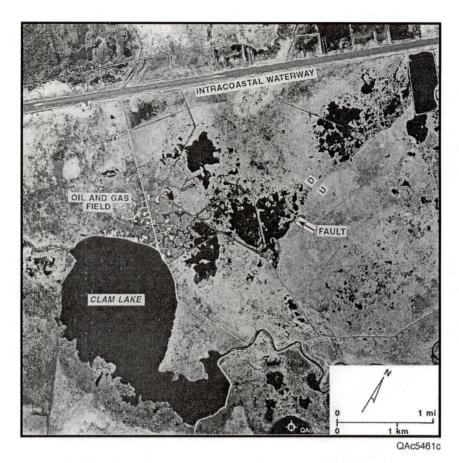
Figure 14. Example of fault trace on a photograph taken in 1989 in the Clam Lake area between Sabine Lake and Galveston Bay. Topographically low marshes and open water (black areas) are more abundant on the side of the fault that is moving downward (labeled D). This fault is not visible on aerial photographs taken in the 1950's, but it is on photographs taken in the 1960's or later indicating that movement along the fault has occurred since the 1950's.⁽¹⁷⁾
