FINAL REPORT

Texas High School Coastal Monitoring Program: 2022–2023

Bureau of Economic Geology

September 2023

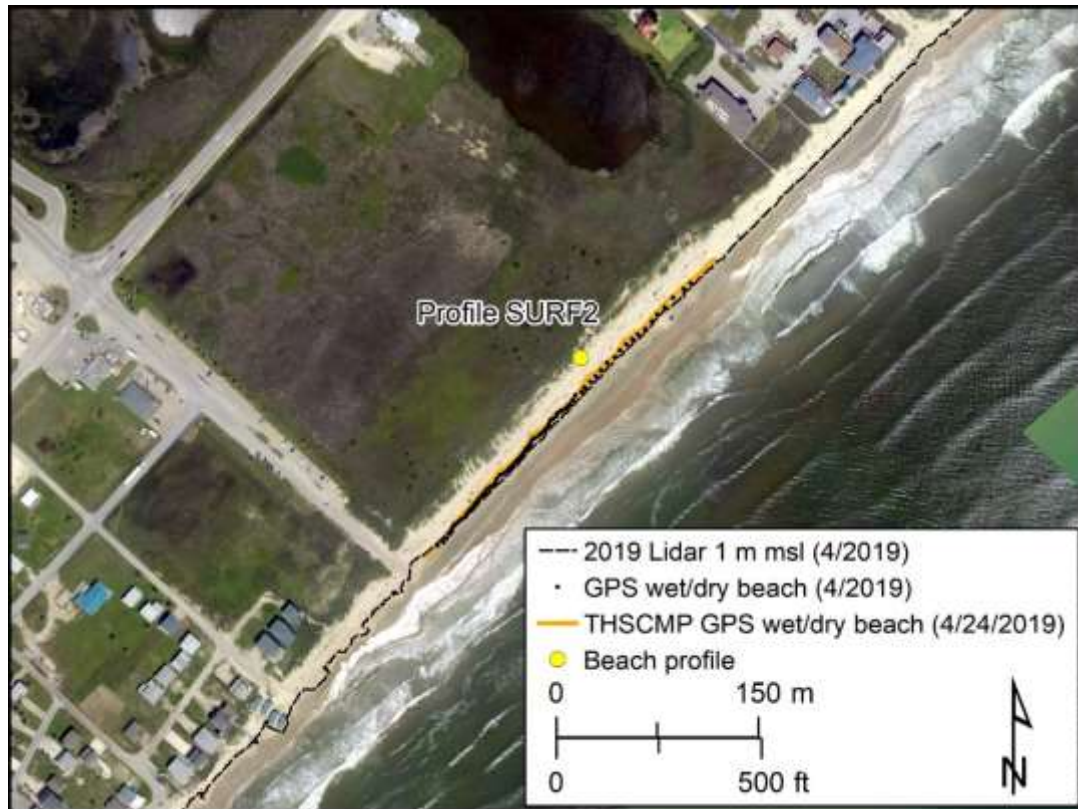
Figure 13. Shoreline position comparison at Surfside Beach site SURF2. Shorelines include the wet-beach/dry-beach boundary mapped on April 24, 2019, by THSCMP students and Bureau staff using ground GPS and the 1 m (3.3 ft) above mean sea level shoreline proxy extracted from airborne lidar data acquired in spring 2019, superimposed on 2019 Bureau imagery. From Paine and others (2021).

The latest update of long-term rates of Gulf shoreline movement along the Texas coast was calculated from 2019 data. The shoreline position extracted from 2019 lidar data was verified by visually comparing the shoreline proxy contour elevation with the wet-beach/dry-beach boundary as shown on georeferenced 2016 and 2018 NAIP aerial photographs and imagery acquired during the airborne survey. We used beach profiles and GPS-mapped shorelines acquired by the THSCMP near the dates of the lidar survey to compare the observed wet- and dry-beach positions. The Surfside Beach profile site SURF2 on Follets Island (**Fig. 13**; Paine and others, 2021) is representative of data comparison all along the Texas coast. At this site, there is excellent positional

agreement between the 2019 lidar-derived shoreline proxy; the wet-beach/dry-beach boundary mapped on April 24, 2019, by THSCMP participants and Bureau staff; 2018 NAIP imagery, and 2019 aerial imagery.

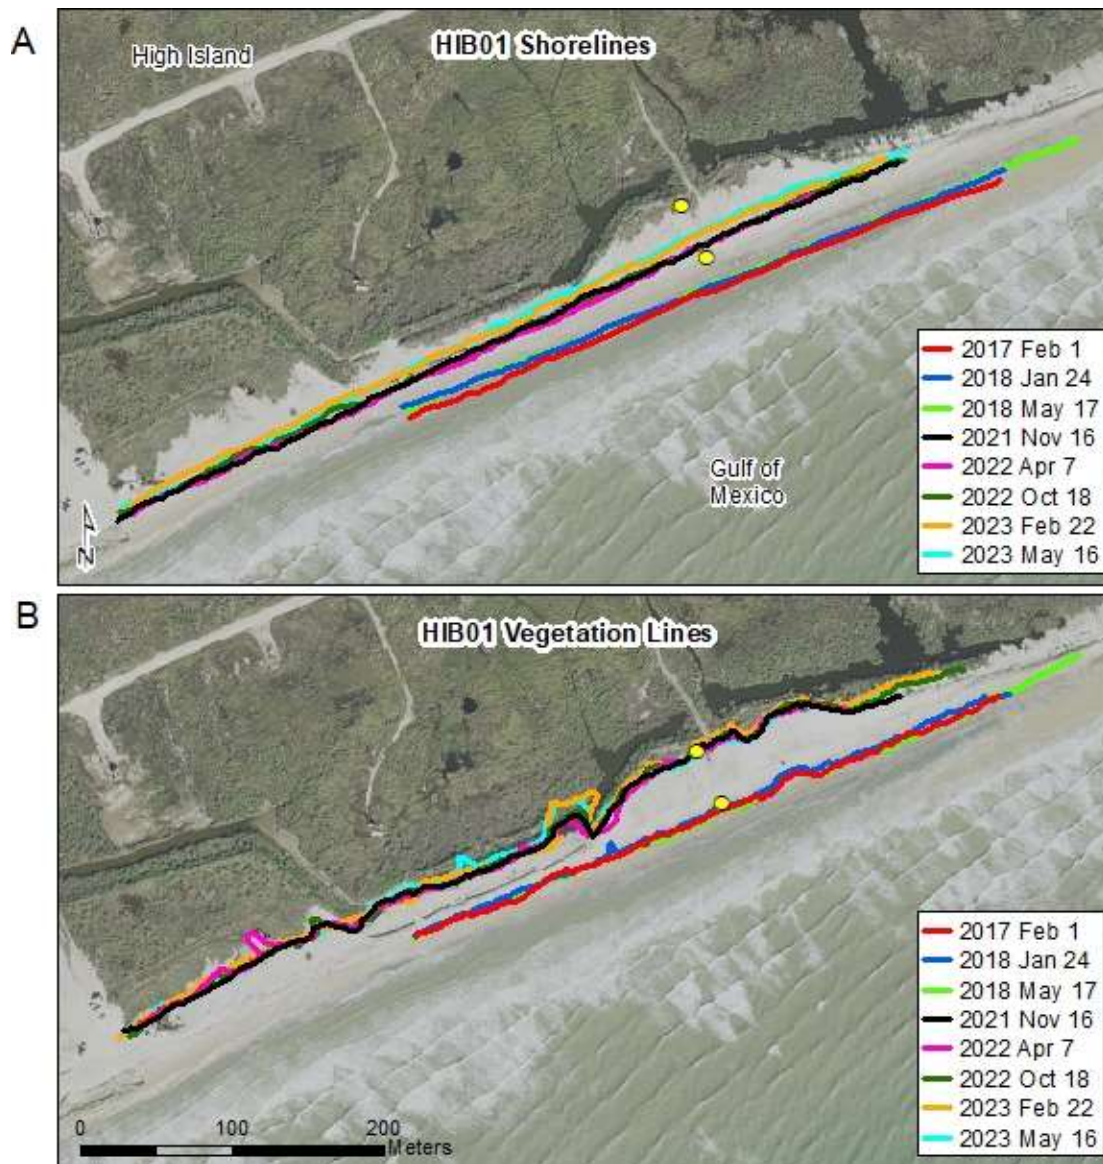
Figure 15. Changes to the position of the (A) shoreline and (B) vegetation line at HIB01 between February 2016 and May 2023.

Between the fall of 2018 and spring of 2021, HIHS students were unable to access the site at High Island Beach because of roadway construction at the intersection of Highway 87 and Texas 124. During that time, the shoreline and vegetation line positions moved landward due to the impacts of the 2020 hurricane season. The original profile site datum was lost due to the erosion of the beach at High Island and reset during the fall 2021 field trip. Between May 2018 and April 2022, the shoreline position moved landward 25 meters (just landward of the original profile datum location) and the vegetation line moved 45 meters landward (**Figs. 14 & 15**).

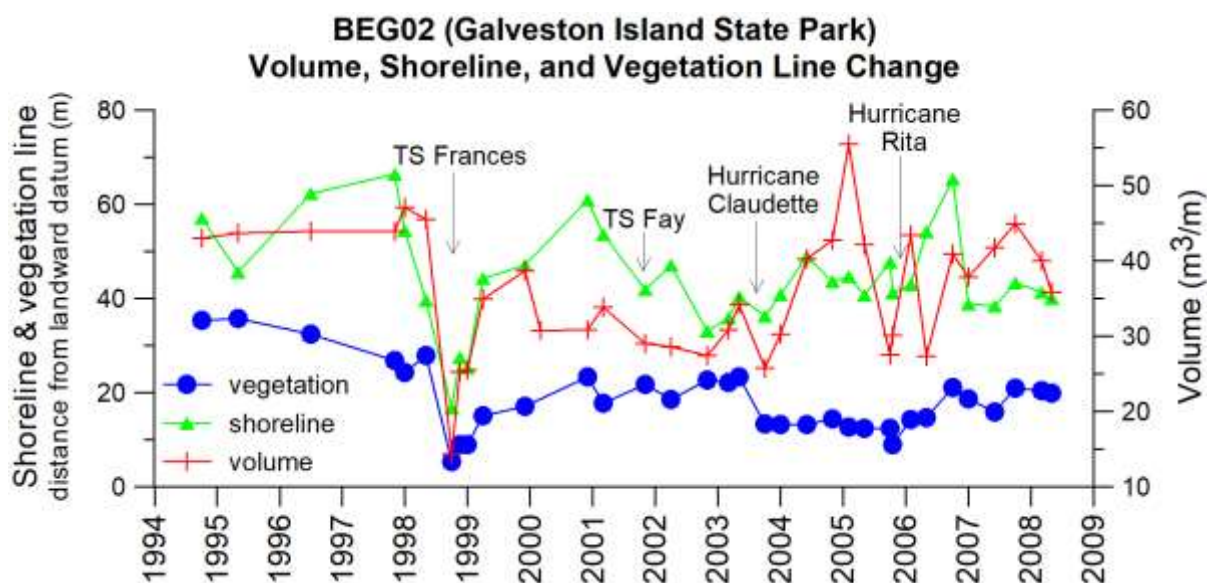
Figure 16. Profile volume, shoreline, and vegetation-line changes at Galveston Island State Park, September 1994–April 2008.

and Follets Islands documented the significant damage to beaches that Frances caused. The storm's damage was comparable to damage caused in 1983 by Hurricane Alicia (Gibeaut and others, 2002; Hepner and Gibeaut, 2004; Morton and Paine, 1985), a Category 3 hurricane on the Saffir/Simpson scale (Simpson and Riehl, 1981). Several other severe storms have also impacted the Galveston study area. Tropical Storm Fay (September 2002) and Hurricanes Claudette (July 2003) and Rita (September 2005) have each caused varying degrees of damage to beaches and dunes along the Texas coast (**Fig. 16**).

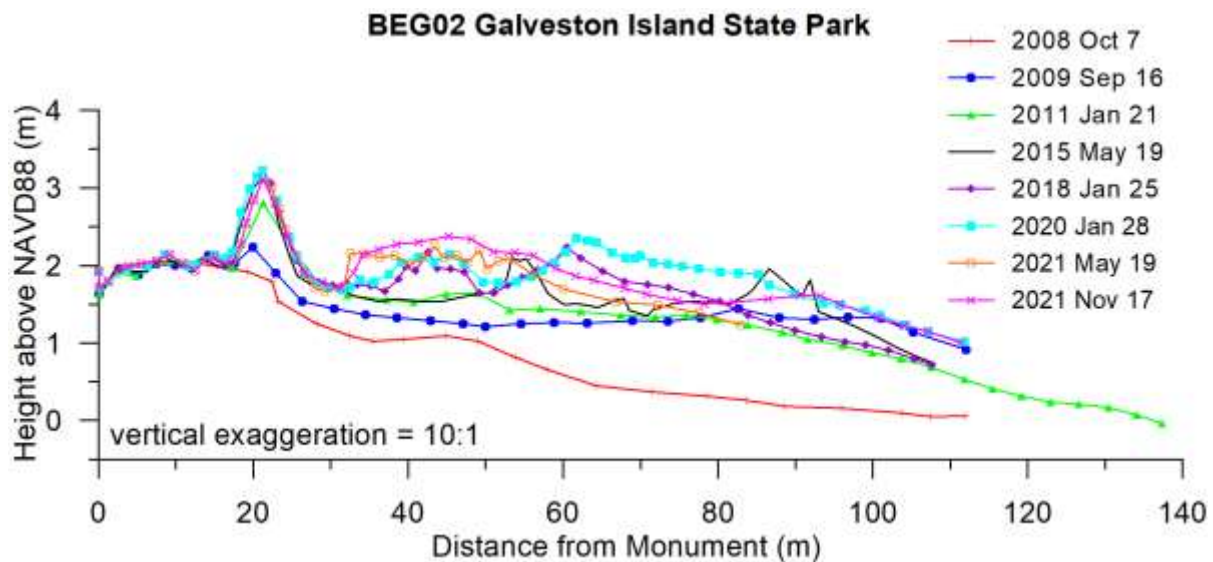
Figure 18. BEG02 datum-reset post-Hurricane Ike profile, plus data collected by Ball High School students. Students are monitoring recovery of the beaches and dunes at this site.

Ball High School students resumed monitoring beaches at the start of the 2009–2010 academic year. Their data collection from BEG02 has documented the recovery of the beach and dune system (**Fig. 18**). Between September 2009 and January 2011, the foredunes at BEG02 had begun to grow. Whether initial growth of the foredunes is due to natural recovery processes or human intervention is unclear. The foredune ridge grew in the intervening years, stabilizing around 2015, and a wide, vegetated zone with

expanding coppice dunes developed between the seaward base of the foredunes and the landward extent of wave run-up (**Fig. 18**).

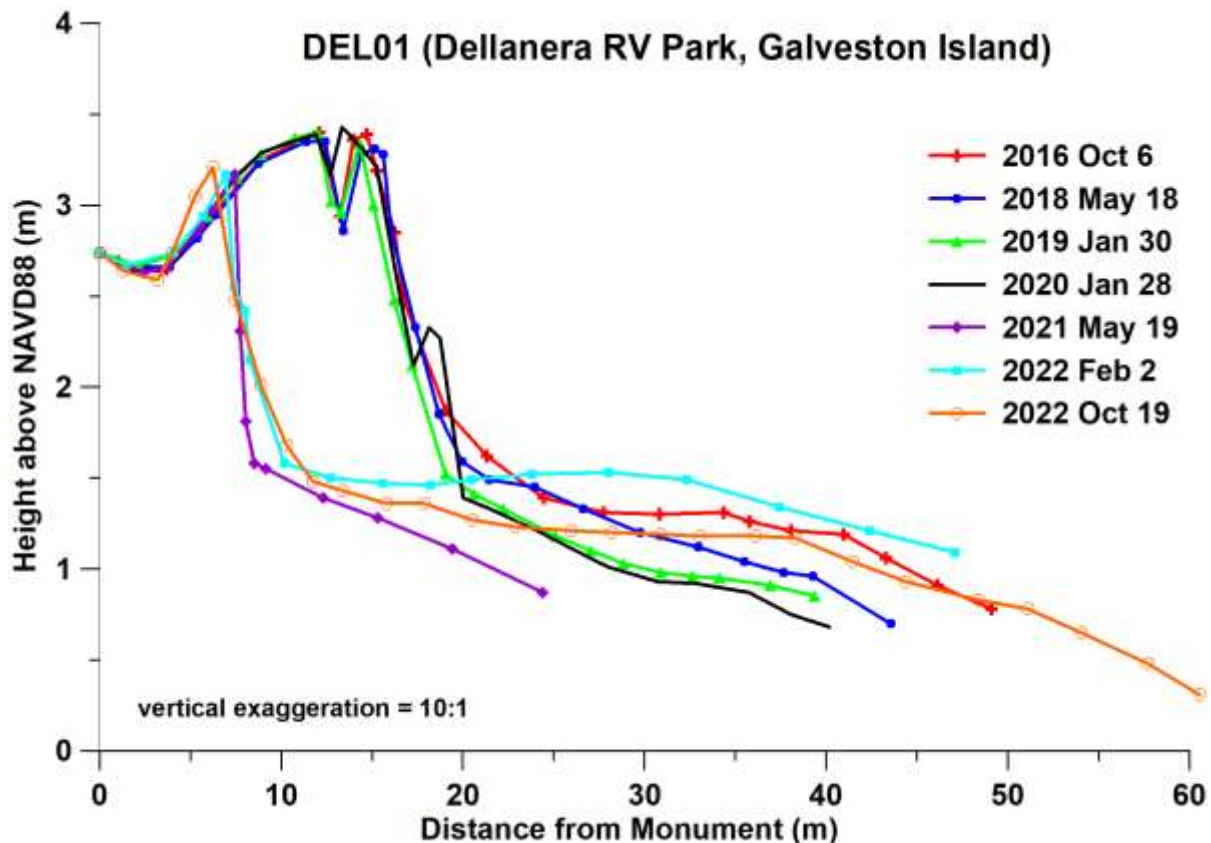
Figure 19. Erosion of the dune at DEL01 in the Dellanera RV Park due to the 2020 hurricane season.

The 2020 hurricane season caused beach and dune erosion at the three sites Ball High School students monitor. At Galveston Island State Park (BEG02), the beach was eroded landward and a washover feature was deposited in the coppice dune area (**Fig. 18**). At the site JAM02 in Jamaica Beach (**Fig. 6**), a community just to the south of the State Park, the 2020 hurricane season caused erosion of the reconstructed dune and landward movement of the vegetation line. The dune at the Dellanera RV Park (**Fig. 6**) that was created as part of a large nourishment and dune restoration project that took place in 2015, experienced significant erosion between January 2020 and May 2021 (**Fig. 19**). Over half the volume of sand in the beach/dune system was removed. A beach and dune restoration project (nourishment) was taking place during January 2023 field trip and students were unable to access the site. Ball students will start monitoring the project when field trips resume in the next academic year.

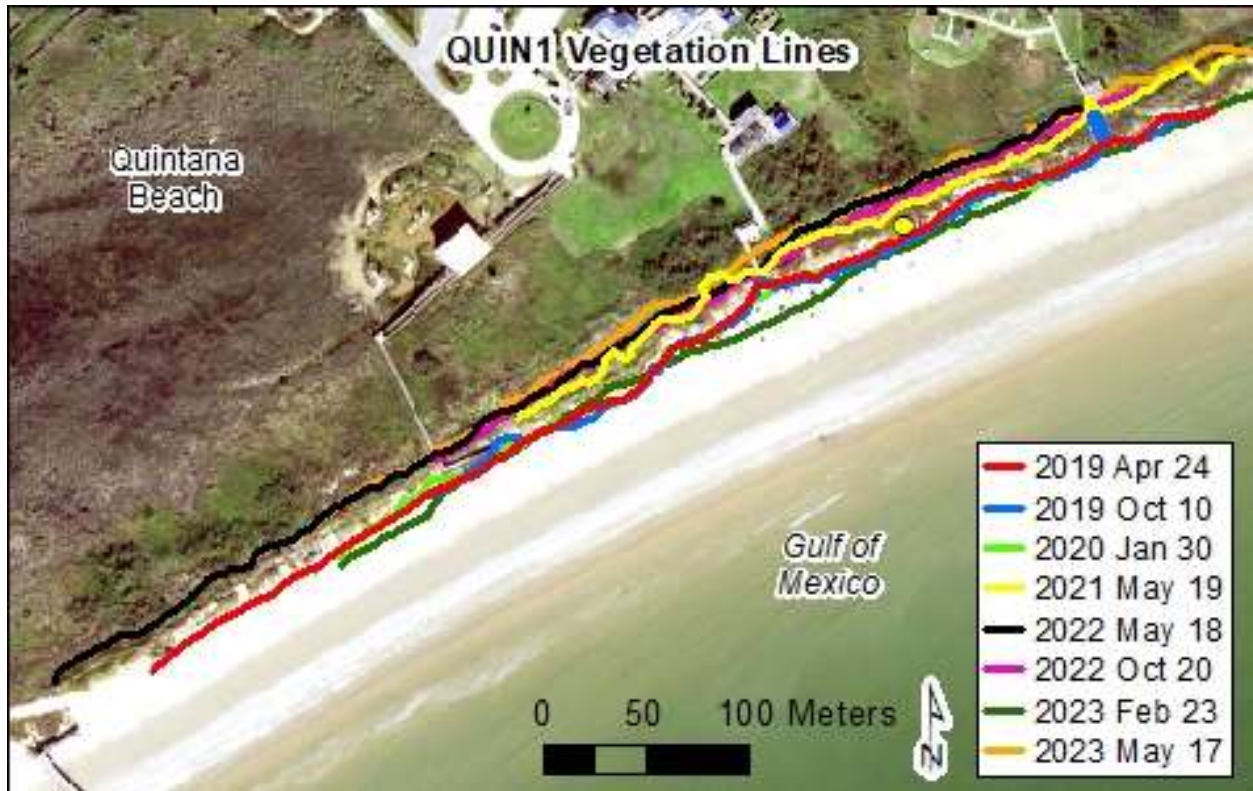
Figure 20. GPS mapping by Brazosport HS students of vegetation line positions at QUIN1 from April 2019 through May 2023.

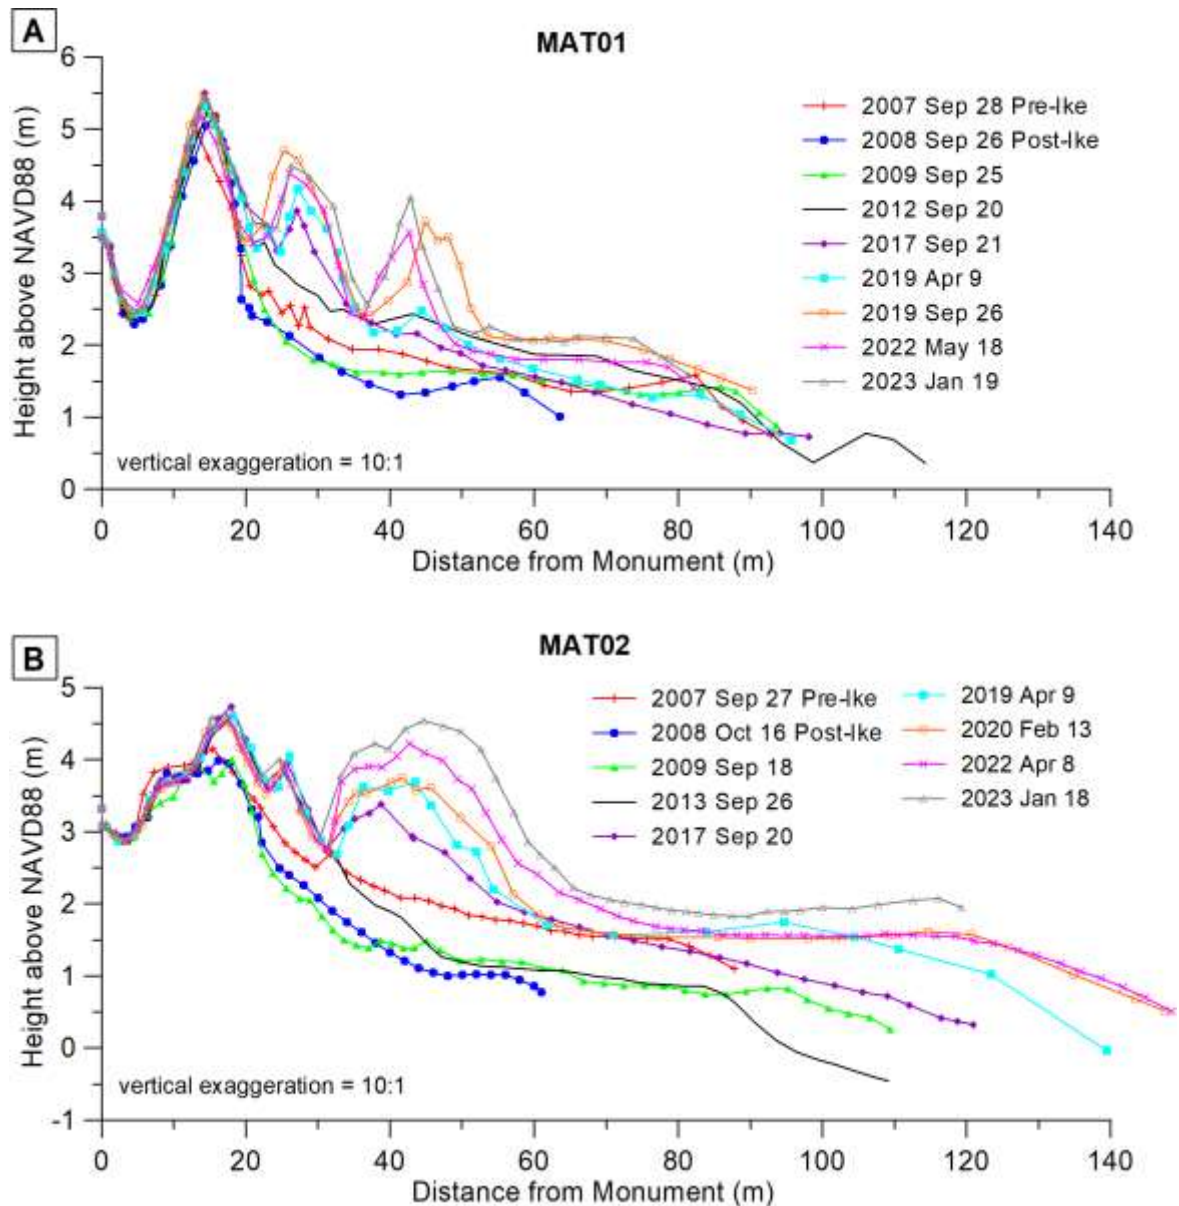
Figure 21. Pre– and post–Hurricane Ike profile data collected by Van Vleck High School students at (A) MAT01 and Palacios High School students at (B) MAT02. Students are monitoring recovery and growth of the foredune at these sites.

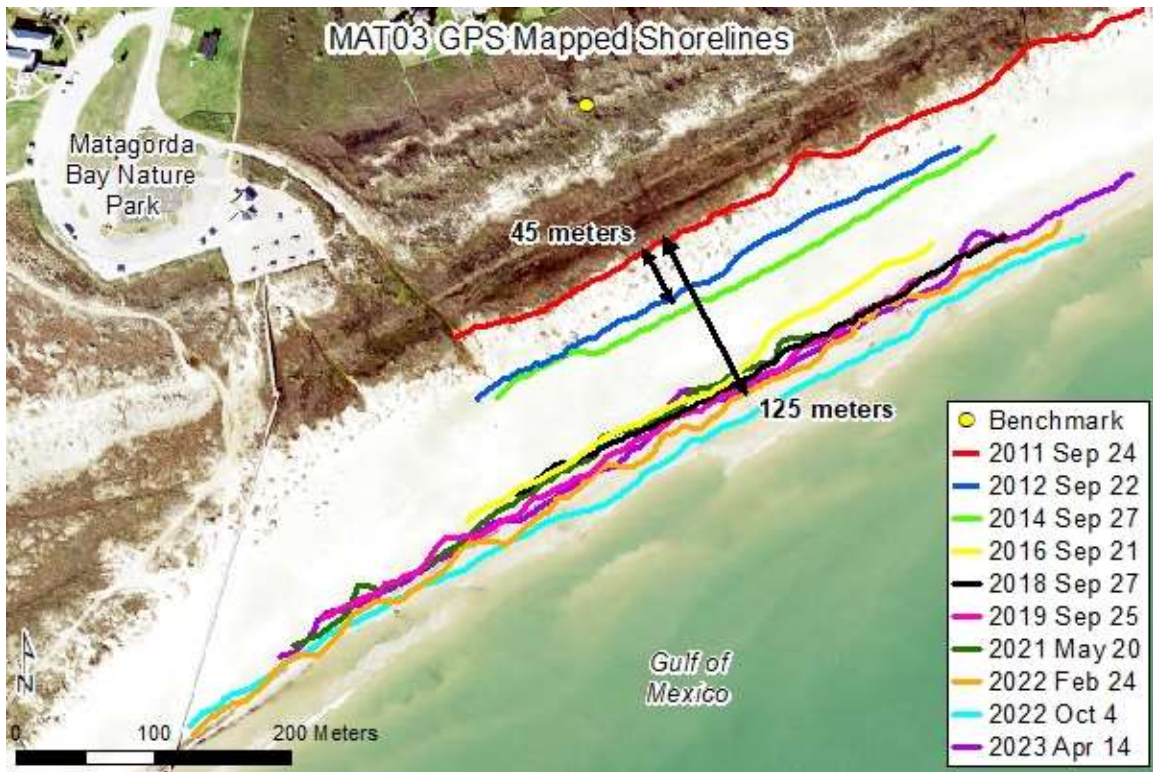
Figure 22. Shoreline position change at Matagorda Peninsula.

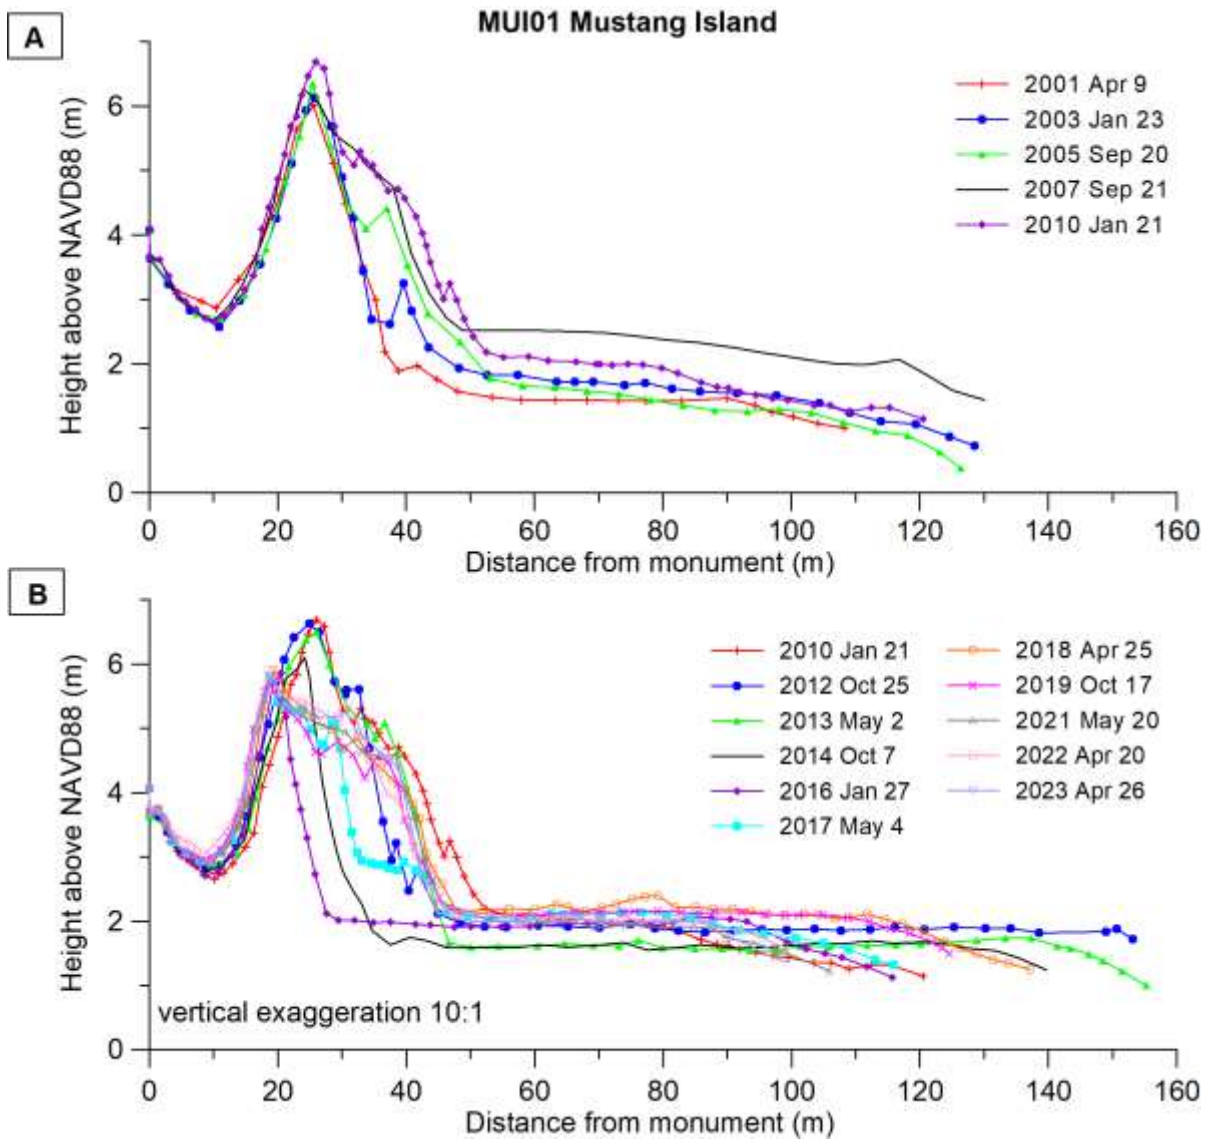
Figure 24. Changes at MUI01 on Mustang Island. (A) Expansion of the foredune between 2001 and 2009. (B) Changes in the foredune due to the beach-maintenance practice of dune notching.

When Port Aransas students arrived to collect profile data in October 2012, a large part of the dune face had been excavated for a beach-maintenance practice called dune notching (**Figs. 24B & 25**). Students documented that sand was replaced in the foredune by May 2013 and that the vegetation line has been reestablished at the toe of the dune. The dune was notched again during the 2014–2015 academic year. The current width of the foredune is still narrower, and the volume of sand in the profile is less than when the THSCMP began monitoring in 1999 (see change plot in Appendix B). Also, the crest of the foredune is lower in elevation because the dune crest was not stabilized by vegetation for a period of time, resulting in sand being carried away by the wind. The excavated area was slowly filled in between 2016 and 2018 (**Fig. 24B**). By the end of the 2018–19 academic year, the foredune was revegetated and stabilized. Between 2019 and 2023, beach profile volume, shoreline position, and vegetation line position has been stable.

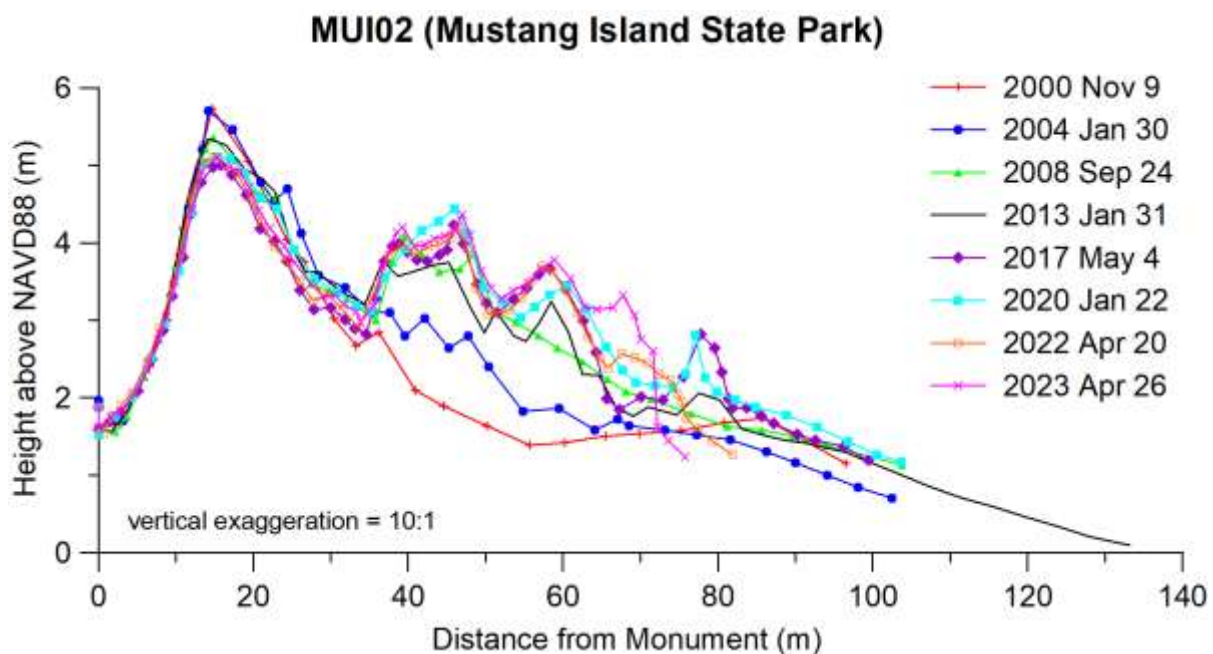
Figure 26. Student monitoring at MUI02 documents an increase in volume of the dune system and seaward migration of the vegetation line.

The MUI02 monitoring site is located within Mustang Island State Park, just to the south of Fish Pass where minimal beach maintenance is performed. This site has seen significant changes since student monitoring began in 2000. Port Aransas students have documented several lines of coppice dunes forming and coalescing into continuous dune ridges (**Fig. 26**). The dune system and vegetation-line position have expanded seaward, and total profile volume has increased at this location but shoreline position has remained stable throughout the monitoring program (Appendix B). The increased dune width and stable shoreline position have caused the beach width (distance between vegetation line and shoreline) to decrease (**Fig. 26**). There have been several field trips since 2020 where the wet/dry line is very close to the vegetation line or a scarp is present on the small, seaward-most dune crest. During the April 2023 field trip, the seaward-most dune crest had been removed and a large scarp was present on the next dune line (**Fig. 26**).

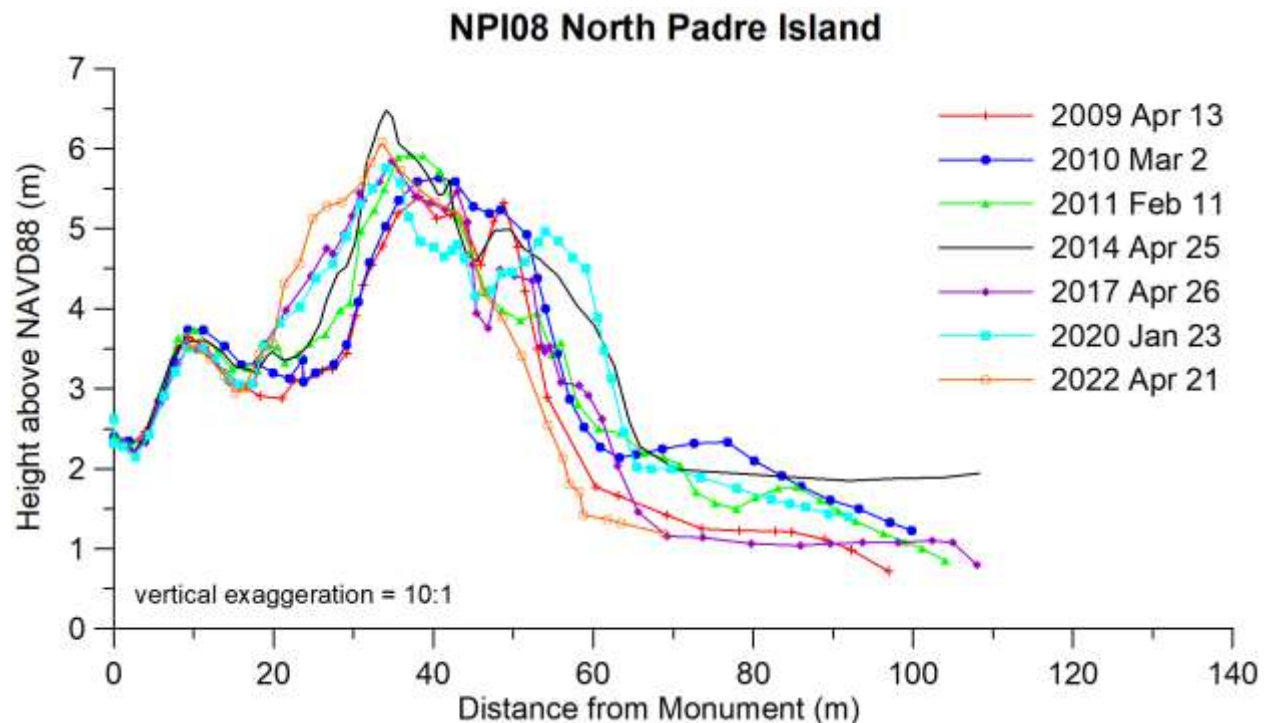
Figure 27. Foredune crest changes at NPI08 monitored by Cunningham Middle School students.

Cunningham Middle School at South Park students monitor sites on North Padre Island (**Fig. 10**) that are interesting to compare with the well-vegetated foredunes on Mustang Island to the north. The students have documented many changes at the NPI08 profile location, which is located adjacent to the northern Padre Island seawall. The dune crest at this site is sparsely vegetated which creates an opportunity for prevailing winds to constantly rearrange and alter the shape and height of the dune crest (**Fig. 27**). Sand is often removed from the dune crest by the wind and deposited at the landward toe of the dune. Until vegetation covers the crest of this dune, it will remain a dynamic site.

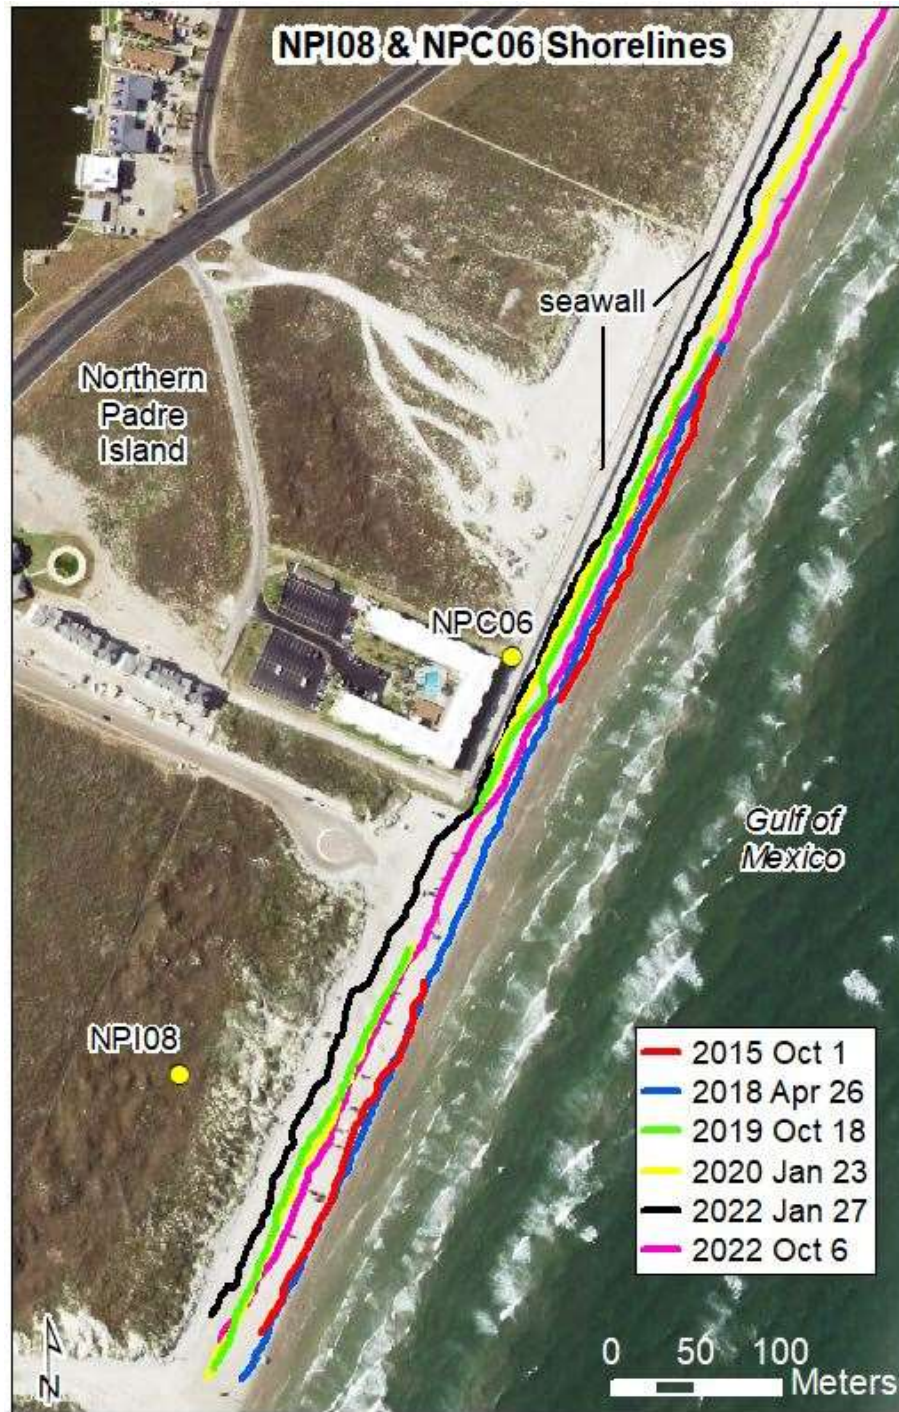
Figure 28. Shoreline position change between 2015 and 2022 along southern end of North Padre Island seawall and adjacent beach.

The site NPC06, near the southern end of the North Padre Island seawall (**Fig. 10**), was added in 2015 to track the effects of nourishment projects and maintenance activities on the beach in front of the seawall and the adjacent natural area (NPI08). The beach in front of the seawall is periodically nourished with beneficial use material from maintenance dredging of Packery Channel. Cunningham students have mapped the

landward movement of the shoreline position since the last beach nourishment (**Fig. 28**). Occasionally, the narrow beach in front of this southern end of the seawall is completely submerged at high tide.
